# ABS Wheel Speed Fault Code Correction for MBSP Equipped Vehicles

## TSB-42-080-FTL

► New Cascadia

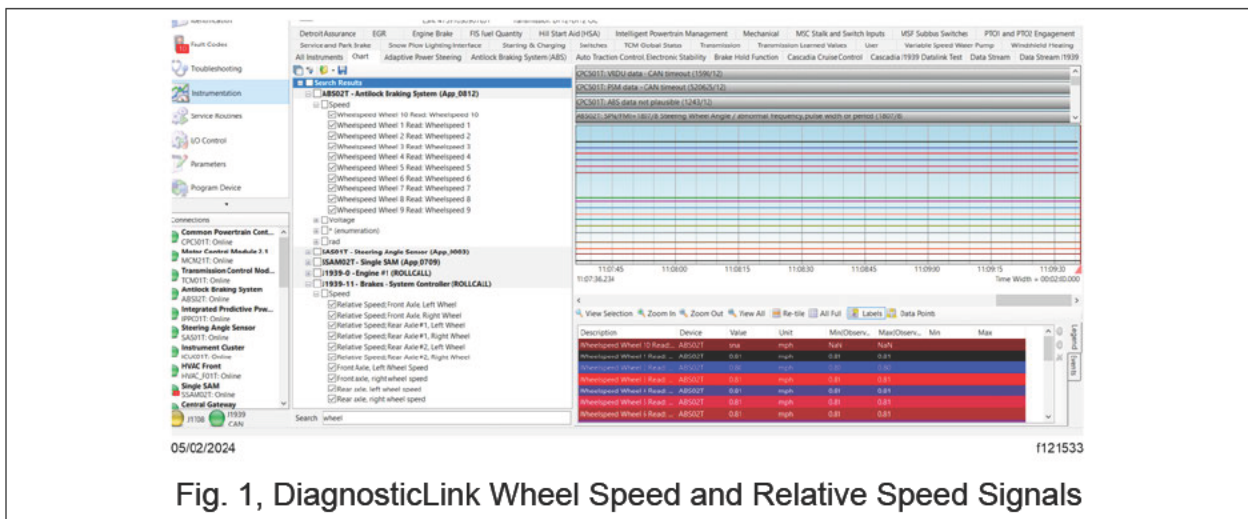
Fig. 1, DiagnosticLink Wheel Speed and Relative Speed Signals

13. ☐ During the test drive, monitor the wheel speeds using DiagnosticLink and ensure that the ABS module and all J1939 connections are active. Do the wheel speeds appear erratic, spike up, or show readings when the vehicle is stationary? It is recommended to refer to the chart instead of the ABS tab/panel. See Table 4 and Fig. 1 for the charting selections in DiagnosticLink.

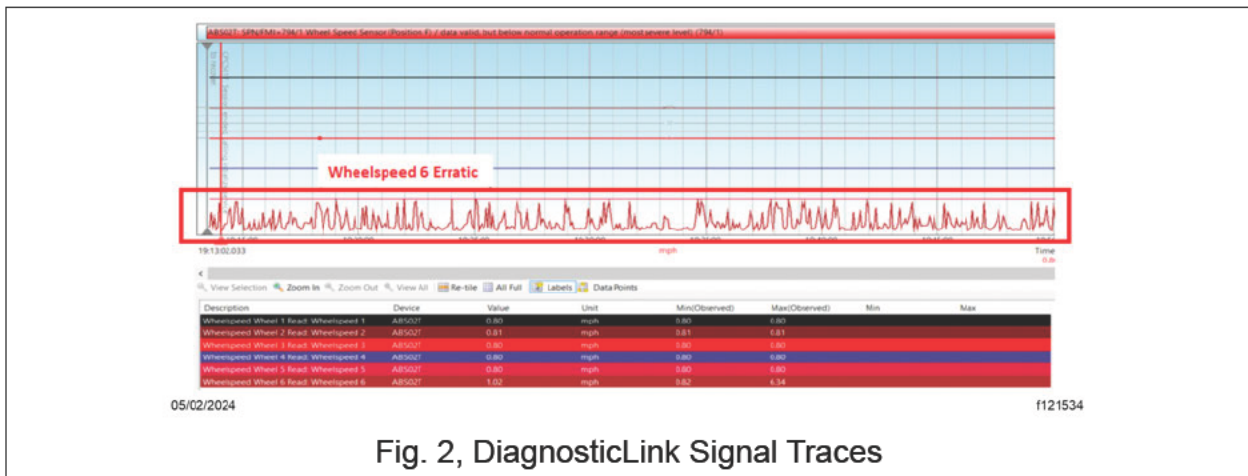
Fig. 2, DiagnosticLink Signal Traces

14. ☐ See Fig. 2 for the traces of the selected wheel speed and relative speed signals. Note the erratic signal on wheel speed 6.

a. ☐ If the readings are erratic regardless of location, or if the issue only happens in damp or wet conditions, install the individual overlays for all four rear wheel ends. See Table 5 for length and part number of WABCO harnesses.
