# Removing Odometer Pause Wiring Modifications

## TSB-54-375-FTL

- ▶ Business Class M2-Plus
- ▶ 108SD Plus/114SD Plus

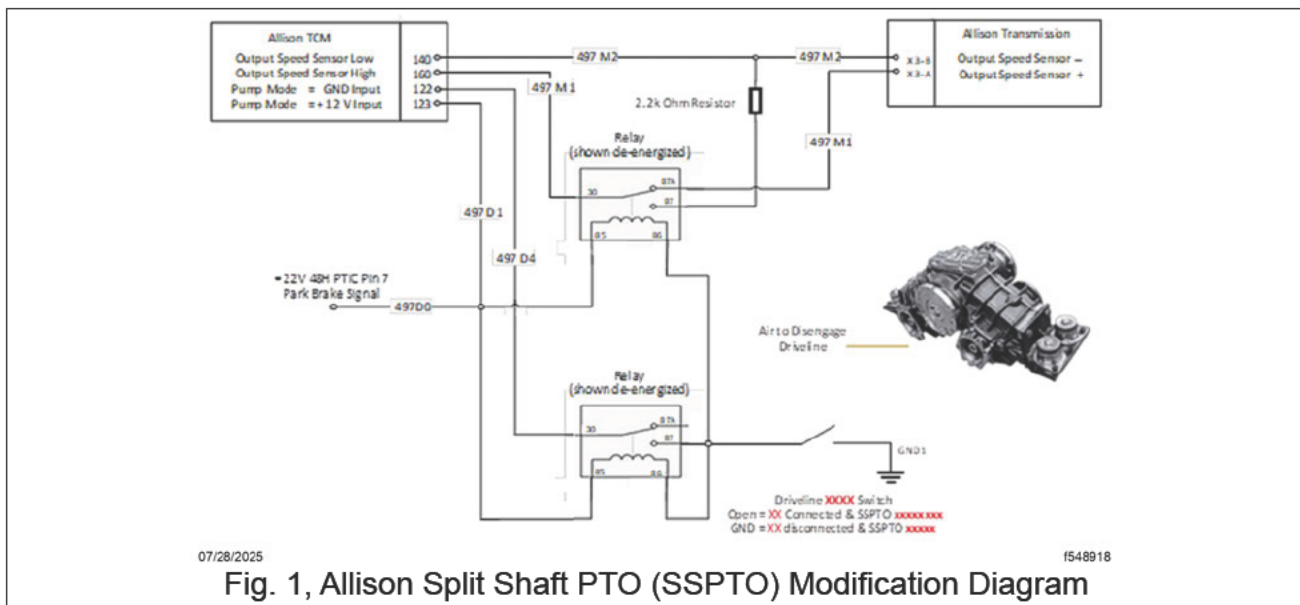
Figure [1](#) shows the modification diagram for the system to be removed.

**Note:** With the relays removed, the control signals, directed to the park brake signal node, and the driveline disconnect switch are to be connected to the Allison Transmission Control Module (TCM) pins 122 and 123. Control signals to TCM 123 and 122 are to be re-established. The two relays no longer sequence signals to the TCM.

1. ☐ Remove the 2.2K ohm resistor. Leave the circuit 497M2 intact.

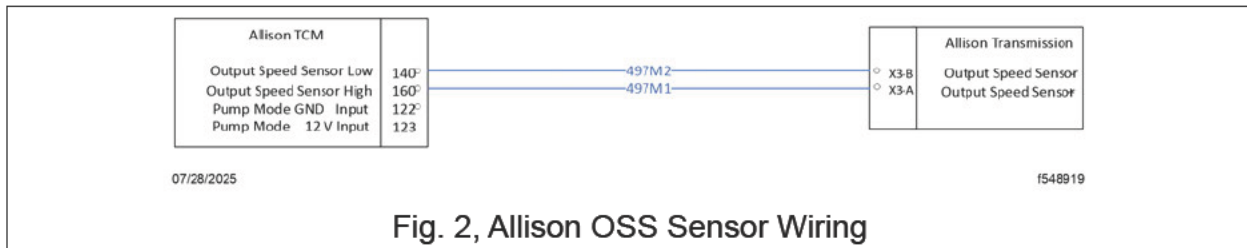
2. ☐ Remove both ends of 497M1 from the relay and connect 497M1 again. Leave the TCM pin 160 and the output speed sensor pin X3-4 intact. The final configuration is shown in Fig. 2.

3. ☐ Remove the remaining relay for the driveline status. Keep the wires 497D1 and 497D4 intact. These wires connect to the TCM pins 122 and 123 and are re-used.
4. ☐ After the relay circuits are removed, the fourth gear lock-up function needs to be enabled by sending power to TCM 123 and a switch to ground for TCM 122 when the driveline is disengaged, and the SSPTO is engaged.
  - TCM 123 reflects the selection of pump mode by the operator and the application of the park brake.
  - TCM 122 indicates that the split shaft PTO is fully engaged, and the driveline is disengaged.
