Service Campaign ID: 76 – 02 Trimark PTL Doors

Issued Date: July 1, 2026

# Technical Service Bulletin

## TSB102

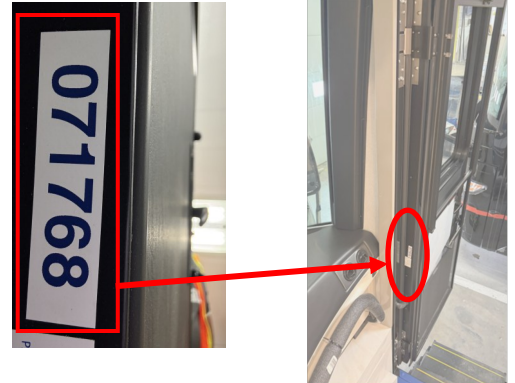
Confirm your door serial number is within #068849 through #072552

Similar to the sticker shown, if your coach serial number is within the range mentioned above, please proceed to Step 1. If your coach door serial number is outside of this range, you can disregard these TSB instructions.

With the door fully open, you can locate the door serial number label on the hinge side, behind the screen door.

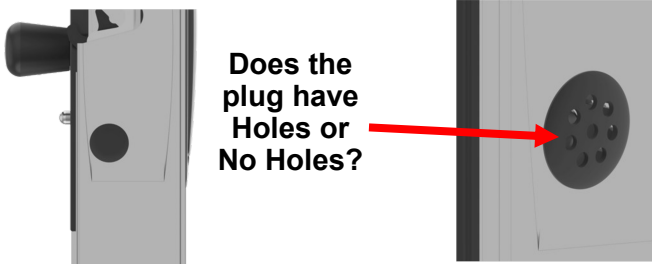
**Step 1:** Inspect the Black Plastic Plug on the door edge to see if there are holes on the top. If there are, the door hardware has already been upgraded, please disregard these TSB instructions.

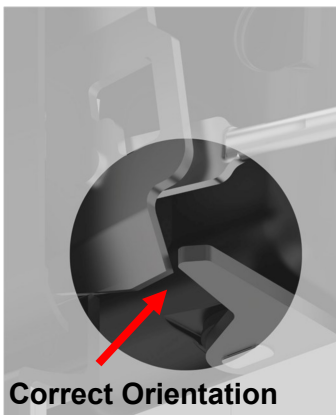
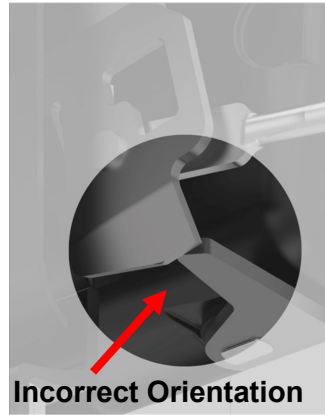
**Step 11a:** Lift the interior handle to make sure the system is seated properly, and the outside driving cam is behind the inside pivot plate, while pressing the inside and outside together.

Correct Orientation

Incorrect Orientation

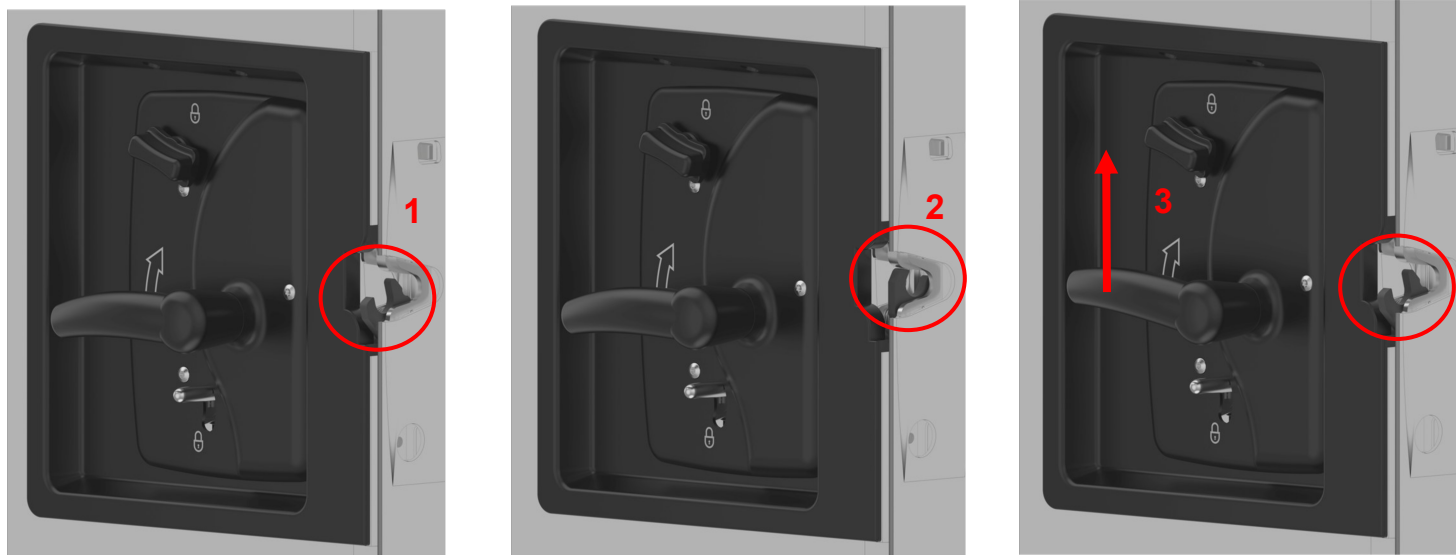
With the door open, manually close the latch and open the latch from the inside handle. The latch should release before the inside handle reaches maximum travel.

### Step 15a: Unlock the door.

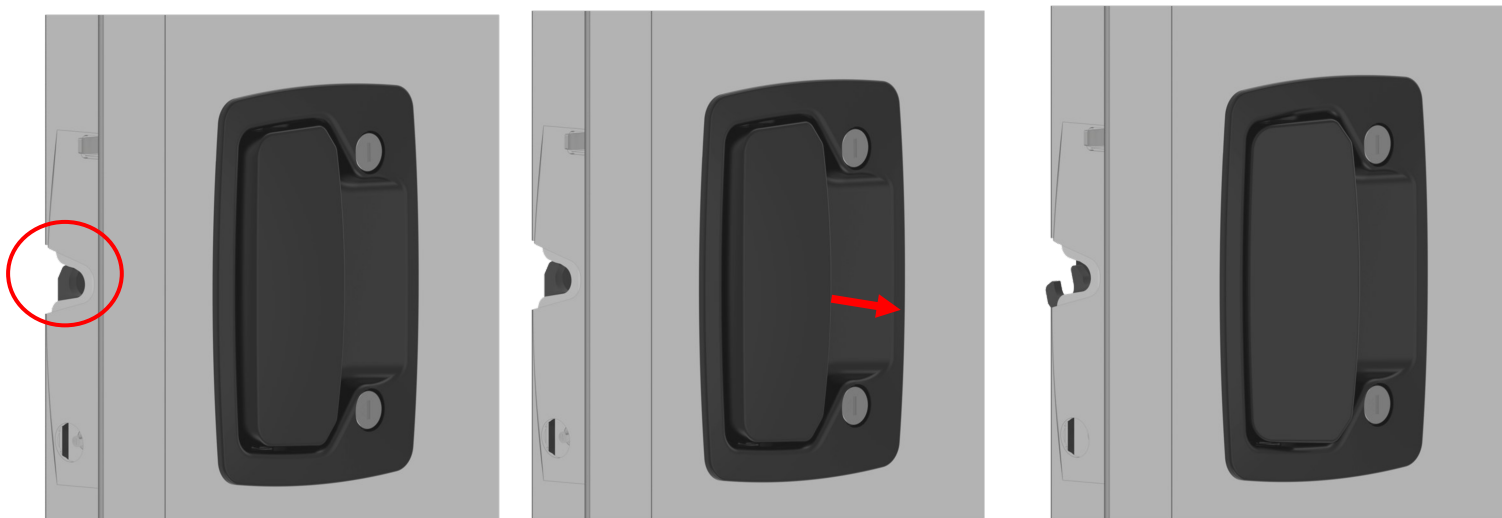
**Step 15b:** With the door open, repeat this operation sequence for the outside handle. The latch should release before the outside handle reaches maximum travel.
