| <b>Topic</b> | Guide on My Bentley App - Error MBB.HTTP.2 When Using Remote Services |
| <b>Brand</b> | Bentley |
| <b>Transaction No.</b> | 2080955/2 |

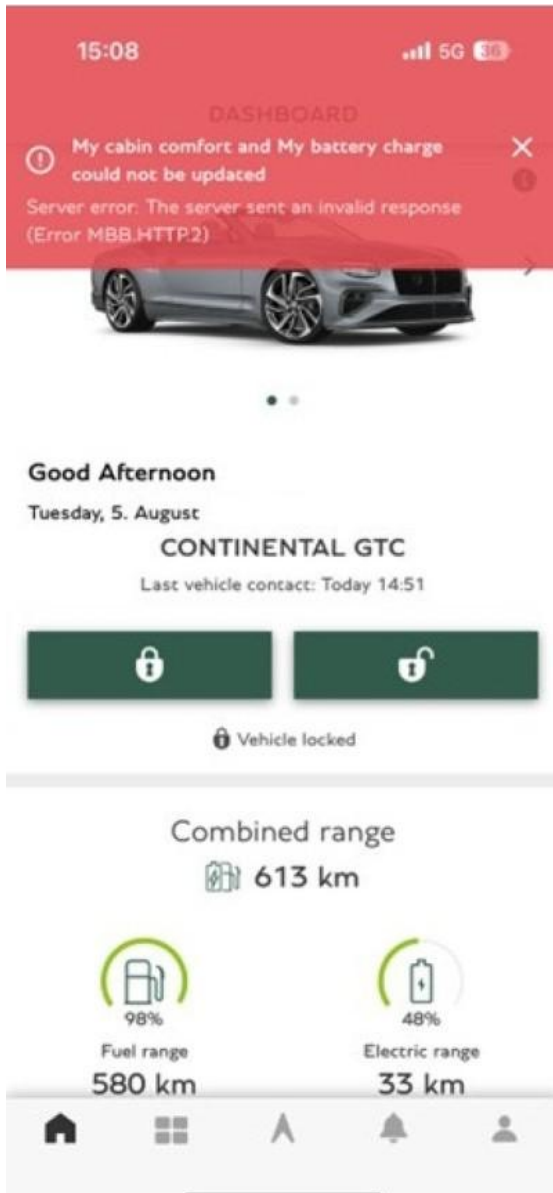
Customers may report that the My Bentley App displays an MBB.HTTP.2 error when attempting to use remote services such as Remote Climate or Remote Charging. The functions fail to initiate from the app.

**Figure 1.** My Bentley App MBB.HTTP.2 error

The MBB.HTTP.2 error is caused by remote climate and charging timers being set to invalid or nonnumerical values within the vehicles MMI. If either timer is set to an invalid state, remote commands from the app cannot be processed and the error is triggered.

1. Check the remote climate timer and the remote charging timer via the vehicles MMI display.

If either value displays incorrectly or appears blank/invalid (NaN) as shown in figure 2, set the timers to any valid time (e.g., 09:00 the following day).

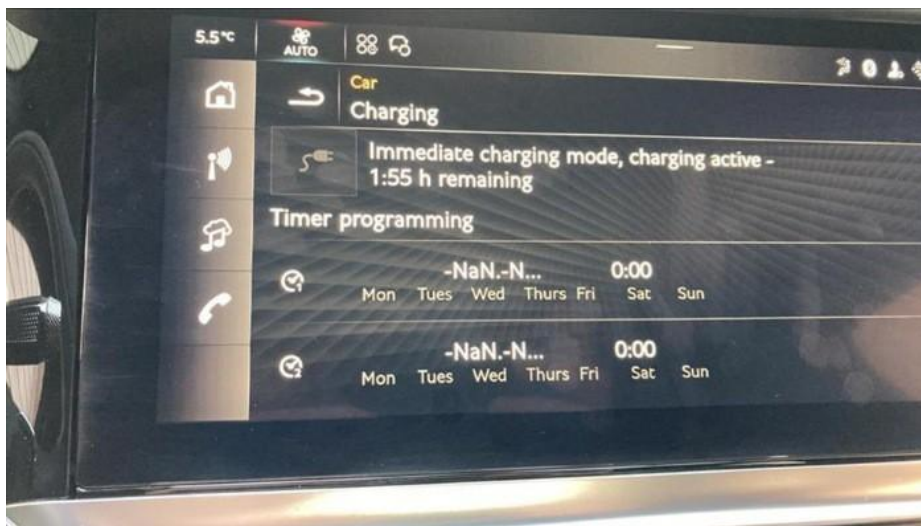
**Figure 2.** MMI displaying incorrectly set charge timers

2. Ensure both are set to valid times.
