| Topic | ODIS Error Message – Best Practice When Performing Baseline (BiL) Updates |
| Brand | Bentley |
| Transaction No. | 2078962/5 |

### 24-26MY Bentayga | 25-26MY Continental GT/GTC/Flying Spur

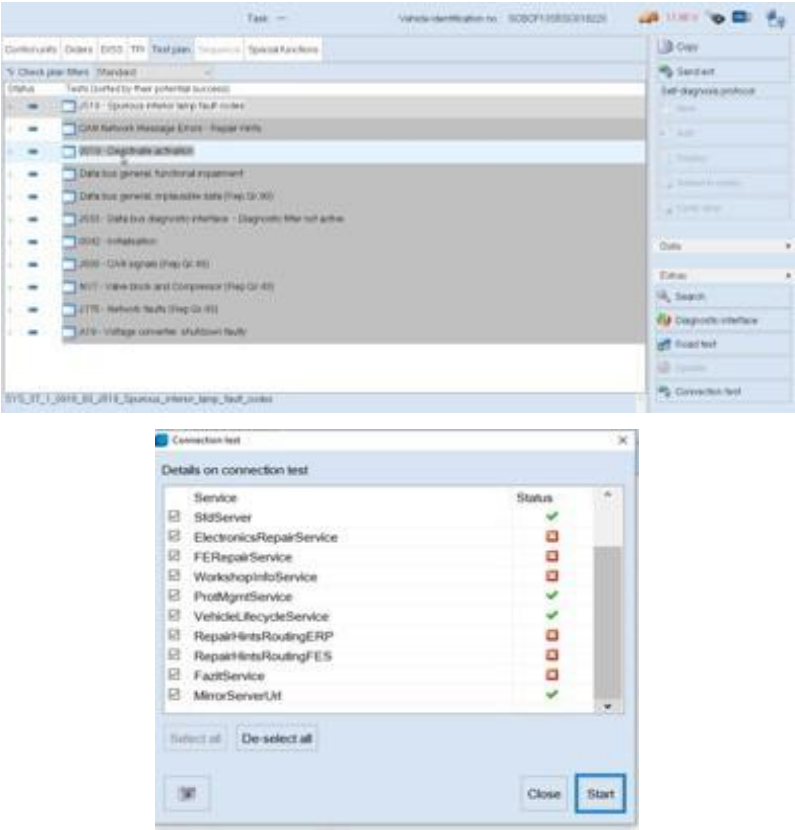
| Step | Action | Images |
|---|---|---|
| Check that the D3 Edge Box is connected | <ul style="list-style-type: none"><li>Perform the 'connection test' within the extra menu<ul style="list-style-type: none"><li>Navigate to "Extras" -&gt; "Connection Test" -&gt; Select "Bentley" (If Multi Brand) -&gt; "Select ALL -&gt; Start</li><li>If the Mirror Server does not return a green ✓ -&gt; Check your D3 setup and IP settings as per the next step.</li></ul></li></ul> | |

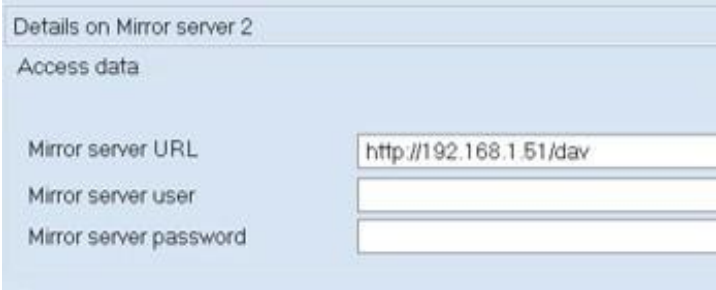
| Step | Action | Images |
|---|---|---|
| Mirror Server Settings | <ul style="list-style-type: none"><li>Check that the URL in the Mirror Server 2 is correct for the new D3 edge box.<ul style="list-style-type: none"><li>Refer to "Operating Modes" -&gt; "Admin" -&gt; "Connections" -&gt; "Mirror Server 2;;.</li></ul></li><li>Ensure that the URL is http://.. And NOT https://</li><li>Enter the mirror server URL into a web browser, and ensure that the flash files are visible on the server.</li></ul> | |

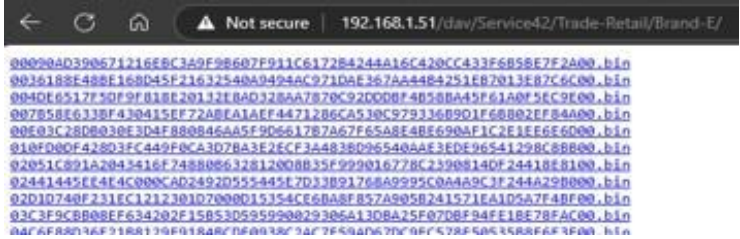
| | <ul style="list-style-type: none"> <li>Copy &amp; paste the Mirror server address into a web browser e.g Microsoft edge) -&gt; Navigate to the flash files location: XXX.XXX.XX/DAV/Service42/Trade-Retail/Brand-E/</li> </ul> | |

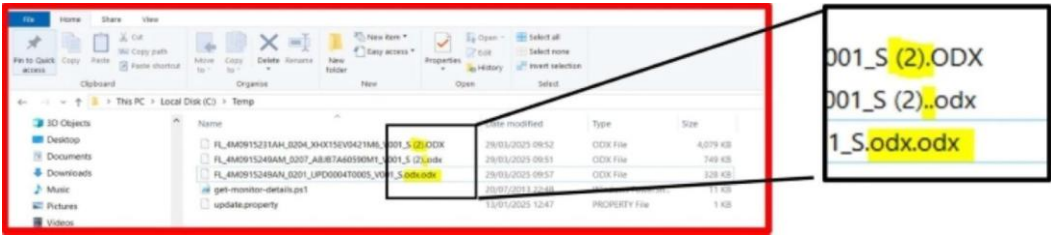
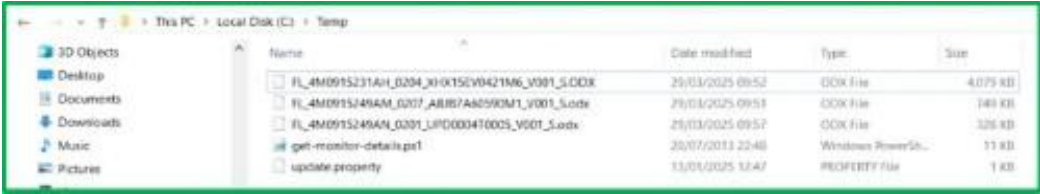
| Local Flash Containers (Using files from c:/temp) | <ul style="list-style-type: none"> <li>If a flash file is being used locally, eg ED40, ED42 download from atheer – this means that the flash container is extracted directly form the C:/temp folder on the users ODIS tester.</li> <li>If the flash files are downloaded incorrectly, or not extracted from the ZIP folders correctly, this means ODIS cannot identify the correct flash file.</li> </ul> <p>Example of Bad file structure / naming:</p> <ul style="list-style-type: none"> <li>Duplicated Download Suffix</li> <li>Multiple or incorrect file extension types</li> </ul> |

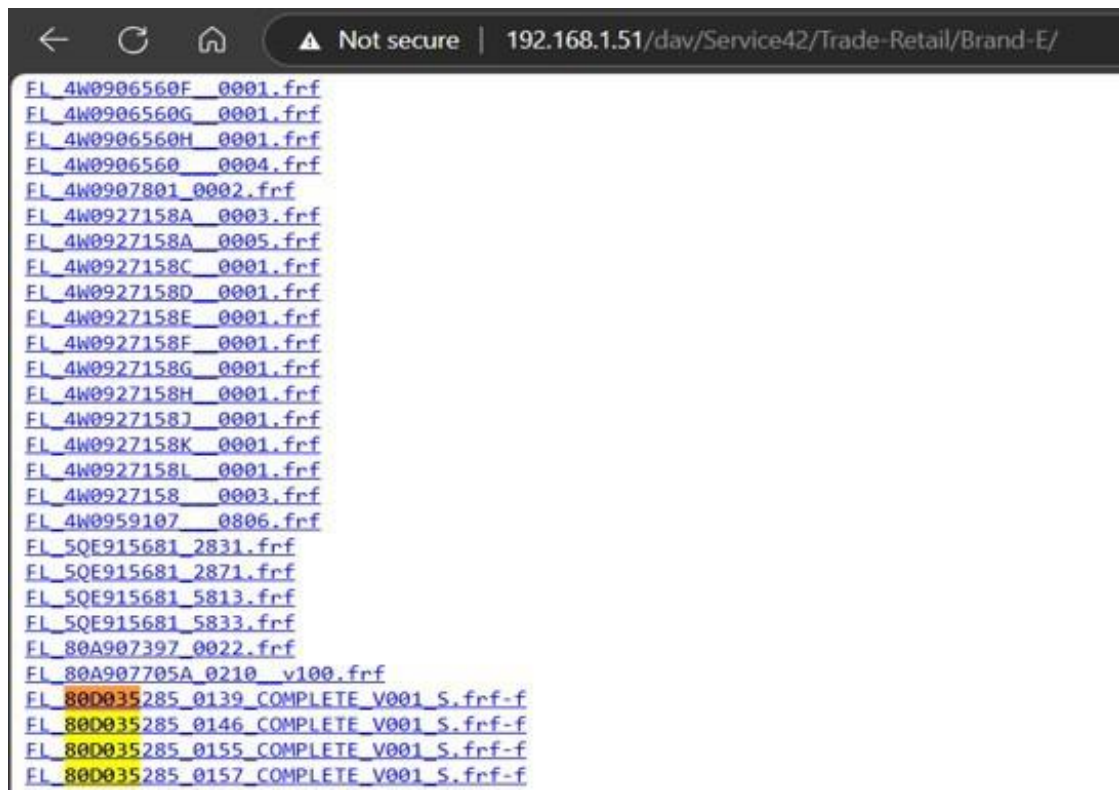
| <p>Online<br/>Link Flash<br/>Containers<br/>(using an<br/>SVM<br/>Code)</p> | <ul style="list-style-type: none"> <li>• When an ECU requires a software update through SVM, ODIS will pull the file from the mirror server/ D3 edge box.</li> <li>• If the Flash Container can not to be linked, check if the files is present on the mirror server</li> <li>• To do this: <ul style="list-style-type: none"> <li>– Enter the mirror server URL into a web browser, and ensure that flash files are visible on the server.</li> <li>– Copy &amp; paste the mirror server address into a web browser (eg Microsoft edge) -&gt; Navigate to the flash files location: XXX.XXX.X.XX/dav/Service42/Trade-Retail/Brand-E/</li> </ul> </li> <li>• Then press 'ctrl' + 'f' and search the Mirror Server for that flash container.</li> <li>• In this example, the FRF file is available to be flashed with ODIS:</li> </ul> |
