## Technical product information

| Topic | ODIS Error Message – Best Practice When Performing Baseline (BiL) Updates |
| Brand | Bentley |
| Transaction No. | 2078962/6 |

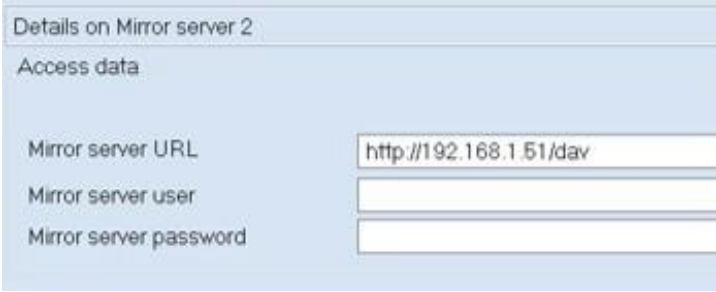
| Step | Action | Images |
|---|---|---|
| Mirror Server Settings | <ul style="list-style-type: none"><li>Check that the URL in the Mirror Server 2 is correct for the new D3 edge box.<ul style="list-style-type: none"><li>Refer to "Operating Modes" -&gt; "Admin" -&gt; "Connections" -&gt; "Mirror Server 2;;.</li></ul></li><li>Ensure that the URL is http://.. And NOT https://</li><li>Enter the mirror server URL into a web browser, and ensure that the flash files are visible on the server.</li></ul> | |

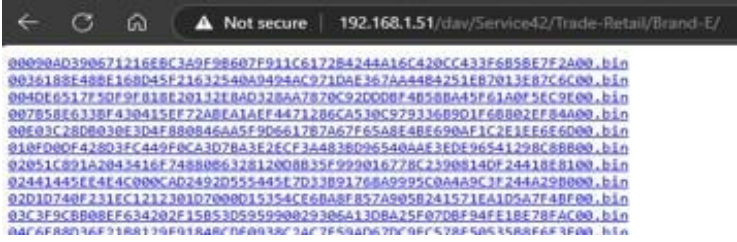
| | <ul style="list-style-type: none"> <li>Copy &amp; paste the Mirror server address into a web browser e.g Microsoft edge) -&gt; Navigate to the flash files location: XXX.XXX.XX/DAV/Service42/Trade-Retail/Brand-E/</li> </ul> | |
