# Service Alert

"HYBRID SYSTEM MALFUNCTION. HAVE THE VEHICLE INSPECTED." WARNING MESSAGE AND MULTIPLE DTC'S STORED

Service Alert No.: SA-044/26

2024-2026 CX-90 (H3T inline 6)

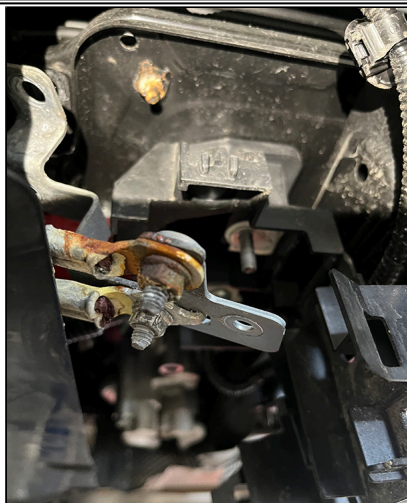
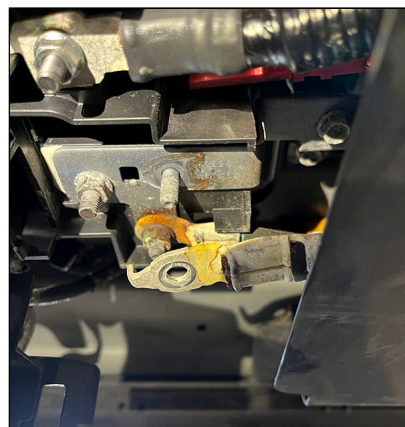
This may be caused by poor electrical connections at the front harness 48V battery terminals:

- Terminal 1442-102C
- Terminal 1442-102D
- Terminal 1442-102E

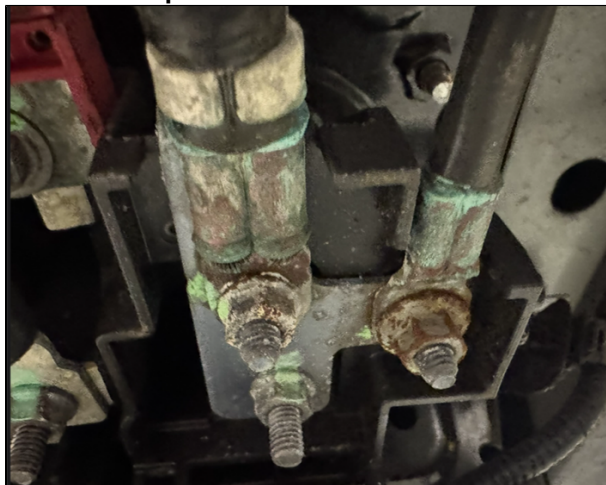
1. Inspect the 48V battery cable connections to the busbar:

- Terminal 1442-102C
- Terminal 1442-102D
- Terminal 1442-102E

Is corrosion present?

- **Was the 9.5 Nm (82 in-lbs) torque exceeded?**
  - If tightened with an electric ratchet, the upper torque limit may be exceeded.
- **Was grease applied to the bolt surface before tightening?**
  - Even with the same torque, the axial force will be higher, leading to damage.
- **Were the stud bolts on the verge of breaking?**

- **YES:** Go to next step
- **NO:** This service information does not apply. Continue with normal MGSS troubleshooting.

## 3. Replace the 48V Battery, Busbar and Cables.

**CAUTION:** DO NOT exceed the torque limit of 82 in-lbs (9.5 Nm).
