# M8 V8 Coolant Hose Drift

**Location:** Powertrain / Engine

**Topic:** V8 Coolant Hose Drift

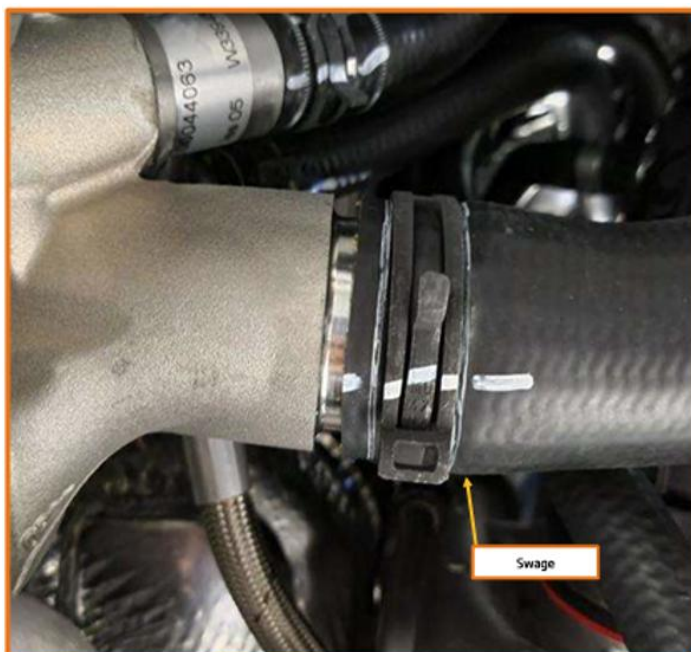
It has been identified that on M8 V8 engines, the lower coolant hose can move away from the spigot shoulder on the water pump, this happens due to pressure testing and when vacuum filling the cooling system.

The coolant hose end to water pump spigot shoulder only serves as an assembly aid to position the hose correctly on the spigot length to ensure the spring band sits behind the spigot barb upon installation.

There is no physical problem with the hose sliding up against the spigot barb under coolant pressure. Perform a repair only if there's a coolant leak.

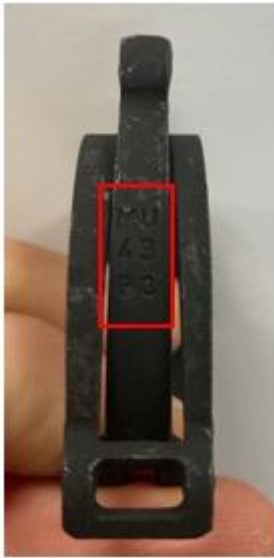
**Care point:** Correct clamp used (Marking: MU 43 P3), and clamp should be positioned behind the clamp marking.
