# McLaren Artura Engine Oil Leak Diagnosis Guide - Oil Cooler

**Location:** Powertrain

**Topic:** McLaren Artura Engine Oil Leak Diagnosis Guide - Oil Cooler

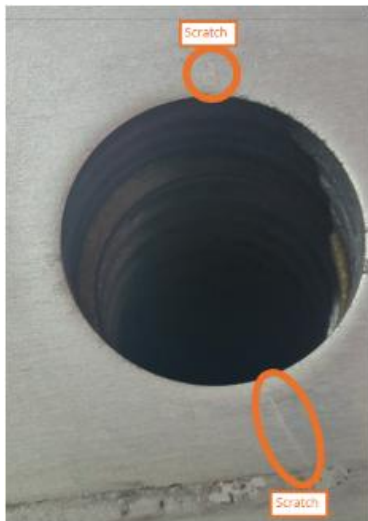
Example:

17. Inspect oil cooler face, and through holes escalate any concerns for review on TR providing images

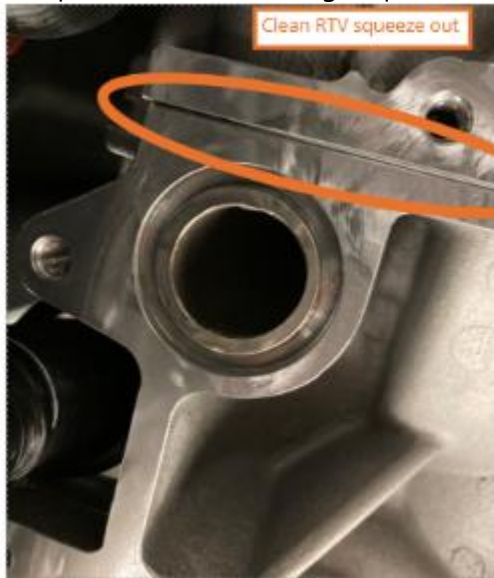
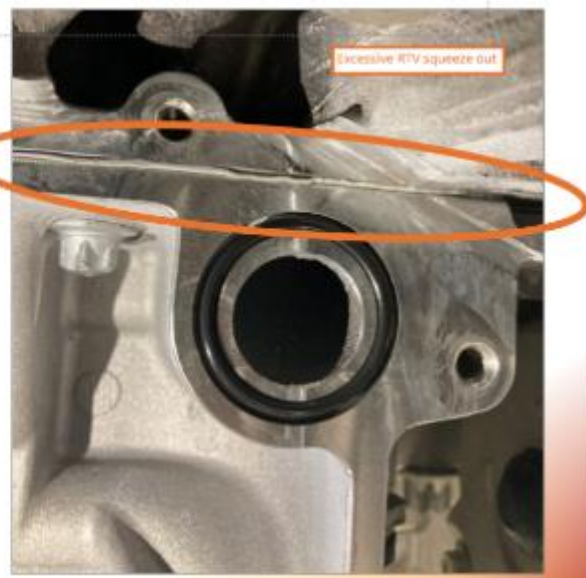
Example of clean face vs high squeeze out:

18. Inspect block interface for RTV Squeeze out, escalate if concerned with squeeze out on TR to the Technical Support team

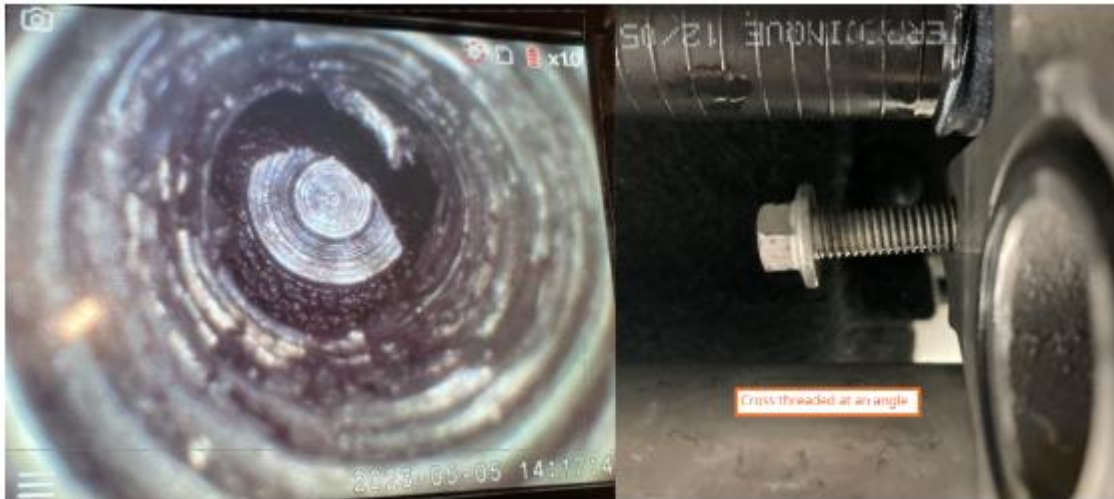
Example:

19. Check the block threads, are these clean and the bolts have not been fitted cross threaded/damaged?
