# McLaren Artura Engine Oil Leak Diagnosis Guide - Oil Pump

**Location:** Powertrain

**Topic:** McLaren Artura Engine Oil Leak Diagnosis Guide - Oil Pump

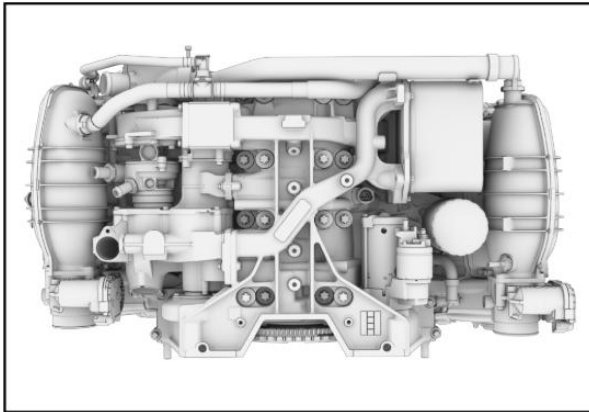
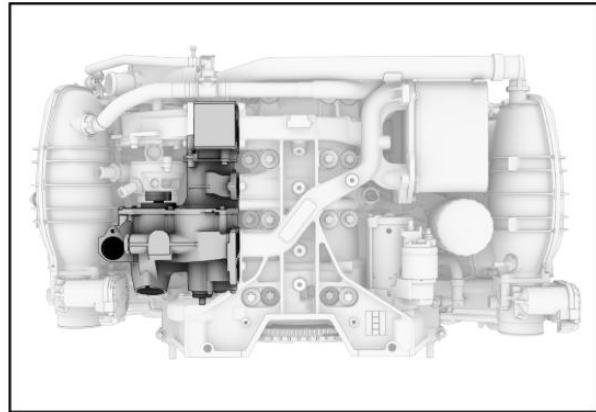
1. Raise vehicle on ramp as per MSP instructions
2. Remove engine underfloor
3. Capture images prior to any cleaning, clearly showing the leaking area. Label images: "Pre-Cleaning"
4. Take picture of engine number and label image "Engine Number"

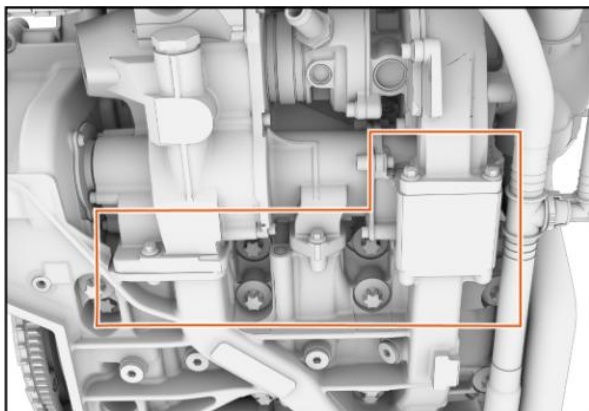
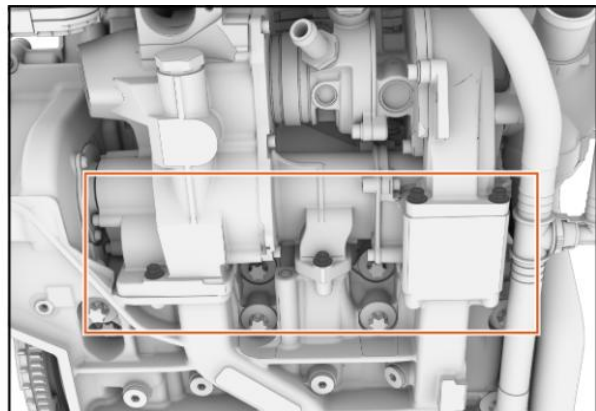
9. Inspect engine. Capture images and label images "Cycle 1", clean area again thoroughly, capture images and label images "Post Cycle 1"

**Care Point: If there is a clear and active leak after step 9, please stop the warm up cycles and submit a TR with supporting images/video**
