# McLaren Artura Oil Leak Diagnosis Guide - Rear of Engine

**Location:** Powertrain

**Condition:** Permanent

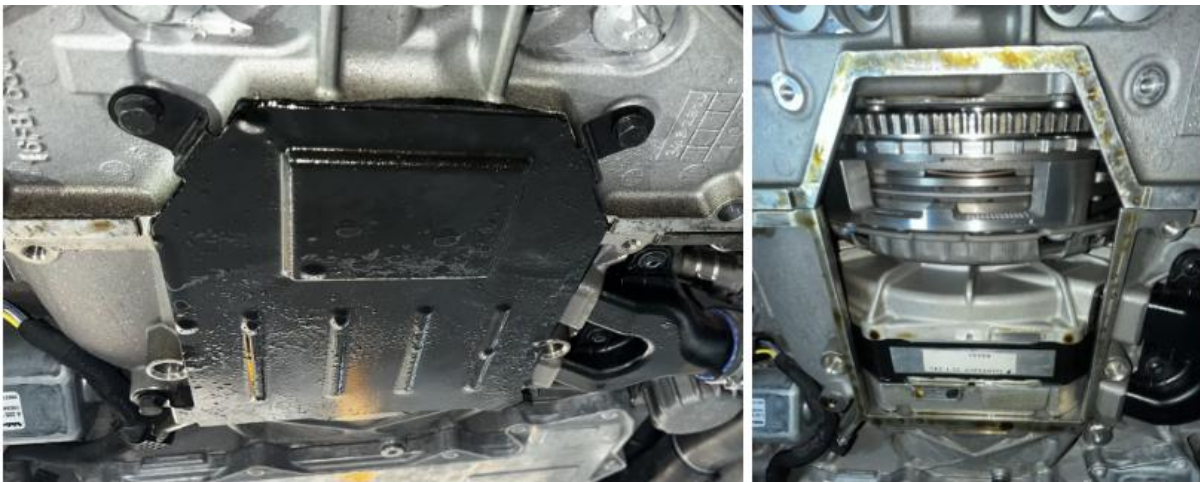
If an Artura is found to have oil traces on the underside of the powertrain at the rear, specifically the rear interface between the engine, transmission and e – motor, please follow the steps below

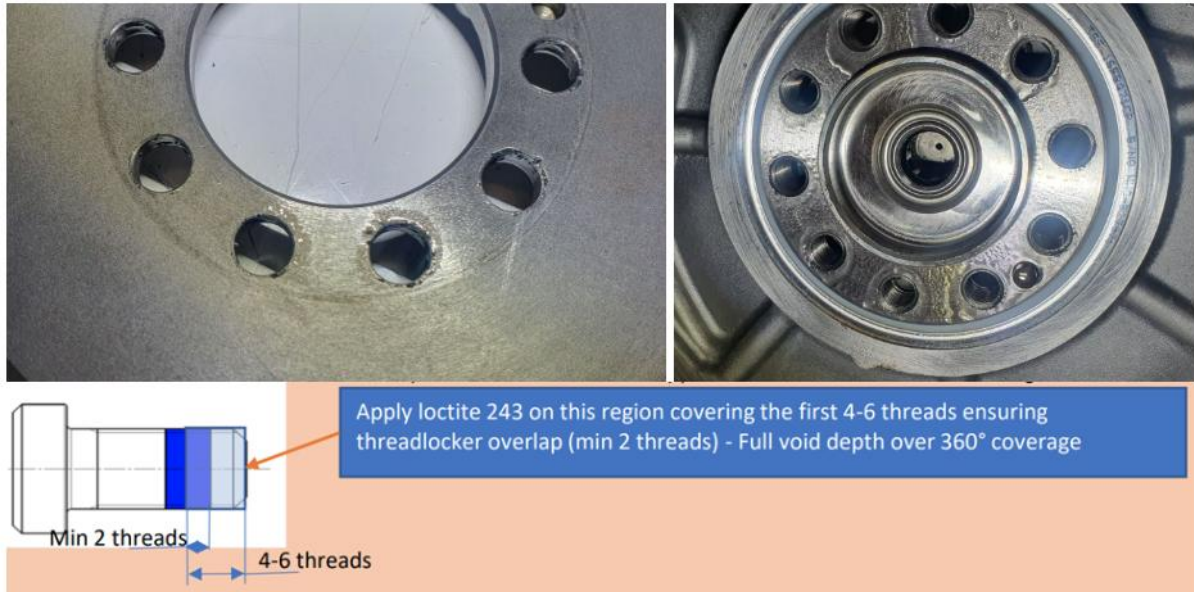
- Remove and inspect each flywheel bolt for signs of oil one at a time, starting from 12 O'clock position labeling the bolts in the order of removal (clockwise) and lay down each bolt on a piece of white A4 paper with the bolt head down (threads pointing up). If oil present on bolts, capture images of the oily bolts and their respective bolt holes on the crankshaft flange – label as "Oil Presence on Flywheel Bolt and Crankshaft Flange threaded hole"
- Capture images immediately of the flywheel, label as "Flywheel Inspection" and inspect. If oil is centralized around the flywheel on the surface this indicates the flywheel bolts are potentially the cause of the leak and new flywheel bolts with added Loctite 243 to the top threads will rectify this

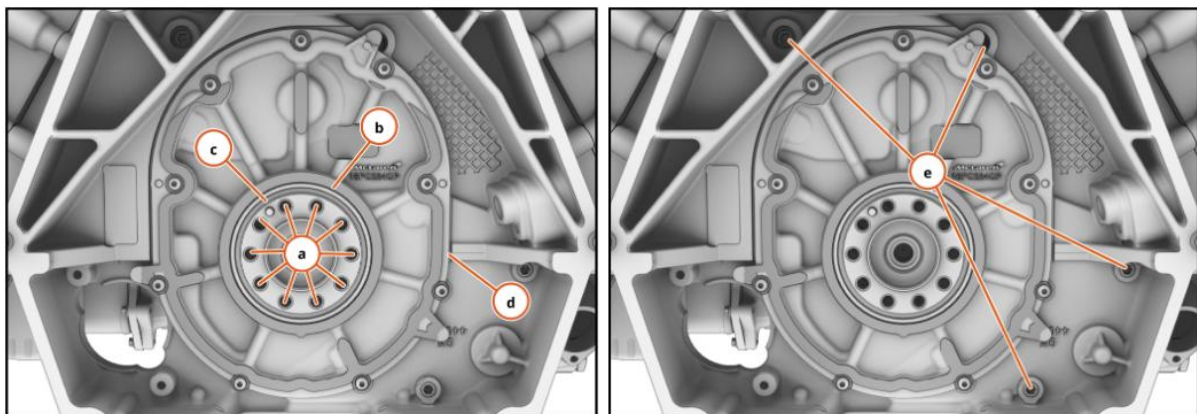
- Identify leaking area of the rear of the engine
  - 1. Flywheel threaded bolt holes (crankshaft flange)
    2. Rear crank seal OD
    3. Rear crank seal ID
    4. Rear cover (RTV Seal - identify exact location)
    5. M14 Pins – Tensioner (escalate with images)

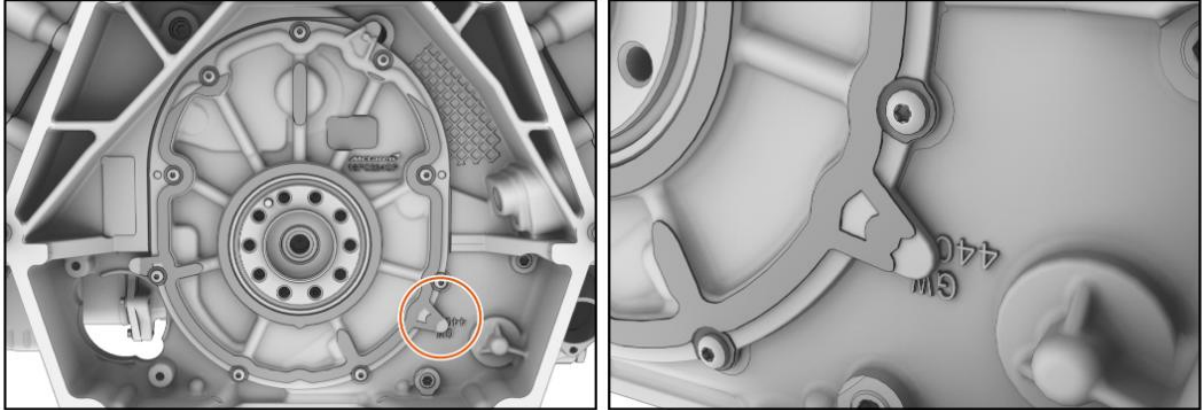
- Check if the rear cover has a tab that clashes with the cylinder block part marking

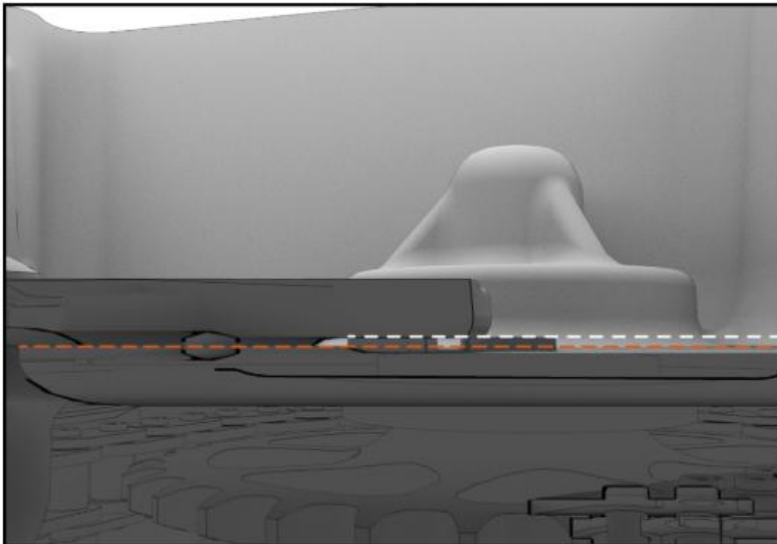
If the Part Marking on the Cylinder Block is present and not machined down, check if the top surface of the lettering is protruding the rear cover sealing surface on the cylinder block

If the Part Marking protrudes, proceed with the tab removal to resolve the potential hard clash of the rear cover which would create a leak path
