## SERVICE BULLETIN

**APPLICABILITY:** 2026MY Outback

**SUBJECT:** Rear Washer Insufficient Flow  
/ Diagnostic and Repair Procedure

**NUMBER:** 12-281-26

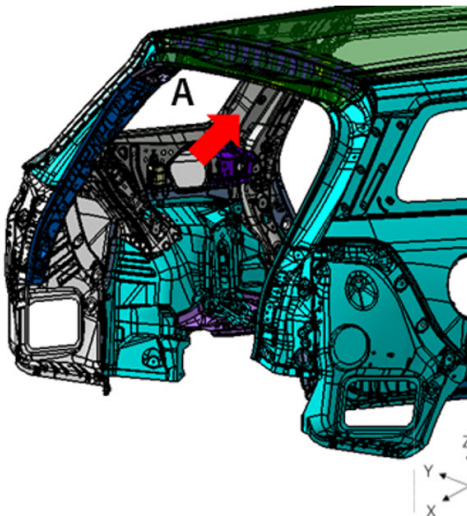
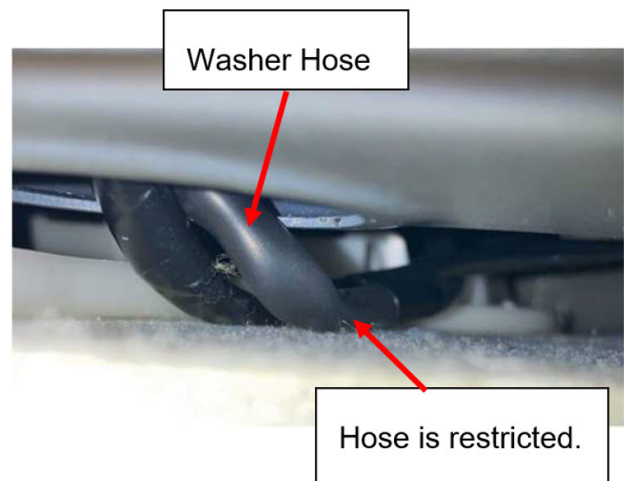
This Service Information Bulletin was developed to provide a diagnostic and repair procedure for customers who report that rear washer pressure or flow is insufficient. Normal spray is defined as a flow rate of 170mL or more in 10 seconds (1 cup or more in 14 seconds). Due to production variation, the L-shaped washer joint can twist the hose during vehicle assembly, resulting in restriction. If this concern is reported, inspect the hose for restriction and adjust the L-shaped washer joint as outlined in this bulletin.

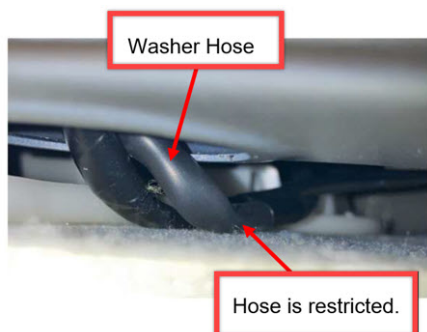
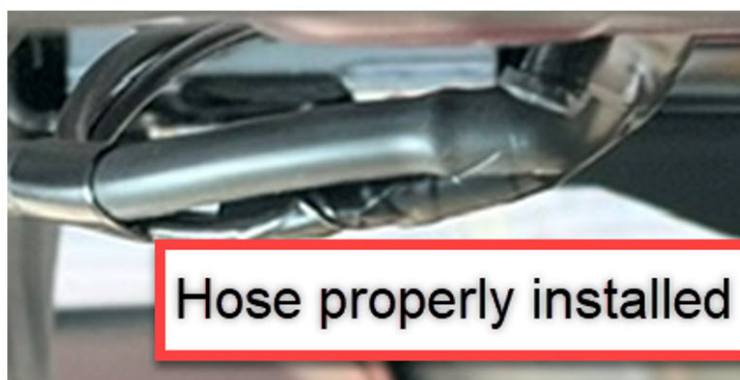
**Step 3:** Inspect the washer's L-shape joint for restriction. If the hose is restricted, continue to Step 4. If not, perform diagnostics as outlined in the service manual.
