## SERVICE BULLETIN

**APPLICABILITY:** 2022-25MY WRX

**SUBJECT:** Trunk Latch / Repair Procedure

**NUMBER:** 12-282-26

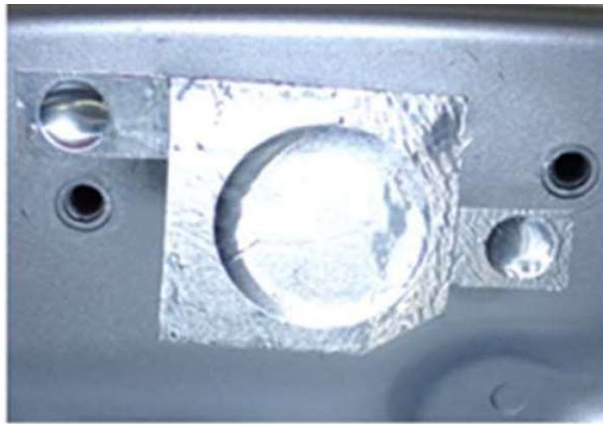
This Service Bulletin outlines a new repair procedure to follow when replacing the trunk lock assembly. Due to its mounting location, the holes behind the trunk lock assembly can allow dust to accumulate inside, which may cause the trunk lid to become difficult to close. If this symptom is reported perform the procedure outlined in this bulletin.

**Step 4:** Apply the tape pieces, making sure the holes indicated below are completely covered.
