## SERVICE BULLETIN

**APPLICABILITY:** 26MY Outback Models including Wilderness models

**NUMBER:** 15-335-25R

**SUBJECT:** Reprogramming File Availability for Optimization of Gen 5 Denso CP25 Infotainment Systems

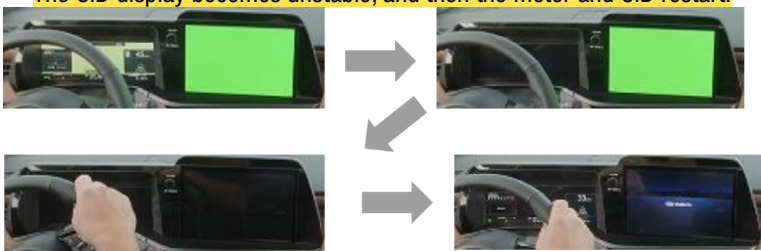
| No | Category | Symptom |
|---|---|---|
| 1 | Launch Navigation | <p>The CID display becomes unstable, and then the meter and CID restart.</p> |

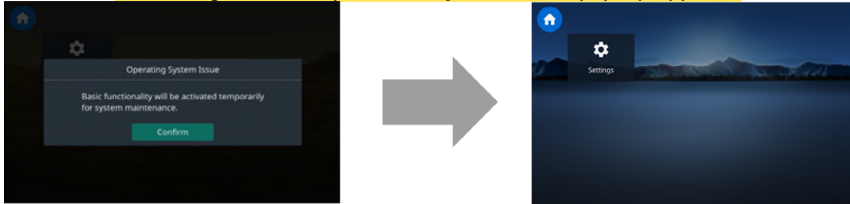
| No | Category | Symptom |
|---|---|---|
| 2 | Launch Navigation | <p>After navigation startup, an "OS System Issue" pop-up appears.</p> |
