## SERVICE BULLETIN

**APPLICABILITY:** 2026MY Outback

**NUMBER:** 15-340-26

**SUBJECT:** Reprogramming Files for DTC B2A20

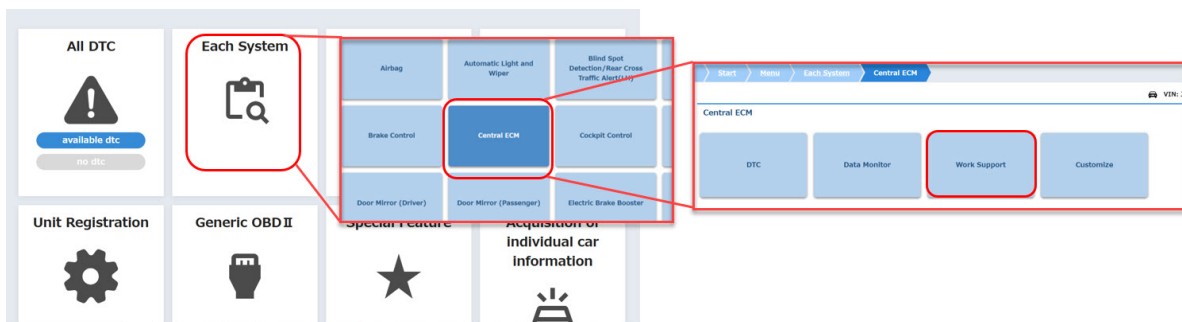
**Step 3:** Using the Subaru Select Monitor, check the Central ECM software. You can access the software information by selecting **Each System > Central ECM > Work Support**.

Is the software 4235303050 or later?

No: Perform software update.

If the Central ECM is determined to require a software update, follow the normal SSM5-R reprogramming procedure, which can be found in TSB 14-28-21R. Ensure the DCA-8000 is set to power supply mode and connected to the vehicle's battery. Subaru of America, Inc. (SOA) highly recommends using either the Subaru Midtronics DCA8000 Dynamic Diagnostic Charging System or the Subaru Midtronics GR8-1100 Diagnostic Battery Charger on the vehicle, and using the Power Supply Mode feature whenever a vehicle control module is being reprogrammed. Once the Midtronics charger is connected to the vehicle, if the battery is fully charged, it takes less than three (3) minutes to boot up the charger, select the Power Supply Mode, stabilize the battery voltage, and prepare it for reprogramming.
