# Service Bulletin

Bulletin No.: PIC6589B

**Subject:** Diagnostic Tip: Whistle/Wind Noise at Highway Speeds

| Brand: | Model: | Model Year: | | VIN: | | Engine: | Transmission: |
|---|---|---|---|---|---|---|---|
| Chevrolet | Trailblazer | 2021 - 2026 | | All | All | All | All |

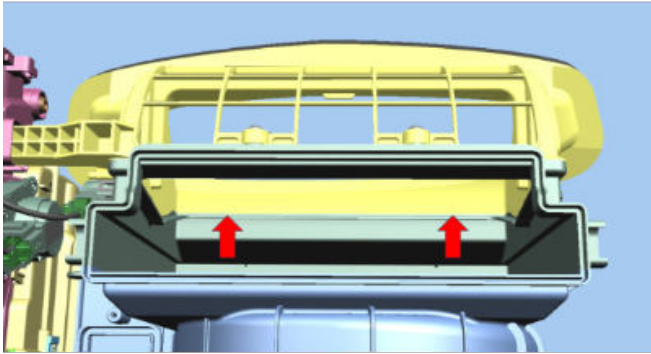
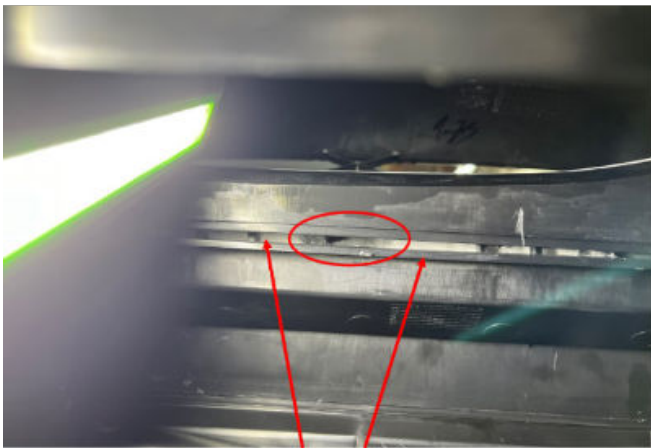
When the top portion of HVAC case is not seated properly, it is causing a gap at the rear of the HVAC case.

This gap is in the area where the Recirc Door seals, which is why when moving the door, it changes the air flow into HVAC case and alters the noise.

To inspect for this condition, remove the cabin air filter and check for a gap at the rear of the case, between the fresh air inlet duct and recirculation door plenum, see examples below.

**Note:** This condition is usually caused by a previous repair to the HVAC housing assembly.

To correct for this condition, the HVAC case assembly will need to be removed and reassembled correctly.

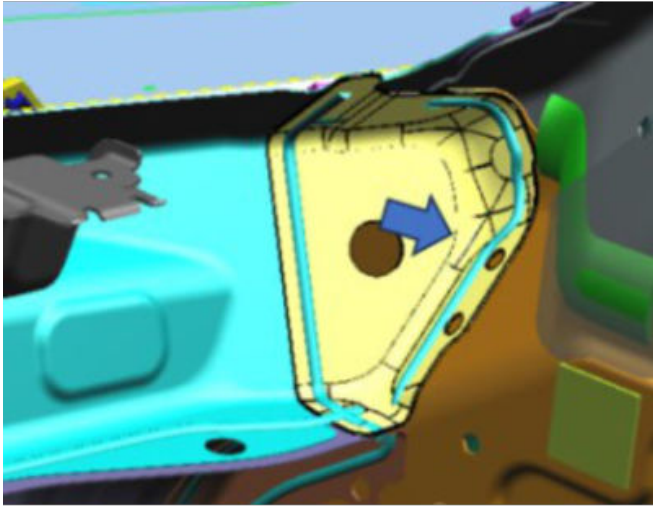
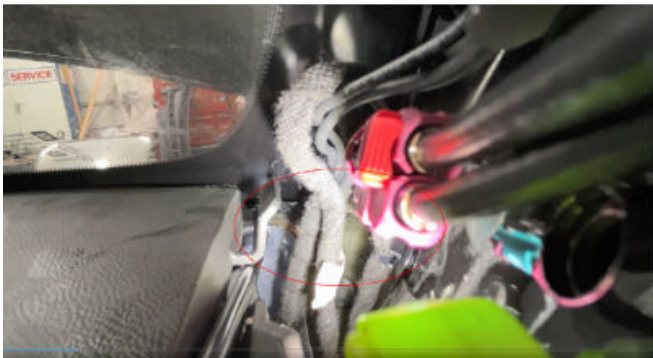
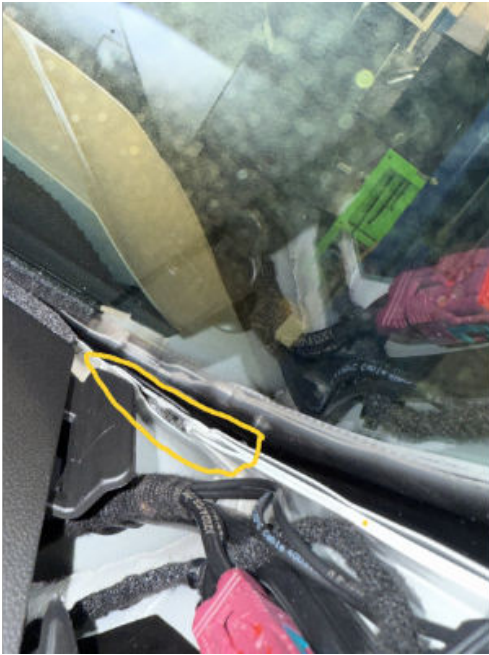
If the whistle/wind noise is not altered or does not go away and, the noise can be heard from the areas shown below.

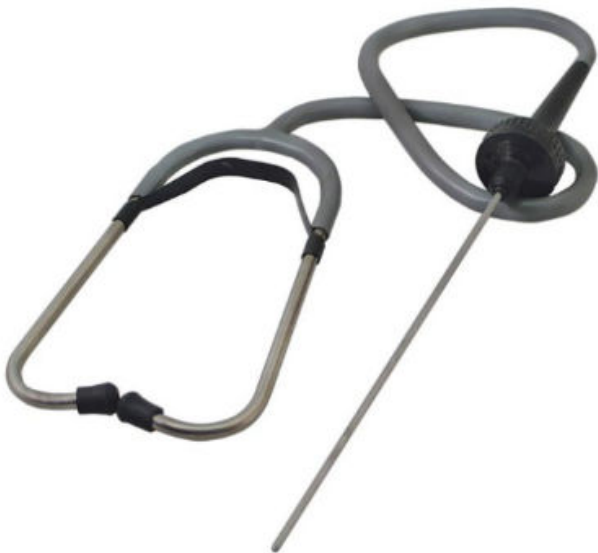
6886216

Using a mechanics stethoscope (image seen below), the tech can remove the metallic probe from the tubing and place the tubing in the area of interest.

The noise will be loudest when the tubing is directly above the leak source.

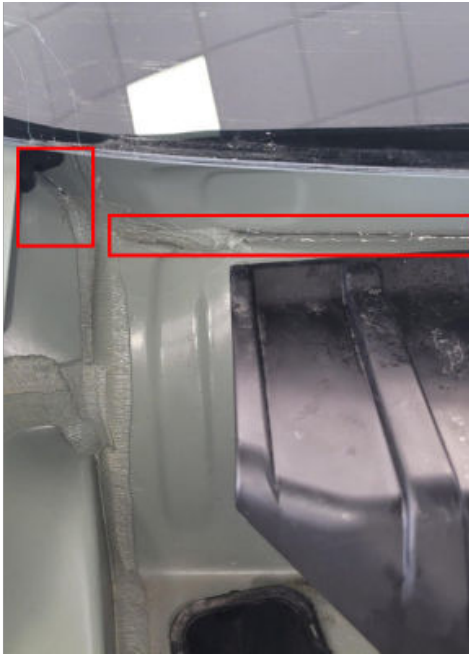
6783046

Inspect the cowl panel for gaps or voids in the seam sealer. See examples below.

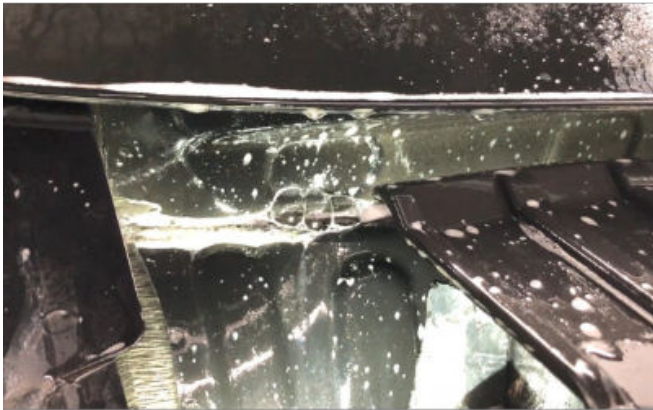
6783049

Using the Soap Suds or Bubble test, SI document 5204781, can be useful in locating the area in the seam that needs repair, see example below.

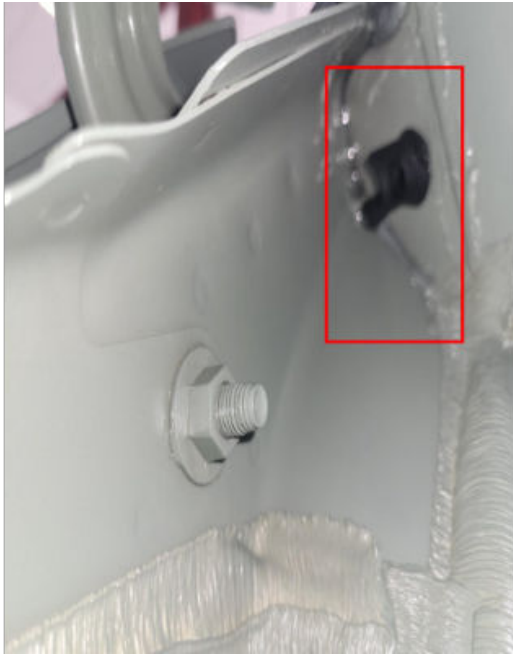
6783047

Technicians will also need to check for leaks in the area shown below.
