## Technical Service Bulletin

Transaction No.: 2081829

93-26-05 - Service Information, High-Voltage Battery DTCs P0AA6, P0D0F, and P0D08

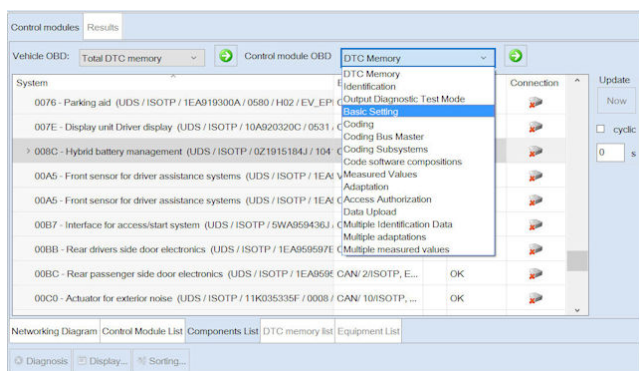
**Figure 2.**

4. Navigate to Self-diagnosis (OBD) in ODIS (see Figure 2).
5. Select the “basic setting” for hybrid battery management control unit (diagnosis address 008C).

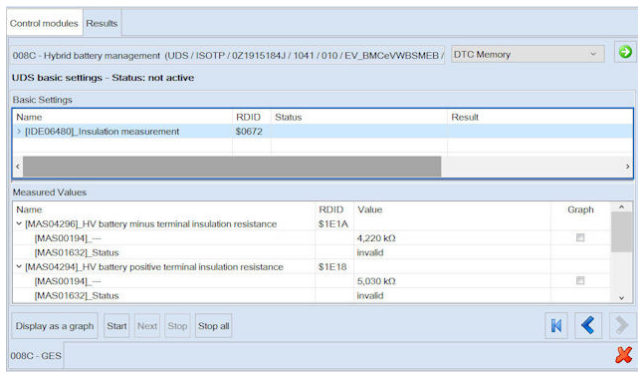
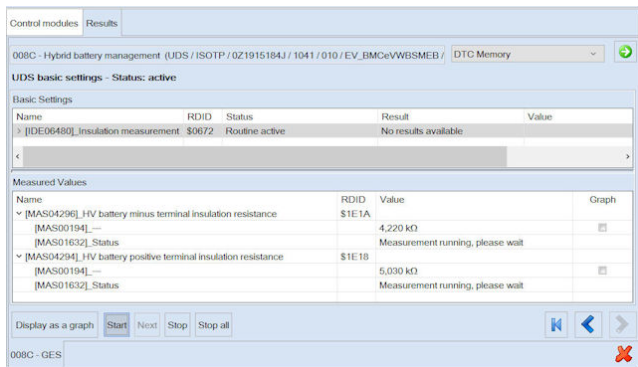
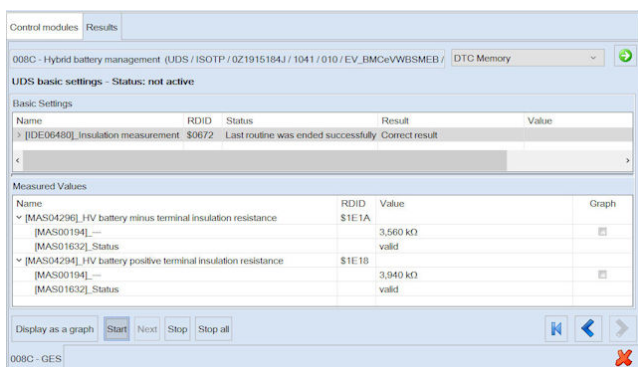
8. Widen columns of data displayed on screen so that contents are visible.
9. Select “start” to run the function and observe “status” and “result” and values in MVB section (see Figures 3 through 5).

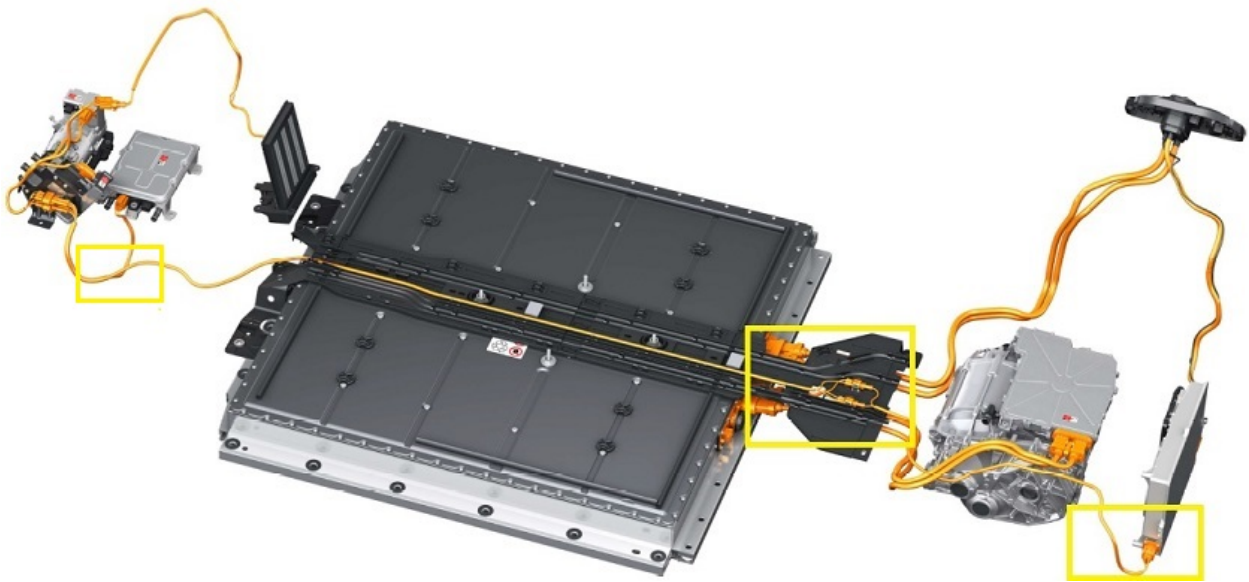
Figure 6.

- Visually inspect the HV wiring for frayed or damaged insulation. If visible damage is found, then continue with 4.b.
- If the high-voltage component wire insulation is not visibly damaged, the high-voltage component wire and surrounding surfaces must be sprayed/drizzled in short sections with soapy water (e.g., liquid hand soap mixed with water in a spray bottle). For example, at bends in the wiring near the steering gear, high-voltage onboard charger, and the high-voltage battery (see Figures 6 and 7, yellow/red rectangles) or at the coupling point near the left side of the rear drive motor (see Figures 8 and 9).

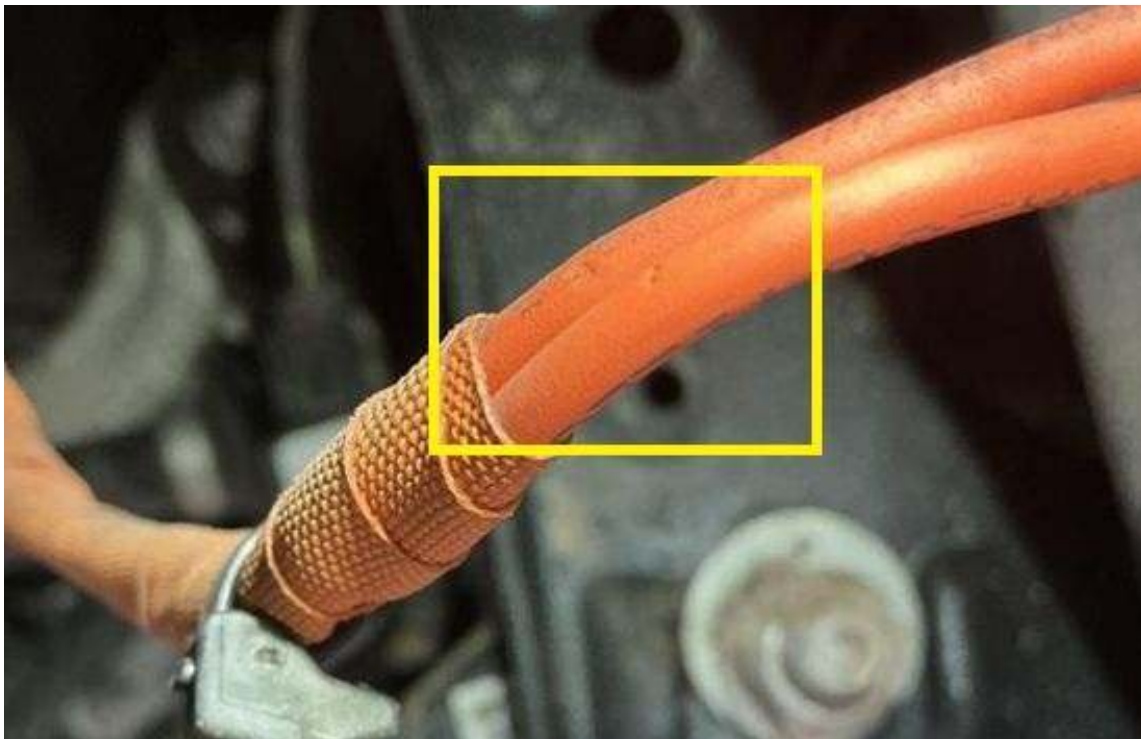
Figure 10.

Wiring insulation damage may result from outside influence (e.g. a rodent bite, Figure 10). If damage was caused by outside influence, neither diagnosis nor any subsequent repairs are covered under warranty.

- Repair or replace the high-voltage component auxiliary harness wire according to the repair manual and parts catalog.
