## Technical Service Bulletin

**2082488/2**

96-26-02 - Front LED interior/reading light inop/warning for airbag system illuminated  
/DTC U112100 and U116500 stored

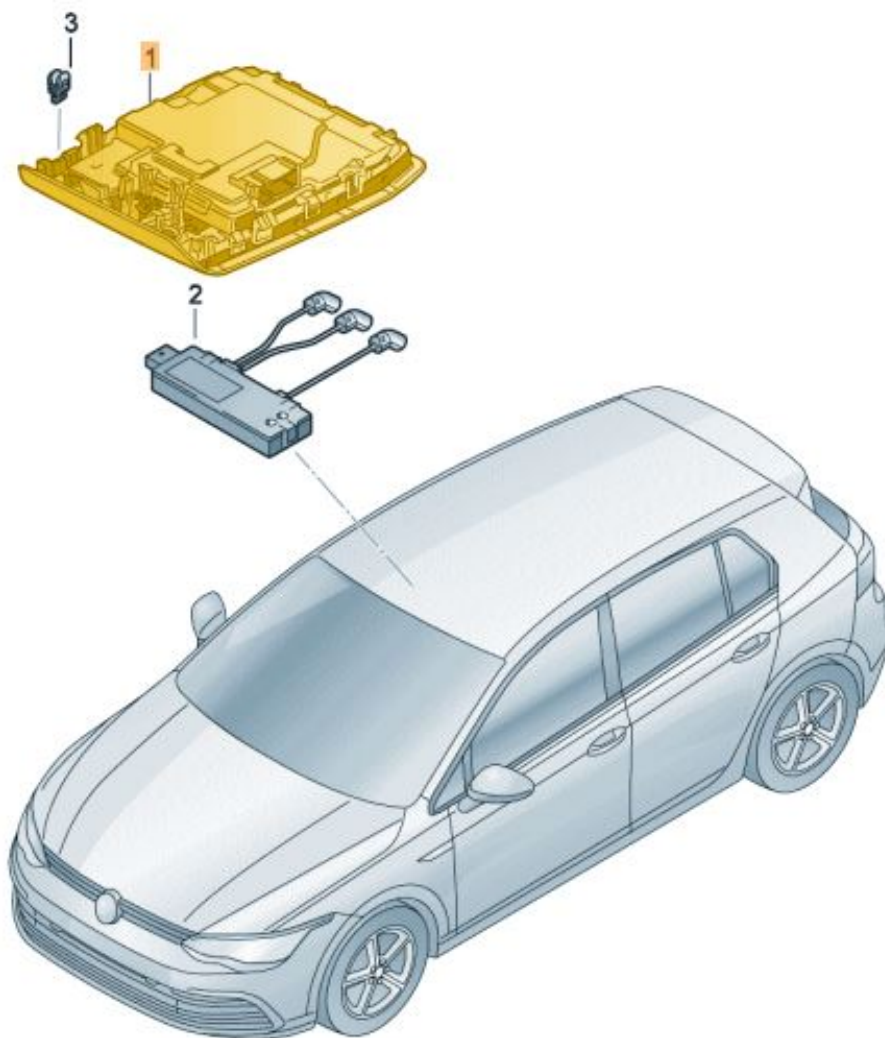
- Unclip/remove control console with front LED interior/reading light (picture 1, number 1 in yellow) from the headliner according to the Repair Manual.

Picture 1) operating unit with front LED Interior/reading light (number 1/in yellow)

Reset control console with front LED interior/reading light (by disconnecting/connecting the connector)

- Disconnect connector for the control console with front LED interior/reading light according to the Repair Manual for at least 10 seconds.
- Clip/Fit control console with LED interior/reading light according to the Repair Manual.
- Finally delete the event entry with the VAS Diagnostic Tool.
