GENERAL MOTORS  
DCS7548  
URGENT - DISTRIBUTE IMMEDIATELY

Subject: UPDATE: N252541251-01– Customer Satisfaction Program  
No Rear Turn-Signal Outage Notification  
Additional Vehicles Added

Models: 2020 Chevrolet Corvette  
2021 Chevrolet Corvette  
2024 Chevrolet Corvette

## N252541251 No Rear Turn-Signal Outage Notification

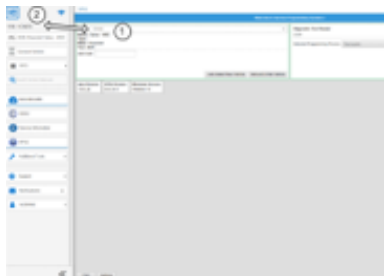
7001095

**IMPORTANT:** The service technician always needs to verify that the VIN displayed in the TLC left side drop down menu (1) and the top center window (2) match the VIN plate of the vehicle to be programmed prior to using Service Programming System 2 (SPS2) for programming or reprogramming a module.

1. Reprogram the Lighting Control Module. Refer to *K219 Lighting Control Module: Programming and Setup* in SI. Carefully read the programming and setup document for further instruction.

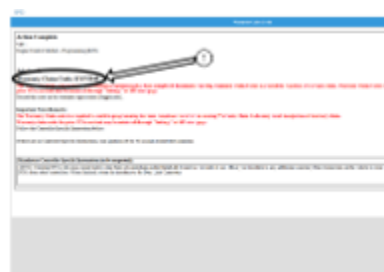
7001097

**Important:** To avoid warranty transaction rejections, you **MUST** record the warranty claim code provided on the Warranty Claim Code (WCC) screen shown above on the job card. Refer to callout 1 above for the location of the WCC on the screen.

- Record SPS Warranty Claim Code on job card for warranty transaction submission. Refer to *25-NA-281 Information on SPS Warranty Claim Code Submission and Retrieval* in SI.
