## Technical Service Bulletin

Transaction No.: **2069594/3**

60 Sloshing noises from roof area when vehicle is moving, water under front trim

Release date: Jul 27, 2026

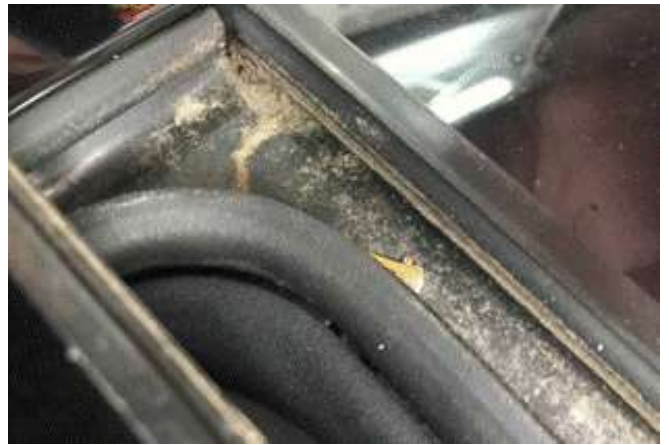
**Figure 2.** Dirt in the front sunroof frame.

2. Figure 2 shows the dirt in the front sunroof frame with the glass panel opened. Carefully remove all accumulated dirt.

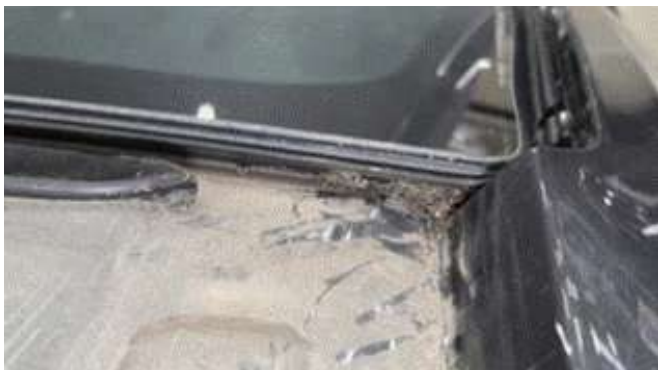
3. The following two figures (3 and 4) show the actual cause. The water drain channel is blocked by dirt here between the windscreen and the A-pillar. In the figures, the front trim has been cut out so that this location can be seen.

**Figure 3.** Water drain channel blocked by dirt.

Clean the blockage

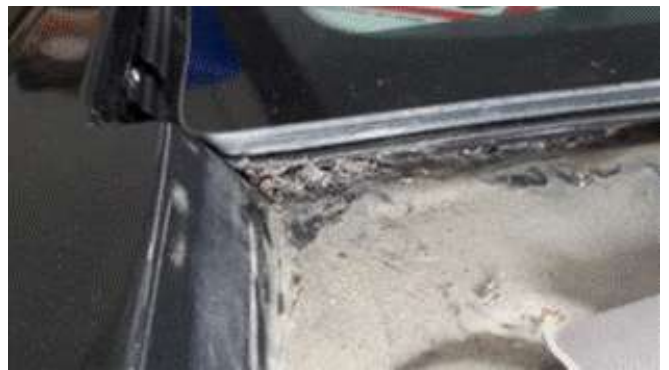
**Figure 4.** Water drain channel blocked by dirt.

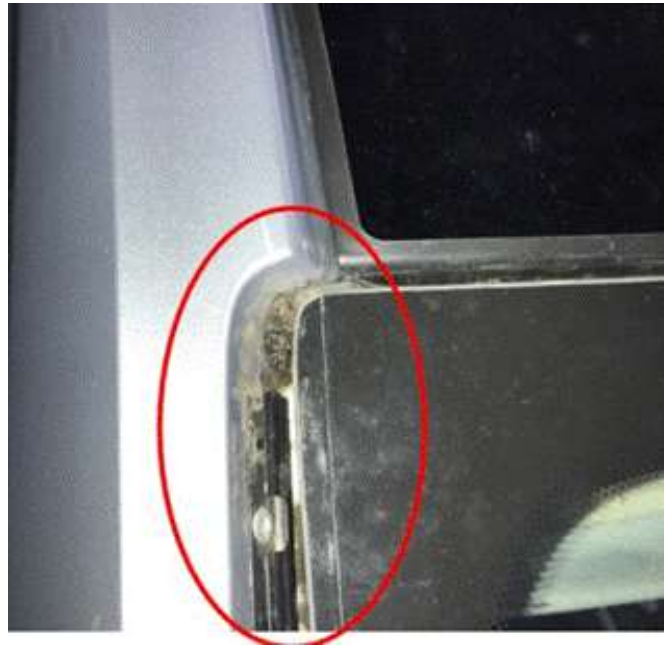
**Figure 7.** *Dirt in exposed channel.*

6. Now take a pneumatic gun and loosen the dirt. **The pneumatic gun must also be held pointed upwards so that the dirt under the front trim is also loosened.** (Figures 8 and 9).

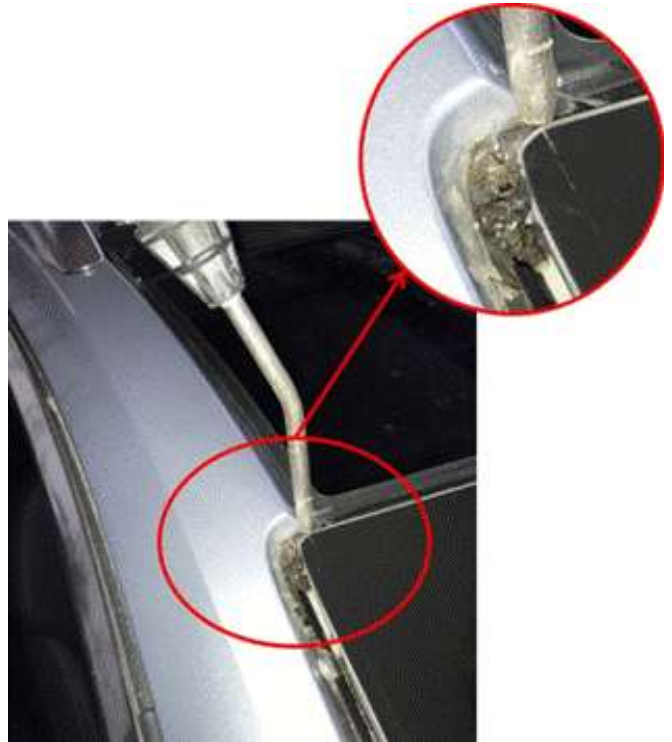
**Figure 8.** *Removal of dirt and debris in the drainage channels using a pneumatic gun.*
