**Condition**

| Model(s) | Year(s) | VIN Range | Vehicle Specific Equipment |
|---|---|---|---|
| A4, A4 allroad, S4, A5, A5 Cabriolet, A5 Sportback, S5, S5 Cabriolet, and S5 Sportback | 2020 | All | With PR code 8I6<br>005F – Information Electronics 1<br>Software version:<br>36**<br>3853<br>4398 |

All part and service references provided in this TSB (**2069596**) are subject to change and/or removal. Always check with your Parts Department and/or ETKA for the latest information and parts bulletins. Please check the Repair Manual for fasteners, bolts, nuts, and screws that require replacement during the repair.

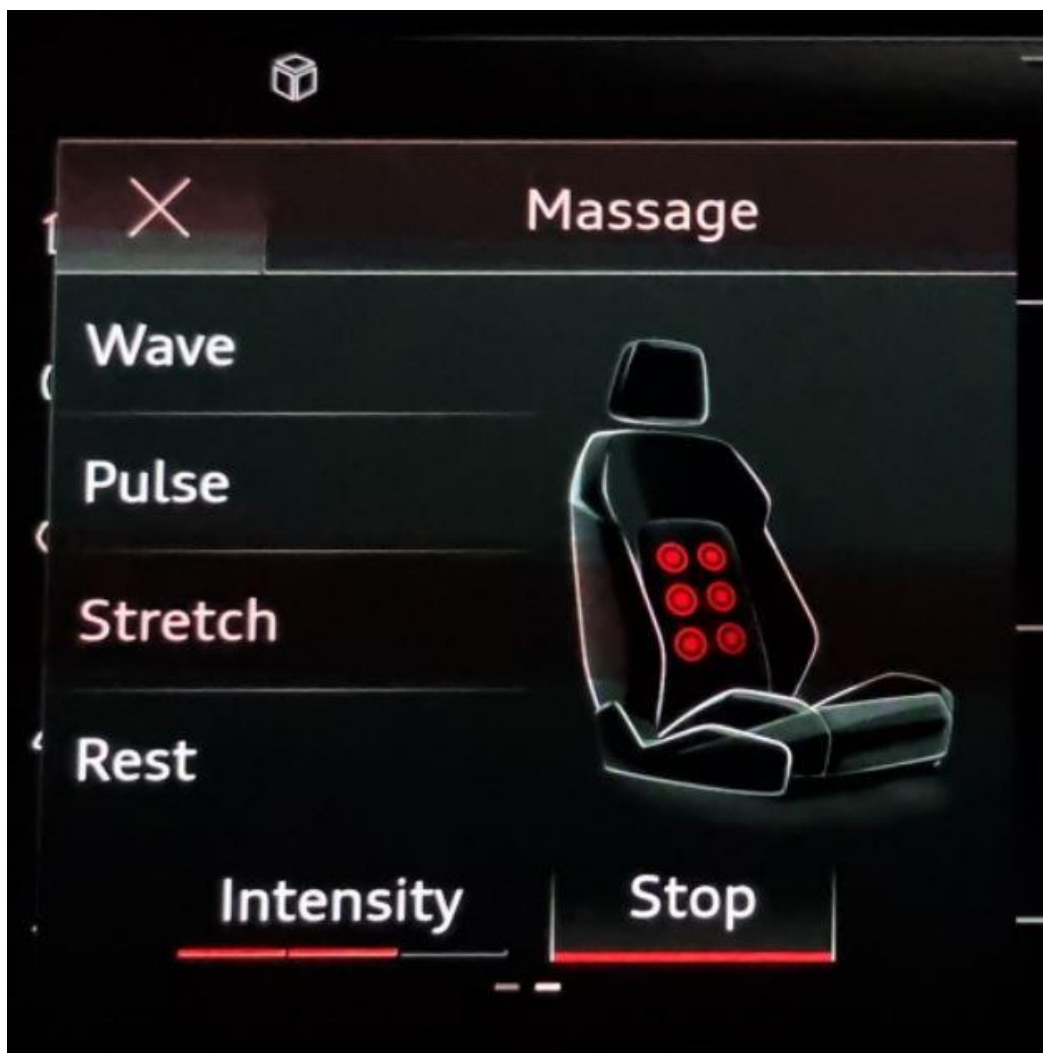
The customer states that the following pop-up does not appear (or no longer appears) on the MMI screen when the seat massage function is activated.

The massage function itself is still available. The massage settings can be changed in the corresponding MMI menu.

Software issue after cluster 35 MMI update on A4/A5 vehicles from model year 2020.

Update the onboard supply control unit (diagnostic address 0009) with the **SVM code 09A058**. Start the update on the workshop tester by selecting “**flash**” and entering the specified SVM code. Follow the instructions on the tester.
