## Technical Service Bulletin

| <b>Topic</b> | 55 Insufficient gap width between the tank flap and the side panel |
| <b>Transaction No.</b> | 2071697/3 |

### Q8, SQ8, RS Q8

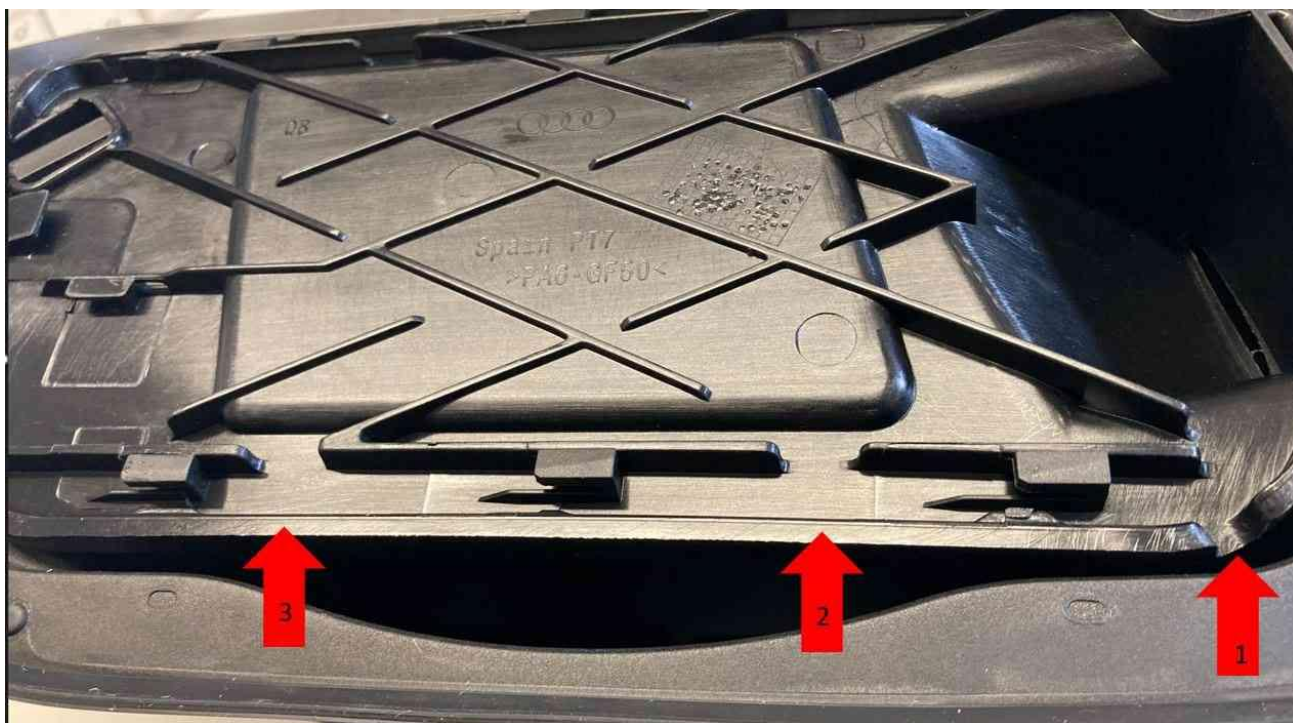
Figure 1 shows the position of the existing water drain at "1".

**Figure 1.** Add two water drains in positions 2 & 3.

Additional water drains must be made at positions 2 and 3 (Figure 1).

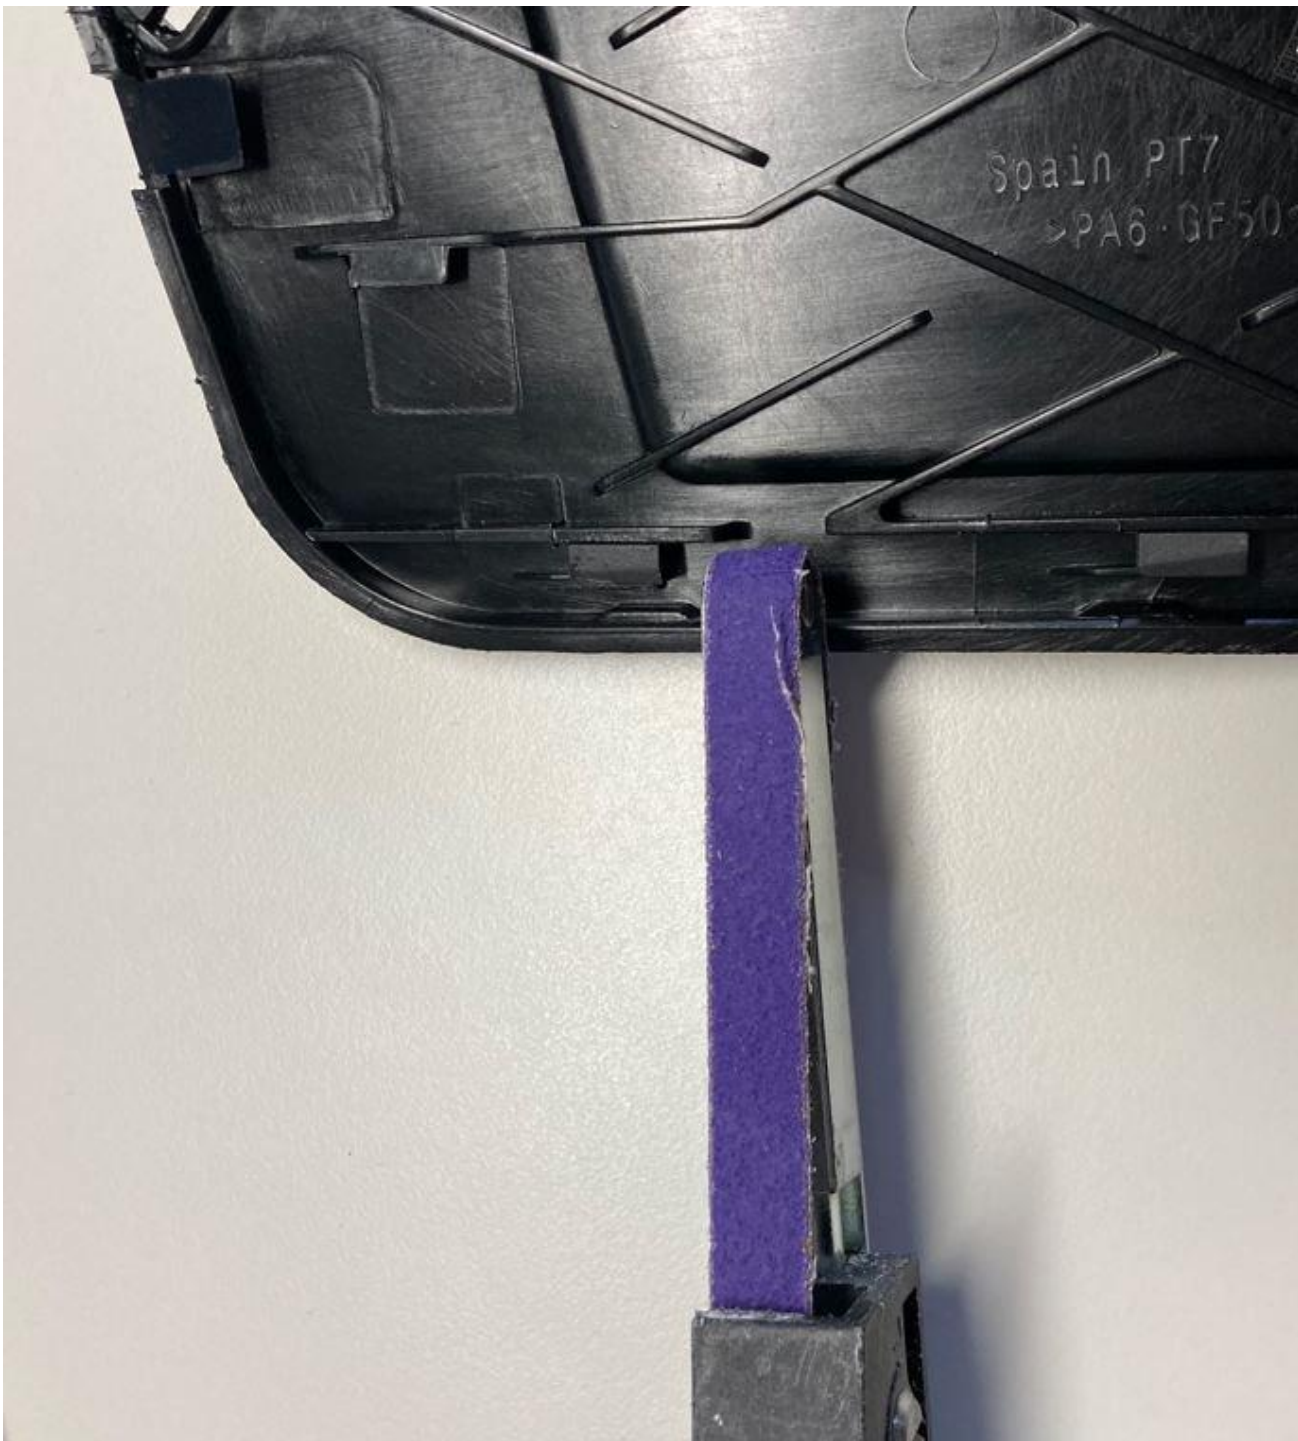
**Figure 2.** *Using a belt grinder to make additional drains.*

Figure 2 shows how to make an additional water drain using a belt grinder.

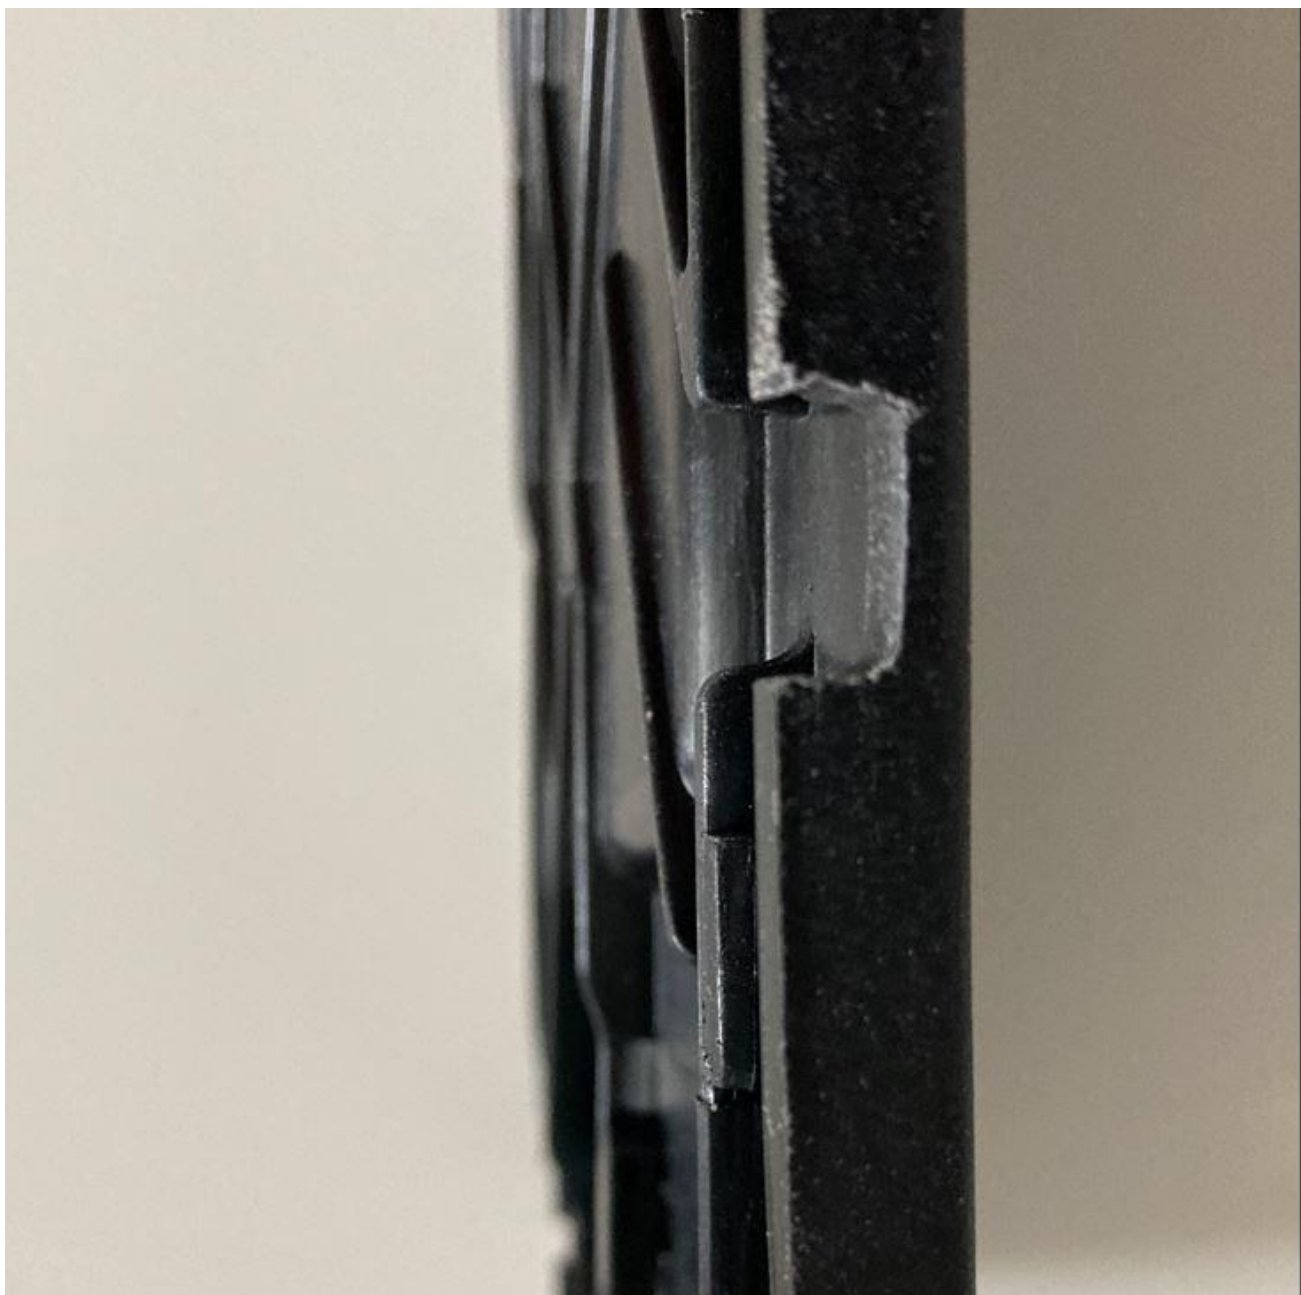
**Figure 3.** *One of the new water drains.*

Figure 3 shows the new water drain.

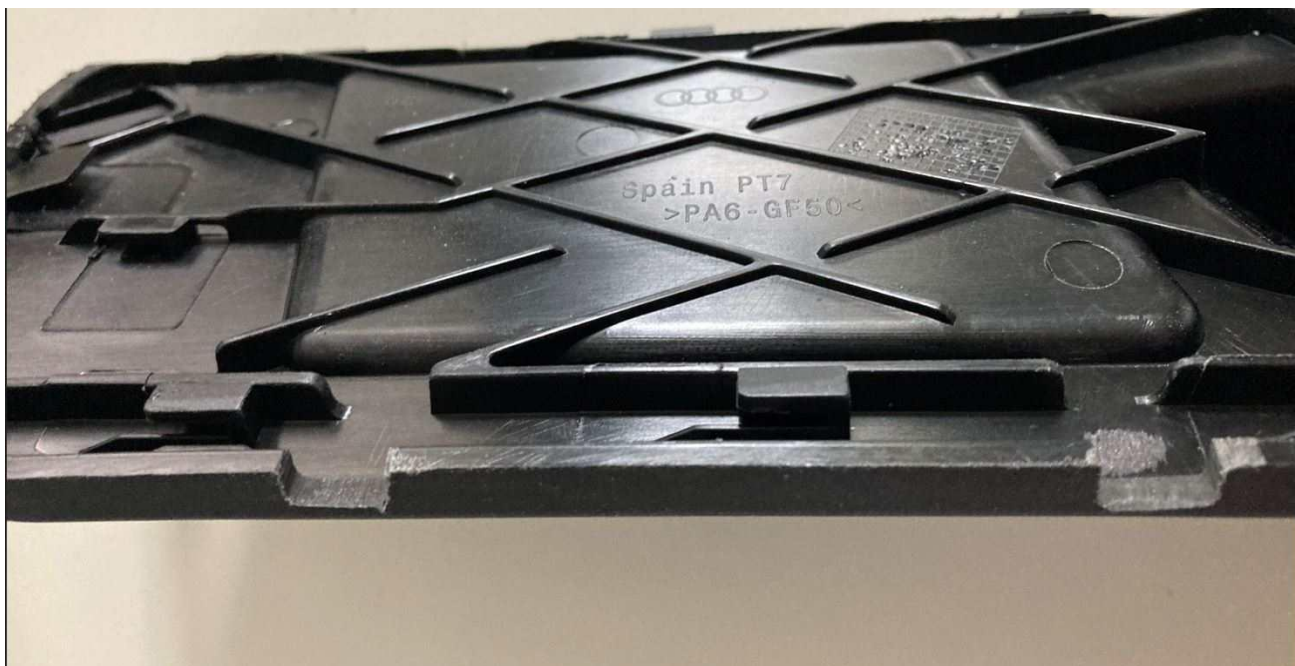
**Figure 4.** Both newly added water drains.

Figure 4 shows two additional water drains.

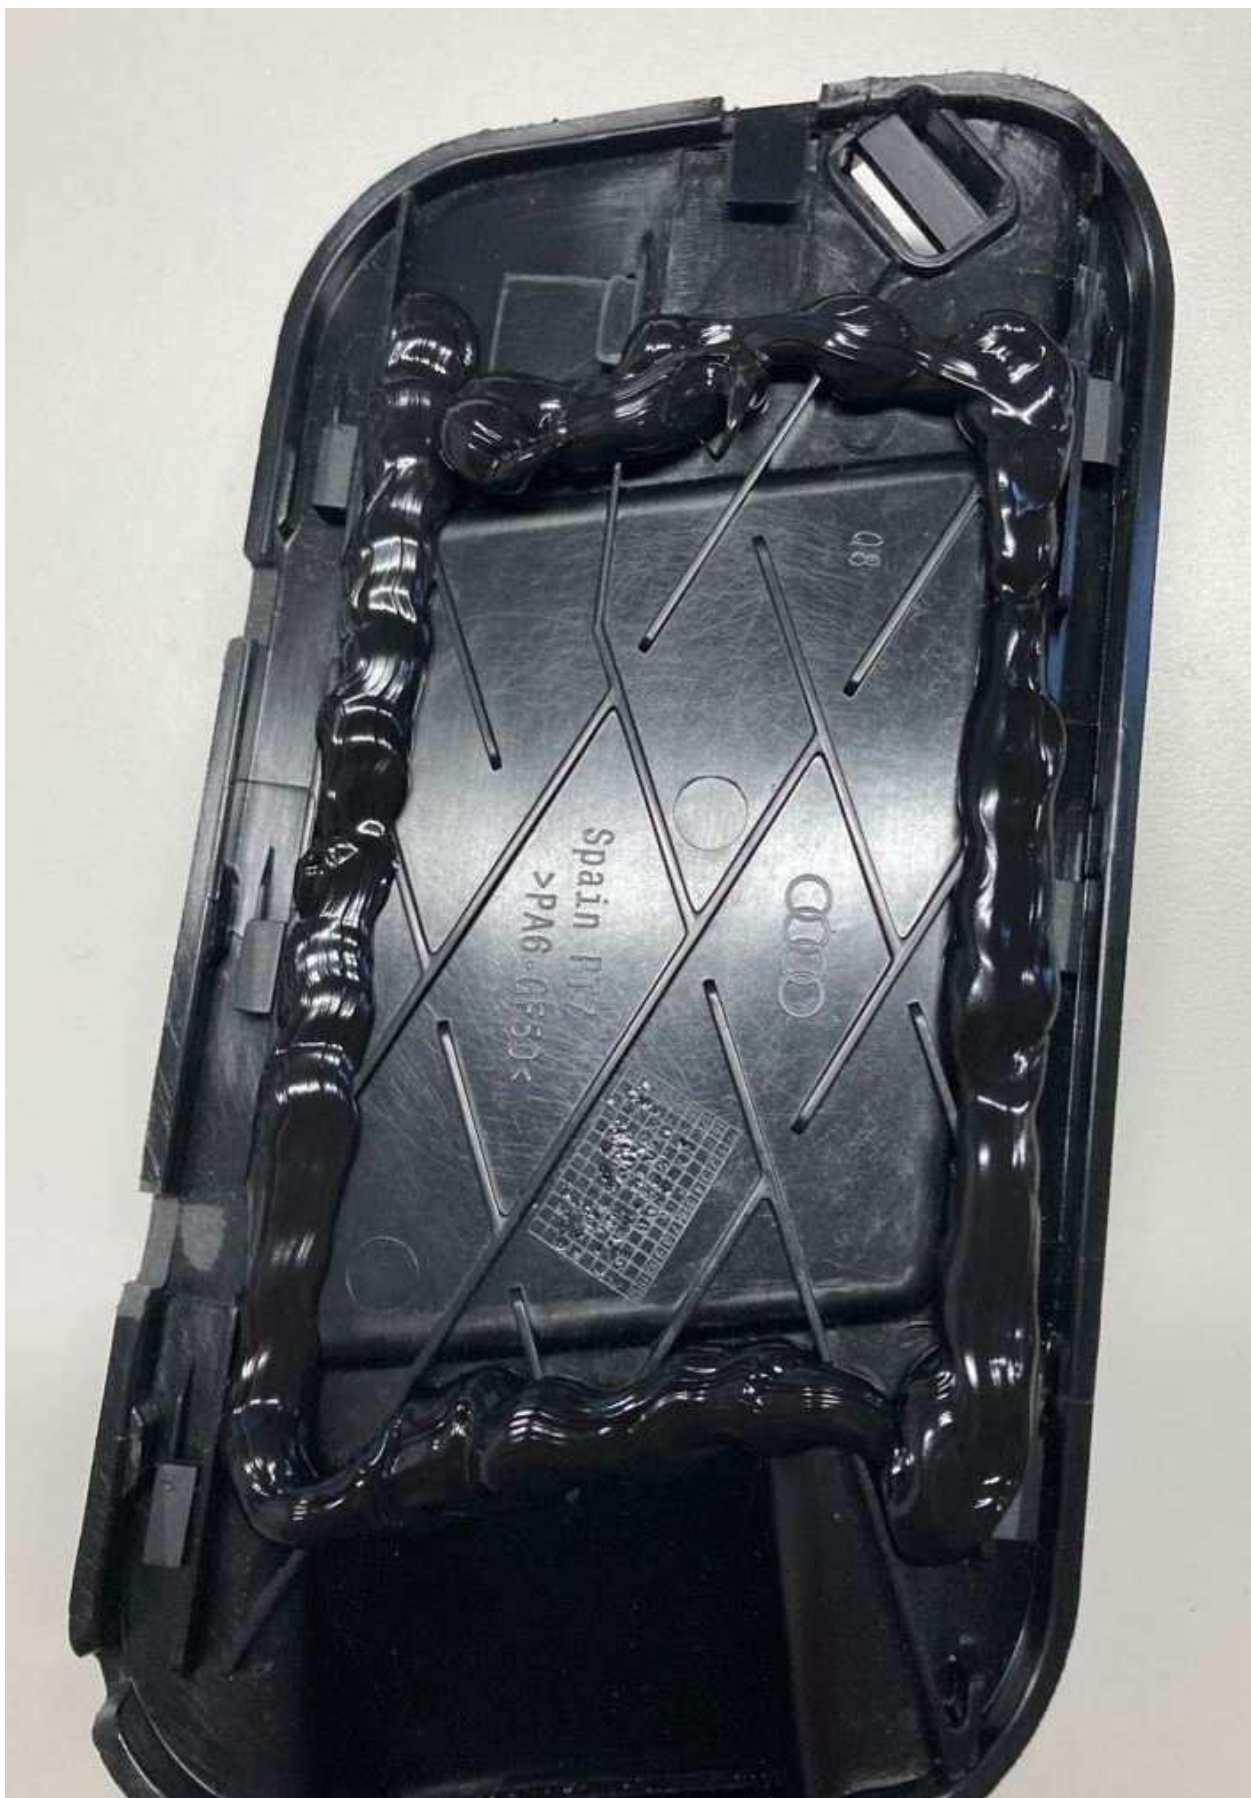
**Figure 6.** Adhesive applied to the bracket.

Figure 6 shows how to apply an adhesive bead D 190MKD A3 (or D 172 090 M2) on the inside area of the bracket. Please note: Adhesive must not be applied to the area around the tank flap closing actuator.

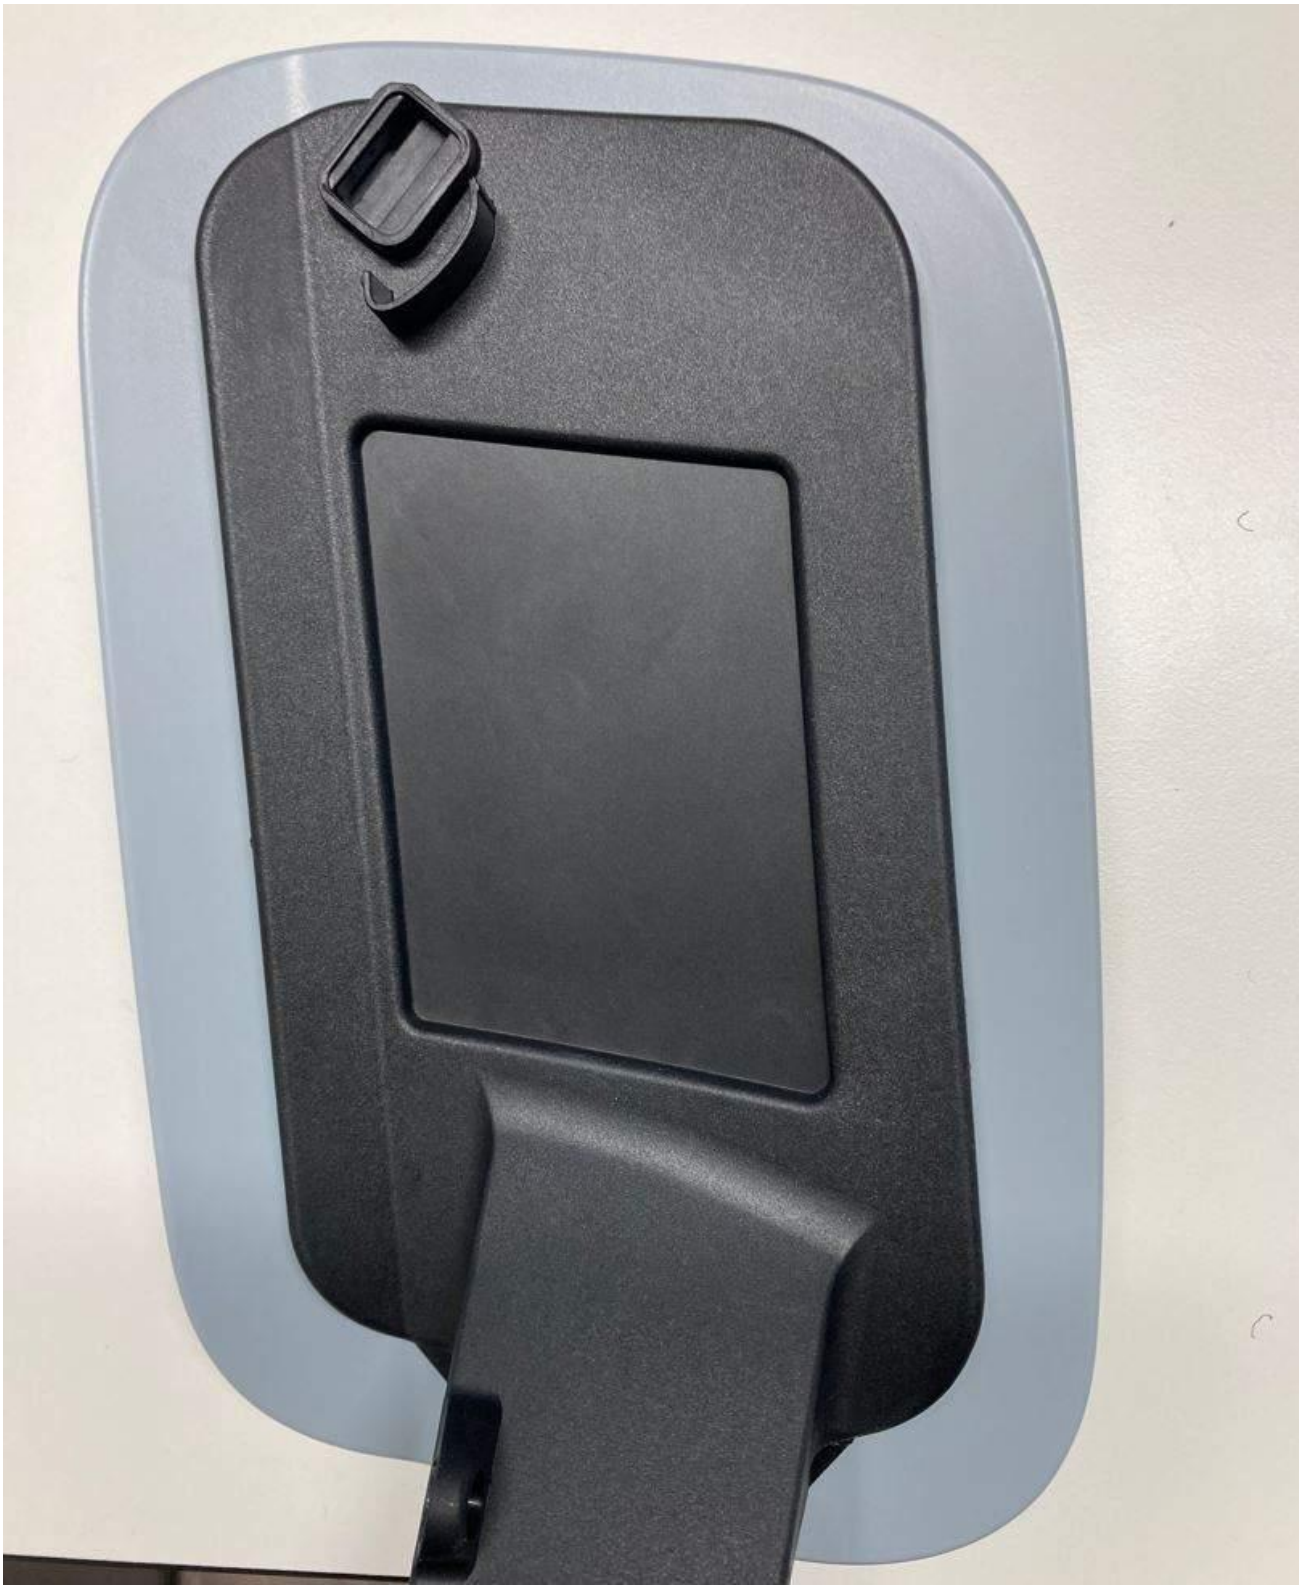
**Figure 7.** Original fuel filler door installed with excess adhesive removed.

Fit the painted tank flap on the bracket (Figure 7).

Any excess adhesive must be removed immediately.
