## Condition

| Model(s) | Year(s) | VIN Range | Vehicle Specific Equipment | | | |
|---|---|---|---|---|---|---|
| A8, and S8 | 2021 – 2023 | All | PR Code: QW4<br>00E0 – Auxiliary display/control head | | | |

There is no seat adjustment menu on the rear display and operating unit (Smart Control, SCON).

| <b>Claim Comment:</b> | As per TSB 2071984/2 |

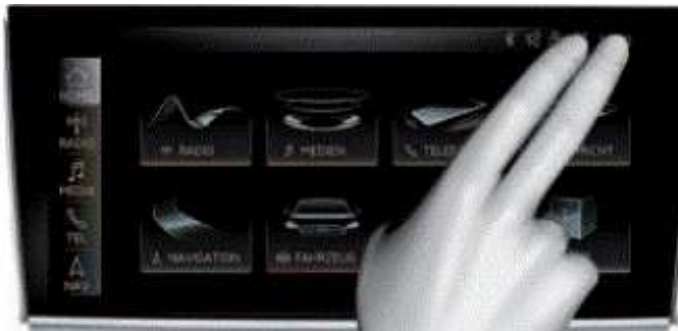
To access the engineering menu, press on top right of upper MMI display J685 for at least 3 seconds with 2 fingers.

Use the red engineering menu to start the update.

Start the update according to the menu navigation.
