## Technical Service Bulletin

Transaction No.: **2073060/5**

19 Loss of coolant from coolant pump - 2.5ltr. TFSI

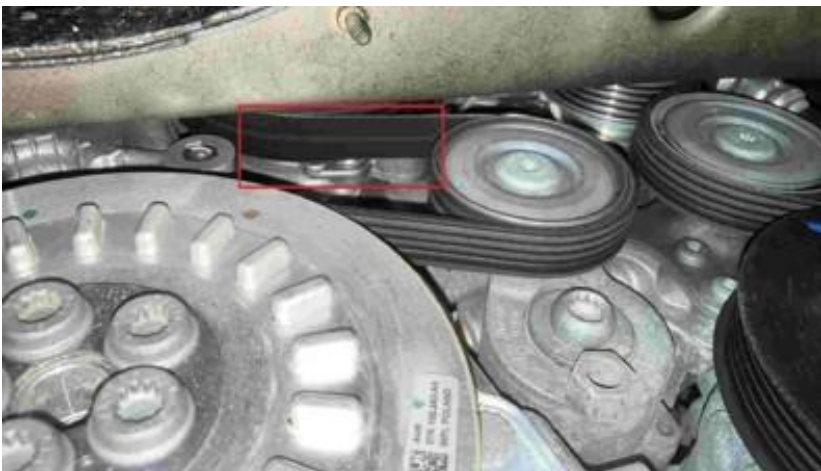
- A leak is detected in the area of the mechanical coolant pump.

**Figure 1:** View from front right wheel well.

1. Clean and dry the leak and traces of coolant **thoroughly**.
2. Fill the cooling system according to the workshop manual.
3. Perform a cooling system pressure test according to ELSA.
4. Reassess the suspected leak.

→ No further fresh coolant is visible I the area of the mechanical coolant pump, it may be a cosmetic leak from the mechanical coolant pump. Replacing the mechanical coolant pump is not required for this reason.

→ If fresh coolant is found leaking from the mechanical coolant pump, please document the leak with photos and/or videos. Then replace the mechanical coolant pump according to the instructions in the Workshop Manual.
