## Technical Service Bulletin

Transaction No.: **2073282/2**

94 Workshop info: film / visible rings on clear glass cover of headlight when dipped beam is switched on

| Model(s) | Year(s) | VIN Range | Vehicle Specific Equipment |
|---|---|---|---|
| All Audi vehicles | 2010 – 2025 | All | Not applicable |

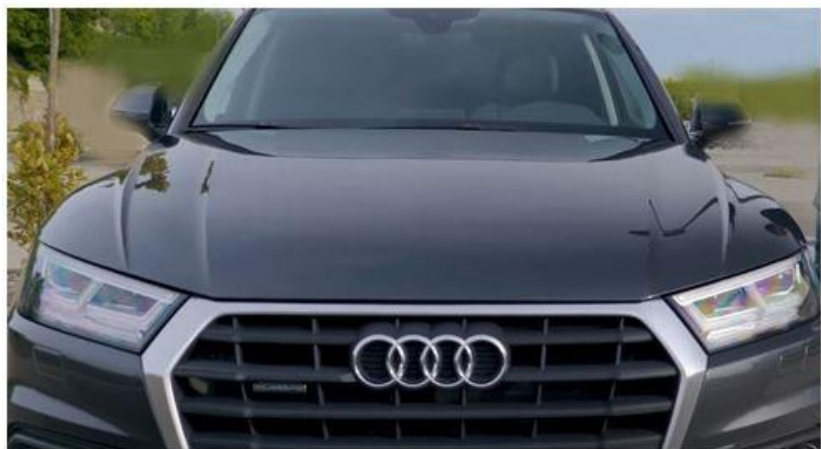
1. The clear glass cover on the headlight has a rainbow-colored shimmer on the inside (Figure 1).

**Figure 1:** Rainbow-colored shimmer on the inside of lens.

**Regarding 1:** The clear glass cover on the headlight has a rainbow-colored shimmer on the inside.

**Regarding 1 / 2 / 3: The clear glass cover on the headlight has a rainbow-colored shimmer on the inside or there is a milky and/or grey-white coating on the clear glass cover, a component inside the headlight, and/or on the lens for the dipped/main beam headlight**

- During normal use of the vehicle, certain chemical components in the headlight may outgas over time under the influence of humidity, temperature, driving behavior and the degree of dirt on the headlight or dust filter/intake filter. These components react with the gases and humidity contained in the surrounding air. The resulting chemical compounds are deposited on the surface of the lenses, a component inside the headlight, or the clear glass cover in the form of a thin white-grey or transparent rainbow-colored shimmering film (see figures 1, 2 and 3).
- This is an unavoidable natural effect. **The functionality, light quality and service life of the headlight are not impaired in any way by this phenomenon.**

- The interference effect, which appears as a rainbow-colored effect on the clear glass cover, can also be a side effect of the hard coating on the clear glass cover. The hard coating is applied to the clear glass cover to protect it from environmental influences.
- The test criteria described under “**Service**” must be used to assess the film.

Complaints about a milky, and/or grey-white, or rainbow-colored film must be checked following the steps below. (See TSB 2061922, 94 *How to properly document optical concerns for headlights and taillights*).

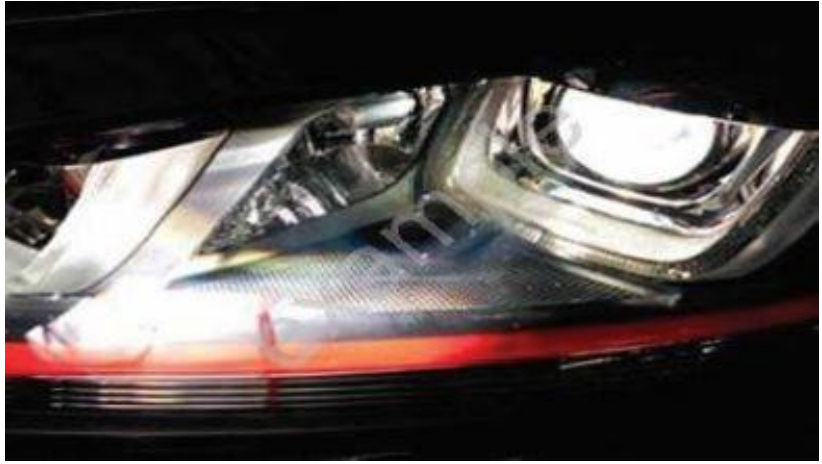
2. The inside of the clear glass cover on the headlight or a component in the headlight is milky or fogged up with a grey-white coating (Figure 2).

**Figure 2:** Grey-white coating on the inside of the lens.

**Regarding 2:** There is a thin milky and/or grey-white coating on the inside of the clear glass cover on the headlight, or on a component inside the headlight, which is visible when the headlight is switched on.

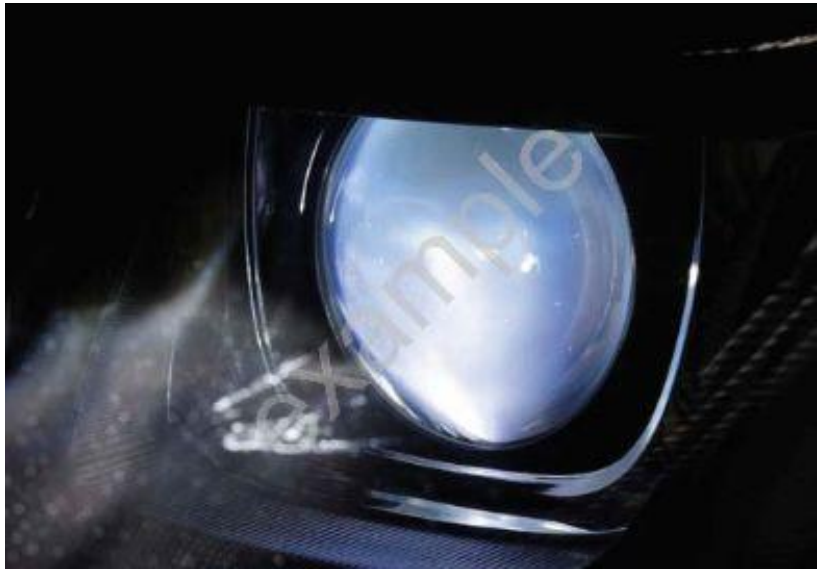
3. The headlight lens is milky on the inside or fogged up with a grey-white coating (Figure 3).

**Figure 3:** Grey-white coating on the inside of the lens.

**Regarding 3:** There is a thin milky and/or grey-white coating on the inside of the lens for the dipped/main beam headlight which is visible when the headlight is switched on.

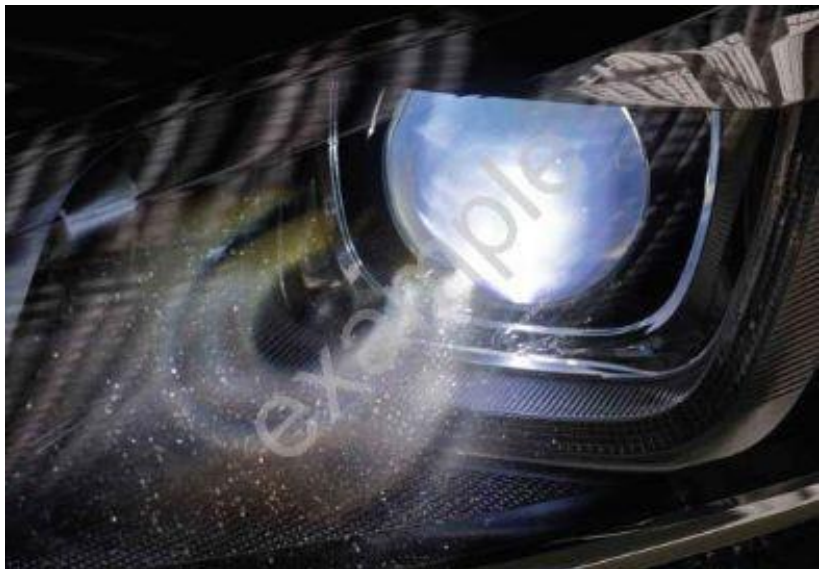
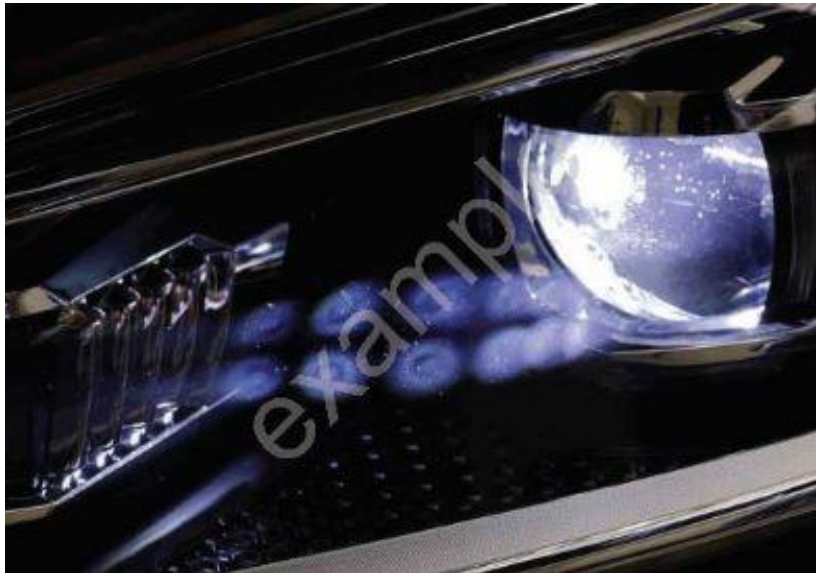
4. Rings are visible on the clear glass cover when the low beam is switched on (Figures 4 and 5).

**Figure 4:** Rings visible with lamp switched on.

**Figure 5:** Rings visible with lamp switched on.

**Regarding 4:** There are rings on the clear glass cover of the headlight which are visible when the dipped beam is switched on.

- The visible rings on the clear glass cover (see figures 4 and 5) of the headlight are created by the projection of the light source. This is an effect of the light reflection in the headlight (see figure 6).

- The film (described under “**Technical background**”) increases this optical effect.
- This is not a **defect in the product** or a **defect covered by warranty**; it is an unavoidable optical and chemical effect. **The functionality, light quality and service life of the headlight are not impaired in any way by this phenomenon.**

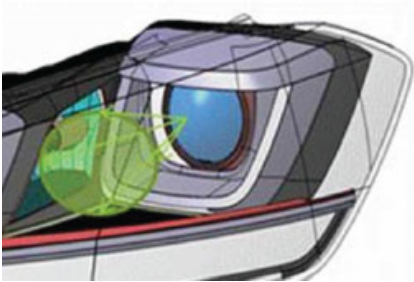
**Figure 6:** Rings caused by light projection.
