## Condition

The customer complains about a musty or damp smell in the passenger compartment and/or a wet footwell in the front of the vehicle.

| <b>Claim Comment:</b> | As per TSB 2076642/2 | | |

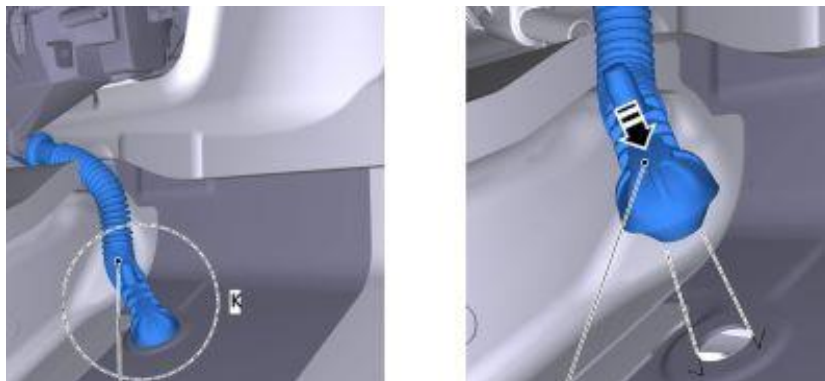
**Figure 1.** Assembly overview for the Audi Q4 e-tron.

Figure 1 shows the assembly overview for the Audi Q4 e-tron.

1. Check and correct the position of the drain hose as shown in the following images.

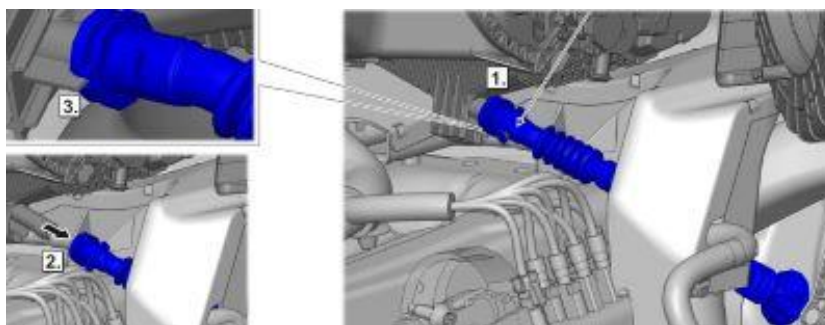
**Figure 2:** Assembly overview for the Audi e-tron GT.

2. Figure 2 shows the assembly overview for the Audi e-tron GT.

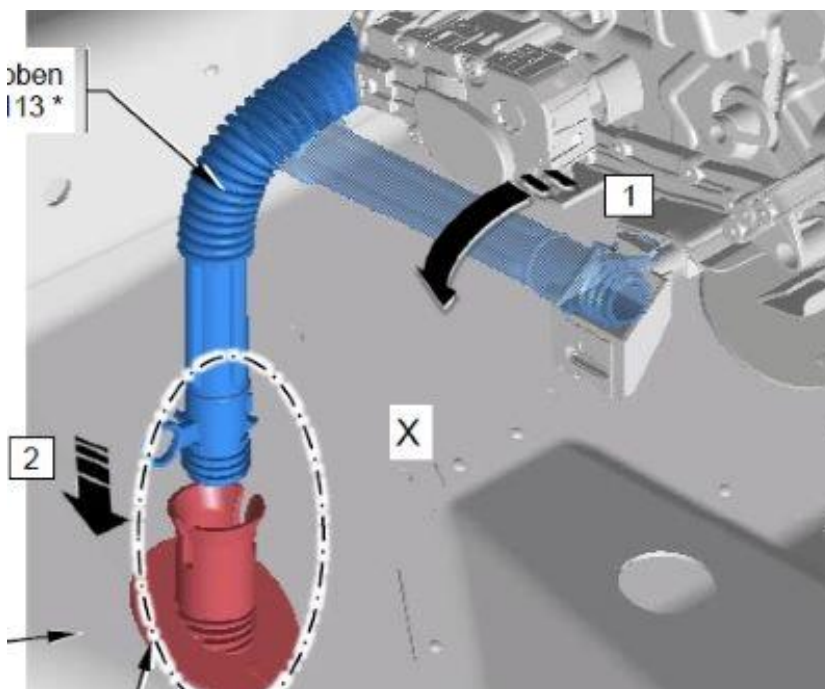
**Figure 3:** Assembly overview for the Audi Q6 e-tron and A6 e-tron.

3. Figure 3 shows the assembly overview for the Audi Q6 e-tron and A6 e-tron.
