## Technical Service Bulletin

Transaction No.: **2082686/1**

97 Engine: drive system fault, pressure differential sender no communication, entry  
P0698, U06010 - V6 PHEV 3.0 TFSI

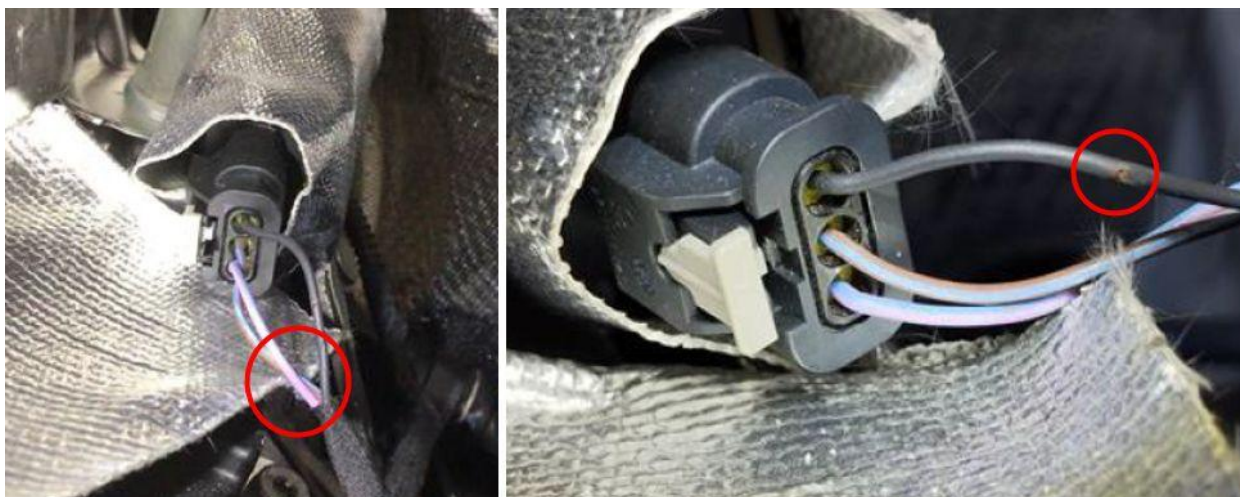
The part of the wiring harness that branches off to particulate filter pressure differential sender 1 may be touching the heat insulation sleeve. This causes chafing on one or more wires.

**Figure 1.** Check the wires around the particulate sensor for issues.

If one or more of the event memory entries specified above is logged in the engine control unit (DA0001), please check the wires around the connector for particulate filter pressure differential sender 1 (refer to photo). If there are any issues with the wires, repair them using VAS1978B. Then apply heat-resistant fabric adhesive tape N10592002 to protect the area where the repair was performed and route the wiring so that it does not contact other components.
