## Technical Service Bulletin

Transaction No.: **2082702/1**

21 Engine Charge Pressure System - MIL on, DTC P003900 Overrun recirculation  
Valve N625 - 3.0L V6 TFSI

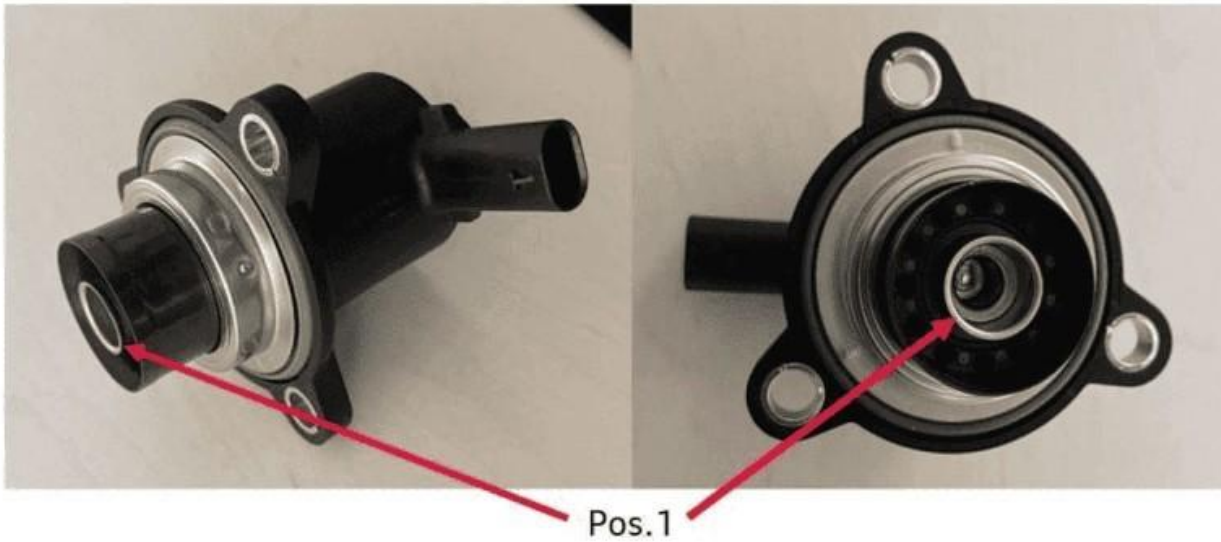
After removal, check whether the centring sleeve is located on the overrun air recirculation valve (refer to item 1 in the example image below).

- Overrun air recirculation valve N625 incl. centring sleeve (OK):

Please replace the turbocharger's overrun air recirculation valve N625.

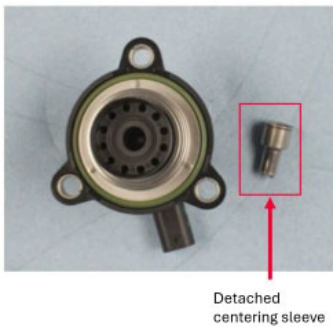
- Overrun air recirculation valve N625 with loose centring sleeve (not OK):

If the centering sleeve is not on the component, check the area around the throttle valve and/or the area between the throttle valve and the charge air coolers and remove the centering sleeve if necessary.

The throttle valve may need to be removed to do this.
