## Technical Service Bulletin

Transaction No.: **2082910/1**

27 Warning message in instrument cluster: P0A1F00 battery control unit

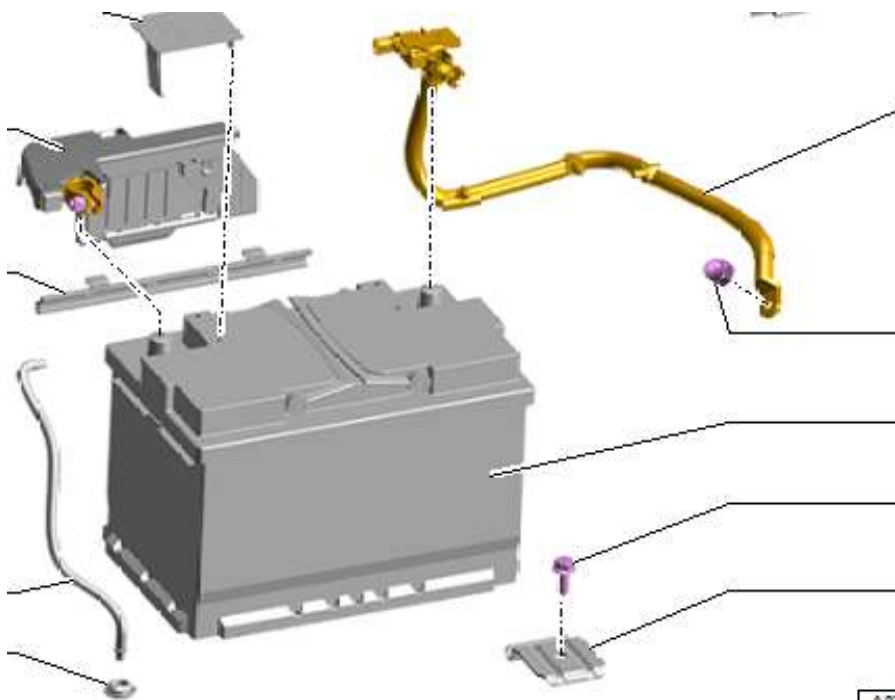
Software issue in battery energy control module

- Replace the BDM (battery monitor control unit, manufactured by Continental) with a BDM manufactured by Hella according to the following list:

**Audi A6 / A7 models:** 4K0.915.181.D (Continental) to be replaced by 8S0.915.181.D (Hella)

**Audi A8 models:** 4N0.915.181.E (Continental) to be replaced by 8W0.915.181.F (Hella)

**Audi Q7 / Q8 models:** 4K0.915.181.E (Continental) to be replaced by 8S0.915.181.D (Hella)
