## Technical product information

| <b>Topic</b> | Bentayga - PDC system not working or PDC system false detection |
| <b>Transaction No.</b> | 2059392/7 |

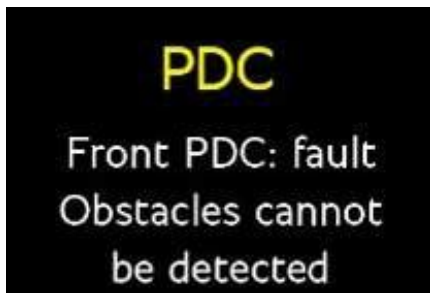
- PDC system not working or PDC system false detection
- Warning evident within the DIP

HINT: The warning shown is the same regardless of model year

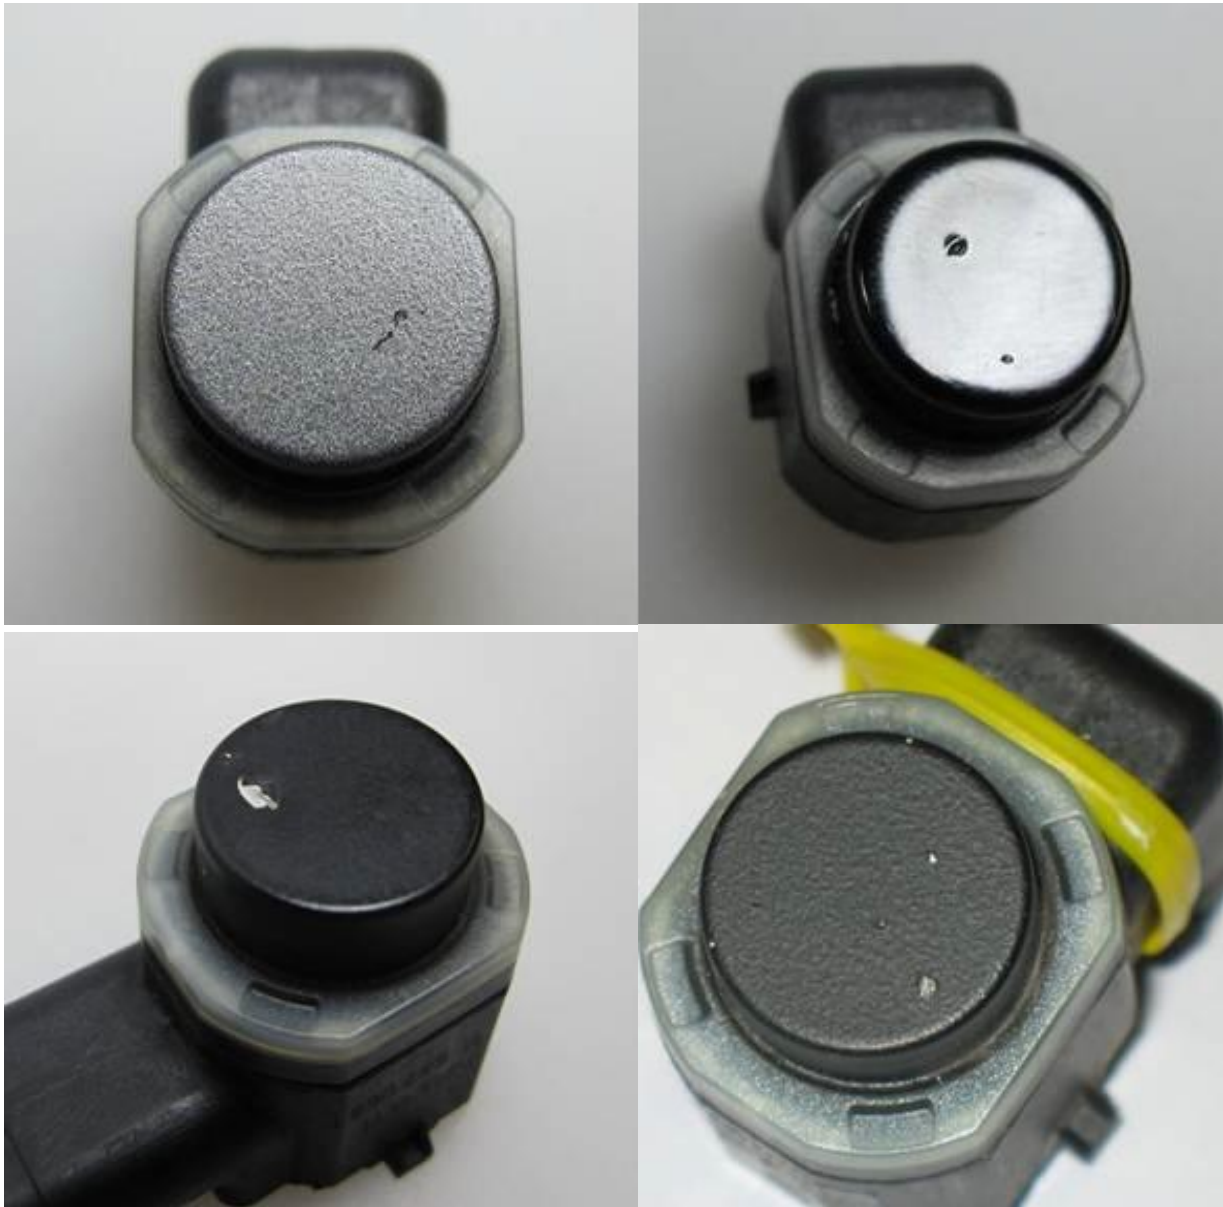
- Dirt, ice, foreign bodies, foil stuck on
- Check any damage on the bumper, air inlet grille and underbody which may indicate a parking accident
- Mechanical damage (stone chips, scratches)

**IMPORTANT: With the following examples stone chips led to the failure of the sensor:**

**Stone chips and scratches are not complaints in the sense of warranty. Therefore dirty sensors should be cleaned and not replaced**

**Any sensors which are replaced for stone chips, scratches or any other type of damage will not be approved for warranty payment**

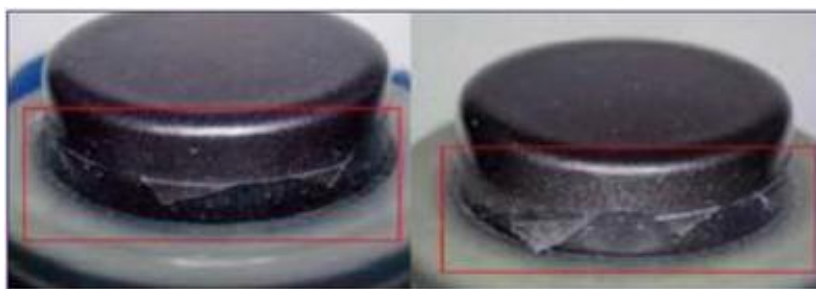
### **Paint overspray**

9. when painting sensors ensure to paint within area specifications, removable layers of paint on the membrane can lead to false signals
