**Warning Message "Vehicle Electrical System Faulty" in Conjunction With Fault Memory Entry "Cell Module X, Ageing Detected" in the High-Voltage Battery Control Unit - BMC (44/25)**

Model Line: **Taycan (Y1A / Y1B / Y1C)**

Concerns: **Cell block module for high-voltage battery (battery module)**

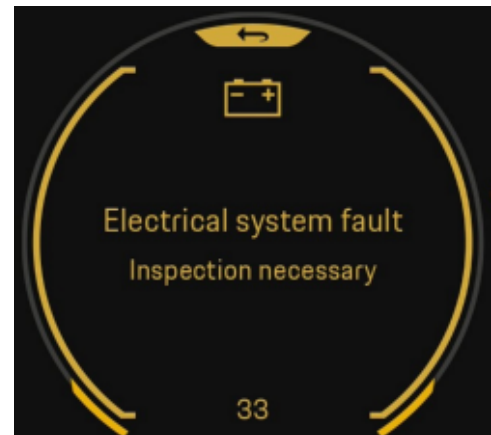
If the high-voltage battery is abnormal, the following warning message will be displayed on the instrument cluster. → *Warning message*

In addition, the charging capacity of the high-voltage battery is automatically limited to 80% and the fault memory entry specified below is stored once or several times in the high-voltage battery control unit (BMC):

*Warning message*

- If the high-voltage battery is **not tested and repaired in the Porsche Center within 180 days**, the **charging capacity is automatically limited to 50%**.

- **As soon as a corresponding warning occurs, a Porsche Center is to be contacted immediately.**

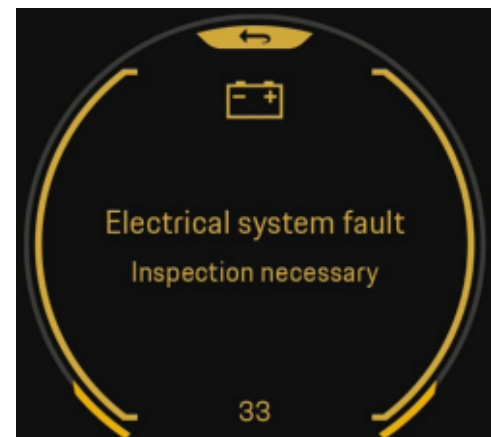
- If abnormalities in the battery modules are detected, the **warning message "Vehicle electrical system faulty"** appears every time the vehicle is started (ignition change) – until the vehicle is diagnosed in the Porsche Center and repaired if necessary.
- For **each cell module affected**, a **separate fault code (DTC)** is stored in the **control unit of the high-voltage battery**. *⇒ Illustration 3 Relevant error codes incl. affected module*
- Example Fault memory entry: B19D9EF\*

*Illustration 2 Yellow warning message after identification of a cell module error*

- The warning message automatically limits the **maximum charging capacity to 80%** to reduce the risk of a short circuit in the battery.
- If, **within 180 days, no testing or repair** is carried out in the Porsche Center, the **charging capacity is further reduced to 50%**.

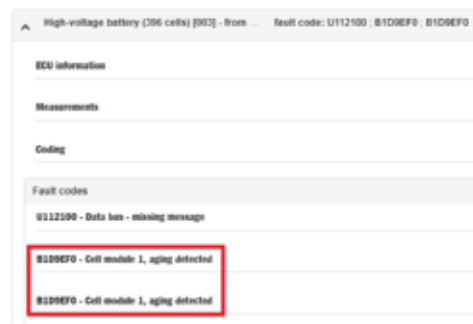
At this point "\*", different **numbers from 1 to 9** or different **letters from A to Z** can be specified, depending on the module number concerned. An example with warning module 1 is shown in Illustration 3.

Illustration 3 Relevant error codes  
incl. affected module
