## Technical product information

| <b>Topic</b> | Front door clash with the rear door brightware Bentayga Series |
| <b>Transaction No.</b> | 2068064/6 |

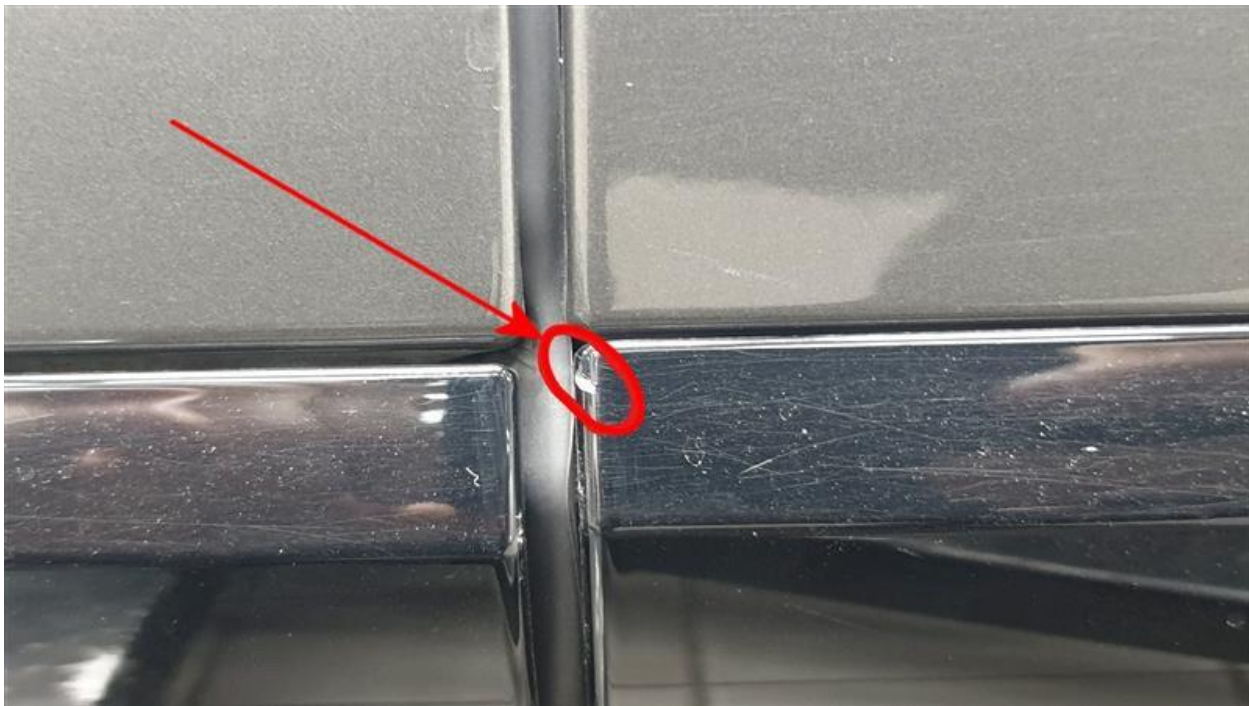
Figure 1

The front door inner panel hem is clashing with the rear door lower brightware (Figure 1) during the closing operation of the front door

The clash condition can occur on the left and/or right hand side

1) With extreme care - Use a suitable "smooth cut hand file" to remove the raised inner door panel hem edge, until the hem edge is as shown in Figure 5

2) Once the protruding hem edge has been suitably reduced, close the front door to confirm the issue is resolved (No clash condition evident between the front door inner panel hem and the rear door lower brightware)

3) Conduct a paint repair to the applicable area **ensuring all approved paint repair guidelines are strictly followed to eliminate the risk of any paint and/or corrosion related issues**

4) Referring to Rep.Gr 66 - Replace the rear door lower brightware

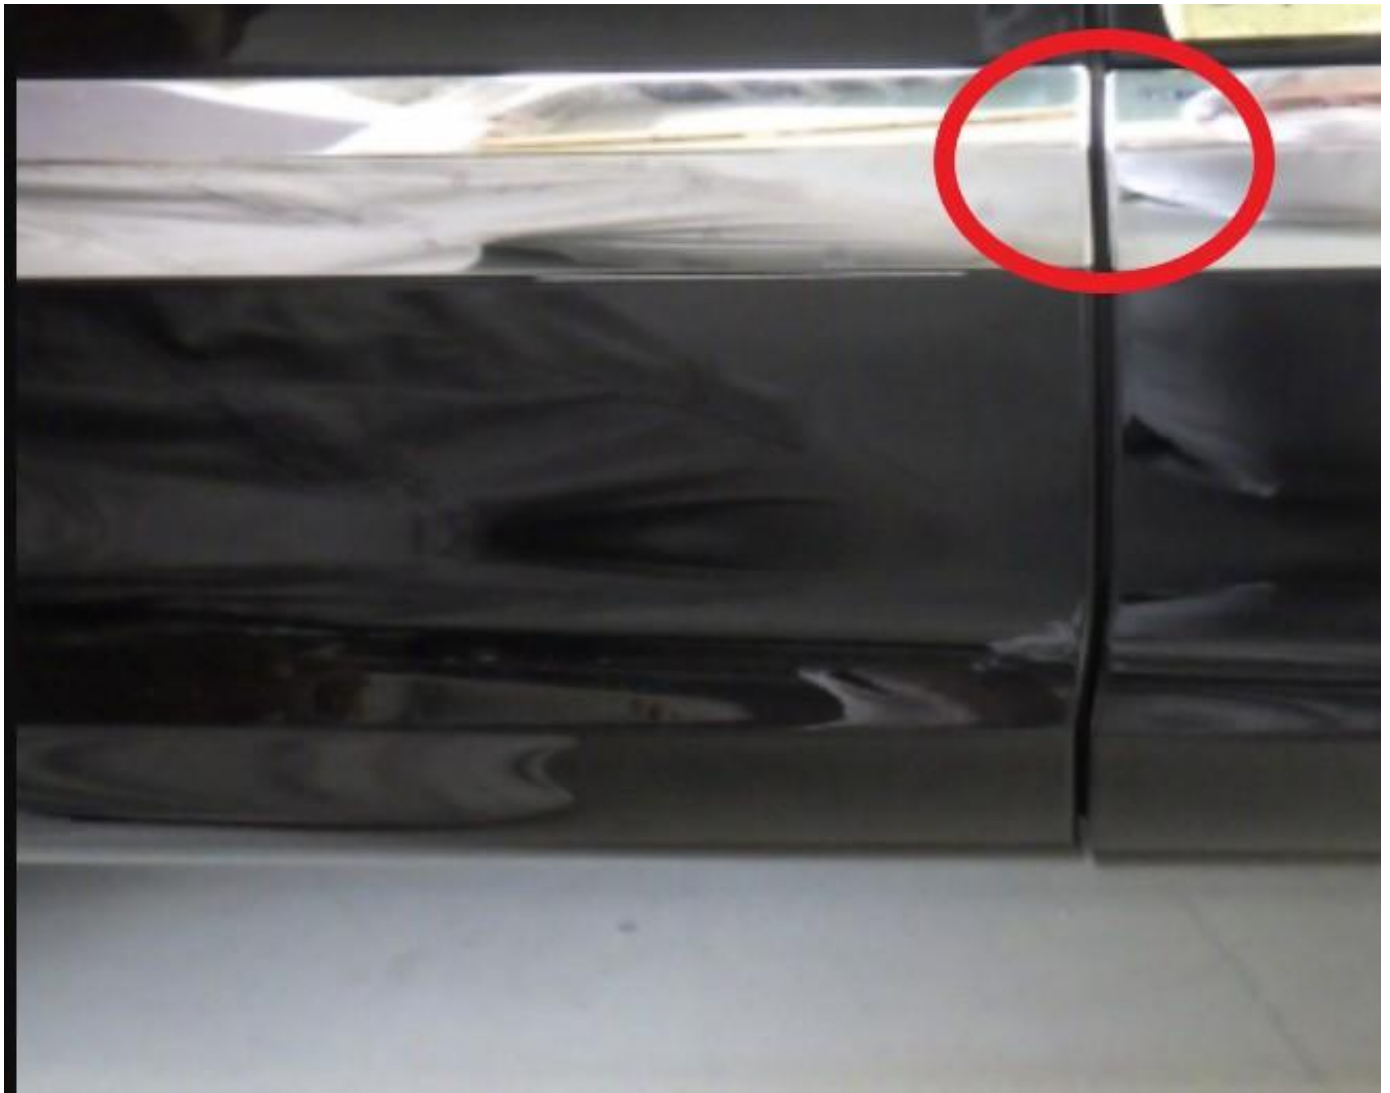
The rear door lower brightware is clashing with the front door brightware (Figure 2)

In the event the rear door lower brightware is clashing with the front door lower brightware as shown in Figure 2 the operative should conduct the instructions within the Measure section for (Scenario 2)

In the event the issue is as described and the clash condition is between the rear door lower brightware and the front door lower brightware the operative must refer to the instructions within Rep.Gr 66 - Door lower brightware – To remove and fit ensuring the following before refitting:

- If you are re-using the old part, replace the adhesive strips with "3M automotive acrylic tape" or similar, locally sourced
- Clean the bonding surface of the door with Cleaning solution 3M VHB before refitting the lower brightware

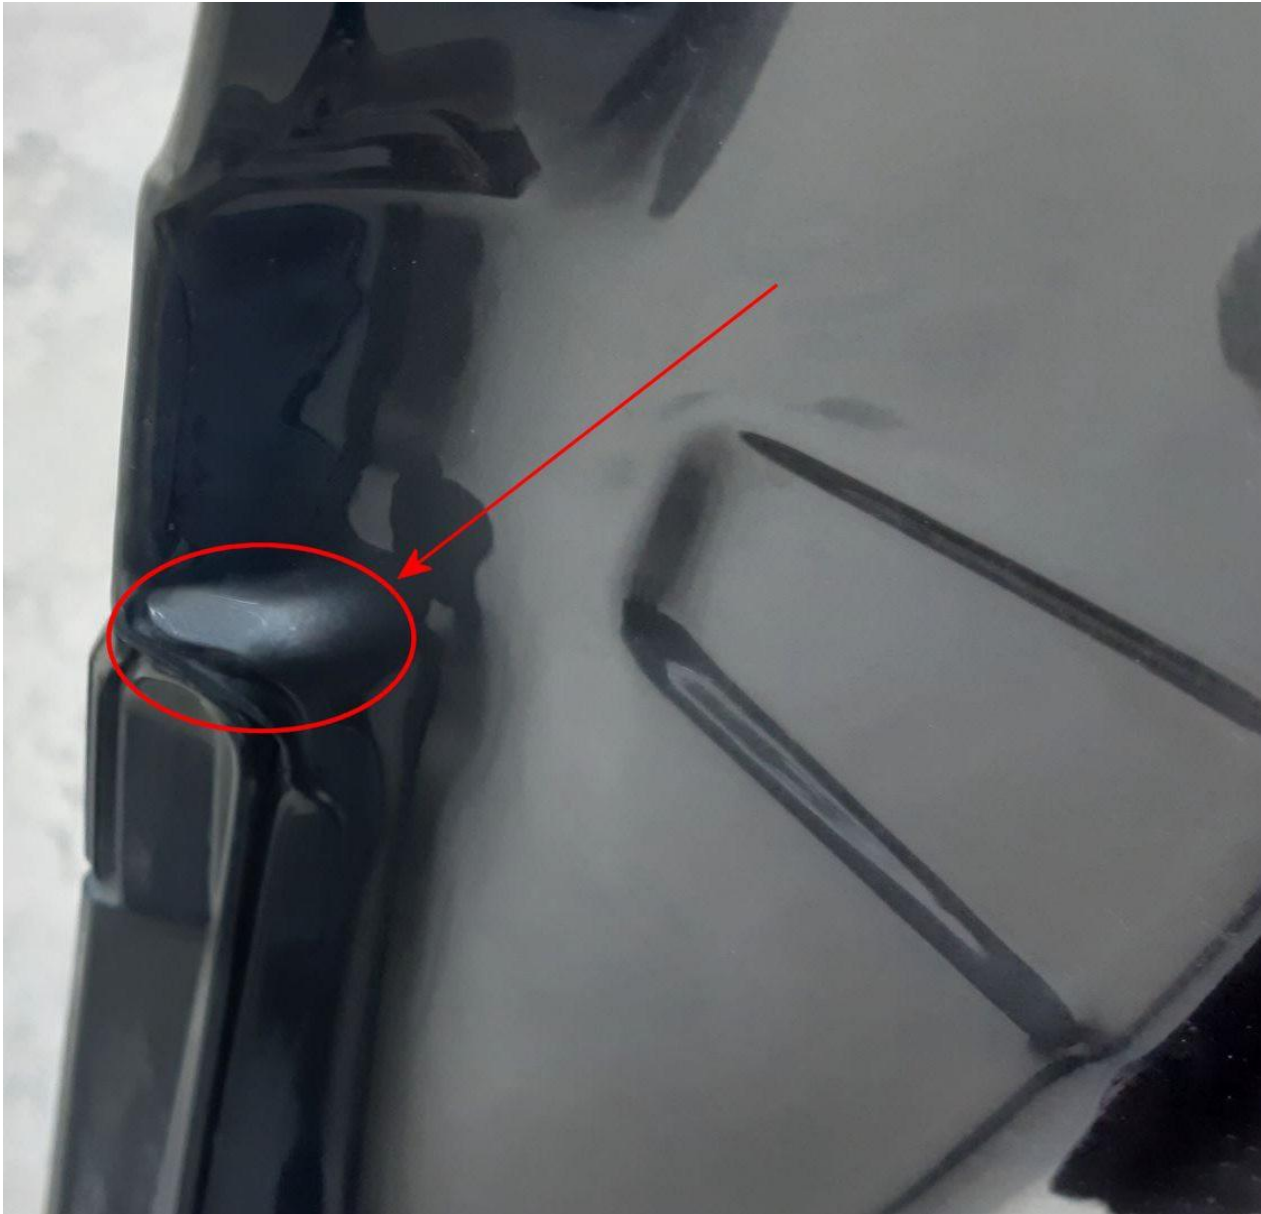
Figure 3

The issue is evident due to a clash condition between the front door inner panel hem (Figure 3) and the rear door lower brightware (Figure 4)

**TIP:** The operative should not attempt to adjust the gap and profile of the front and/or rear door to attempt to rectify the clash condition, for this issue only the operative should conduct the instructions within the Measure section of this TPI
