Noises in B-Pillar Area - Correct Felting of B-pillar Trim Panel (SY 61/26)

Model Line: **Taycan (Y1A/Y1B/Y1C)**

Model Year: **from 2025**

Concerns: **Reworking the B-pillar trim panel in the event of noises**

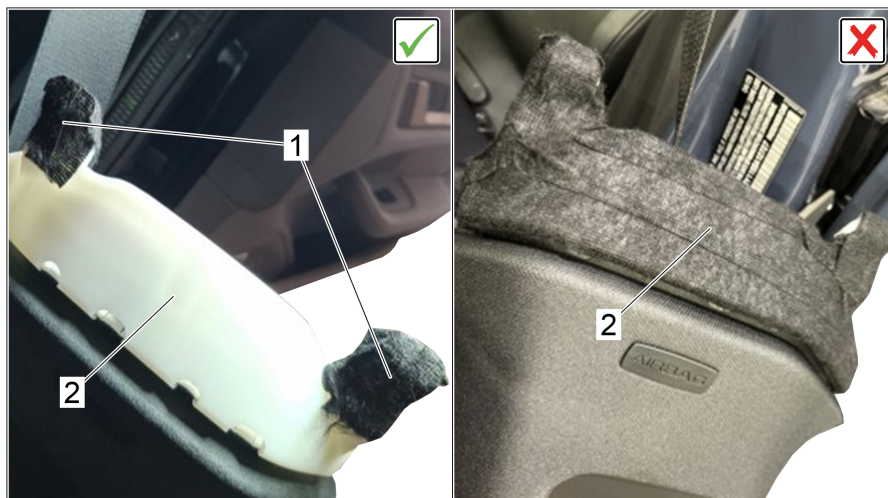
If the B-pillar trim panel on the airbag ramp is reworked/taped with felt, the **airbag triggering behavior can be impaired**.

Remedial Action: In the event of a noise complaint from the area of the B-pillar in which the upper B-pillar trim panel in the inside is to be reworked with felt, **only -1-** mask the **guide pins**.

**The airbag ramp -2- must not be covered with felt.**
