## SERVICE BULLETIN

ID No. SB 26-004  
Ref. No. TSB 001-26  
Release Date 7-16-2026

### SB 26-004 2015-2020 MY COE CAC INLET HOSE

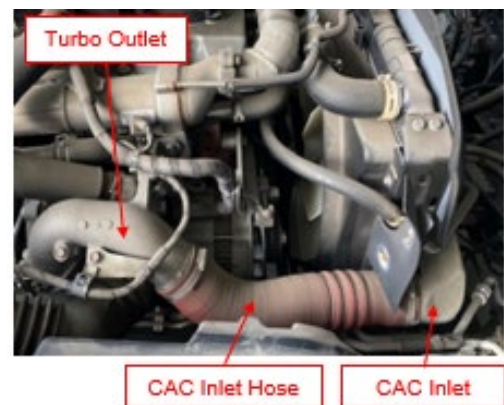
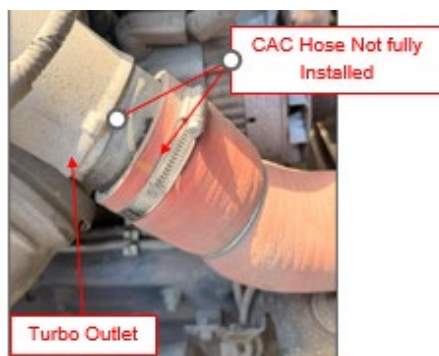
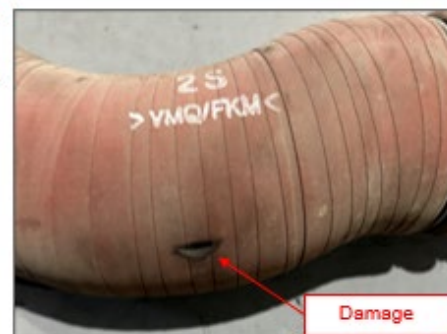
**1.** Inspect the CAC inlet hose for signs of sliding off the turbo outlet or damage. Is the CAC inlet hose sliding off or damaged?

**1.** Remove and discard the existing CAC inlet hose and hose clamps. Install the enhanced CAC hose (Part No. 1734278350) using 3 new hose clamps (Part No. 9003460049). Install two hose clamps on the turbo outlet end of the hose and one on the CAC inlet end. The clamp screws must be positioned 45 degrees (or more) apart. Reference the diagram below. Tighten the clamps to the specified torque. Once all 3 clamps are tightened, re-torque the clamps a second time to the specified torque.
