| <br>PARTS & SERVICES | | <b>Technical Service Bulletin (TSB)</b><br><b>Global Telematics Box (TBM) Firmware Over</b><br><b>The Air (FOTA) Update To SW 4.39</b> | | | |
| <b>REFERENCE:</b> | <b>TSB:</b> 08-296-26<br><b>GROUP:</b> 08 - Electrical | <b>Date:</b> | July 28, 2026 | <b>REVISION:</b> | — |
| <b>VEHICLES AFFECTED:</b> | <b>2025 (WD) Dodge Durango</b><br><b>This bulletin applies to vehicles equipped with Global Telematics Box Module (Sales Code RDG).</b> | | | <b>MARKET APPLICABILITY:</b><br><input checked="" type="checkbox"/> NA <input type="checkbox"/> MEA<br><input type="checkbox"/> SA <input type="checkbox"/> IAP<br><input type="checkbox"/> EE <input type="checkbox"/> CH<br><b>NOTE:</b> This bulletin applies to the North America market. | |

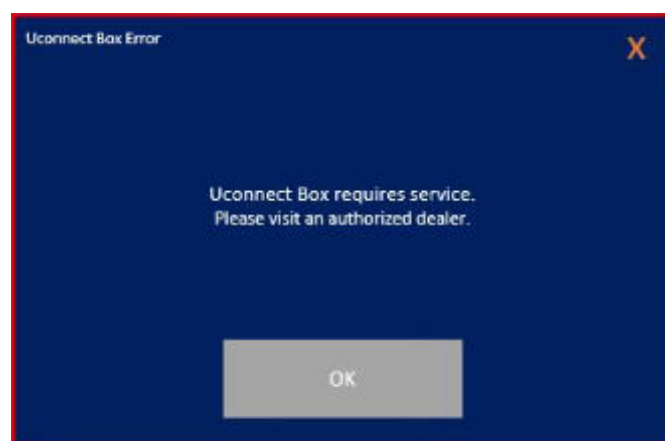
**Fig. 1**

| <b>CUSTOMER SYMPTOM:</b> | <b>Customers must experience a Malfunction Indicator Lamp (MIL) illumination and one or more of the following Diagnostic Trouble Codes (DTCs):</b> <ul style="list-style-type: none"><li>• B22A9-96 - ECU Internal Performance-Component Internal Failure.</li><li>• B1560-11 - Cellular Antenna 1-Circuit Short To Ground.</li><li>• B1560-13 - Cellular Antenna 1-Circuit Open.</li><li>• B1561-11 - Cellular Antenna 2-Circuit Short To Ground.</li><li>• B1561-13 - Cellular Antenna 2-Circuit Open.</li><li>• B1562-14 - GPS Antenna-Circuit Short To Ground Or Open.</li></ul> <b>Customers may also experience the following:</b> <ul style="list-style-type: none"><li>• "UConnect Box Requires Service" Message in Radio Display.</li></ul> | | | | |
| <b>CAUSE:</b> | <b>TBM Software</b> | | | | |

Uconnect Box Error Message

Message display on the radio screen "Uconnect Box requires service. Please visit an authorized dealer." [Fig. 1.](#)

This bulletin provides information regarding the latest Firmware Over The Air (FOTA) update and provides the service technician an overview of the steps a customer will need to take to complete the update. The TBM software will be updated from 4.37 and 4.38 to 4.39 (243187 SW PN number).

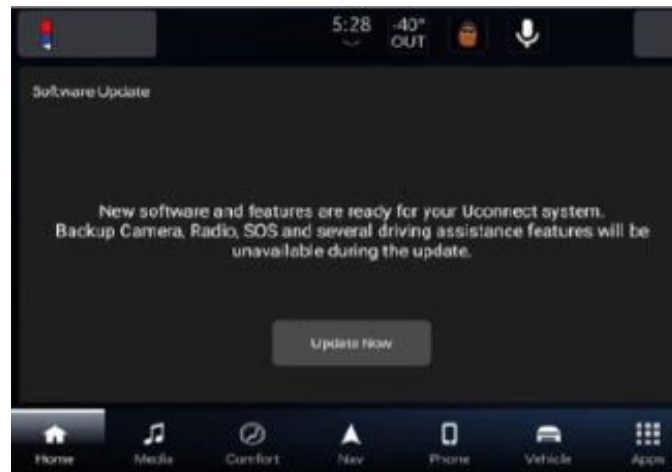
**Fig. 2**

Software Acceptance Screen

1. The vehicle needs to be in 'Park'. The ignition needs to be in the off position.
2. If the customer selects “Update Now” [Fig. 2](#), they can shut off the vehicle and leave. The update will be completed automatically.

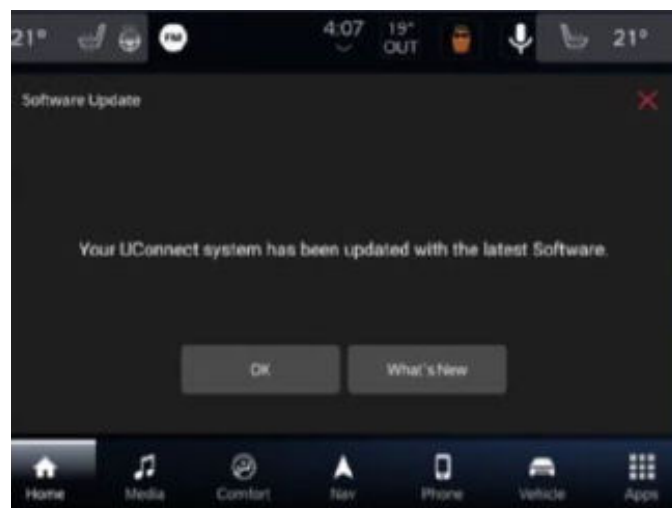
**Fig. 3**

Software Update Confirmation Screen

3. Upon completion of update, the radio will display a confirmation message [Fig. 3](#).
