**Technical Service Bulletin (TSB)**  
**R1H Radio USB Update to U41.17**

| REFERENCE: | TSB: 08-287-26 REV. A<br>GROUP: 08 - Electrical | Date: | August 1, 2026 | REVISION: | 08-287-26 |
| VEHICLES AFFECTED: | 2026 (H1) Jeep Commander<br>2026 (M1) Jeep Compass<br>2026 (N4) RAM Rampage<br>This bulletin applies to vehicles built on or after **June 09, 2025 (MDH 0609XX) and on or before July 10, 2026 (MDH 0710XX).** | | | MARKET APPLICABILITY:<br><div><input checked="" type="checkbox"/> NA<input checked="" type="checkbox"/> MEA</div> <div><input checked="" type="checkbox"/> SA<input type="checkbox"/> IAP</div> <div><input type="checkbox"/> EE<input type="checkbox"/> CH</div><br><b>NOTE:</b> This bulletin applies to the North and South America, and Middle East & Africa markets. | |

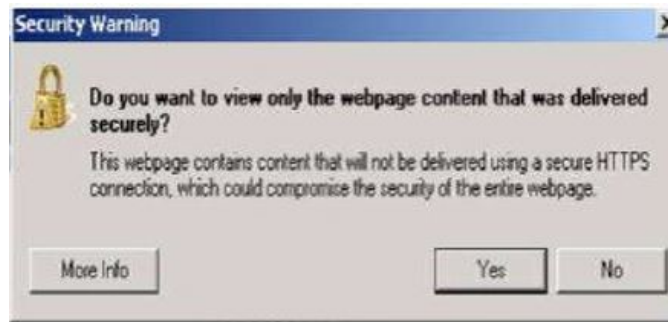
**Fig. 1**  
Pop-Up Security Message

1. Check if the radio software has been updated. Go to “Vehicle Settings” then select "System Information" and look for “Radio Version”.
2. Was the radio software at or above U40.20?
  - YES >>> This bulletin does not apply.
  - NO >>> Proceed to [Step 3](#).
3. Has a **4 GB** USB flash drive been created?
  - YES>>> Proceed to [Step 12](#).
  - NO>>> Proceed to [Step 4](#).
4. Go to DealerCONNECT>Service>Uconnect Command Center>Uconnect>Dealer software downloads to download the files.
5. If a security message appears “Do you want to view only the web page content that was delivered securely?” [Fig.1](#). Press “No” to continue.

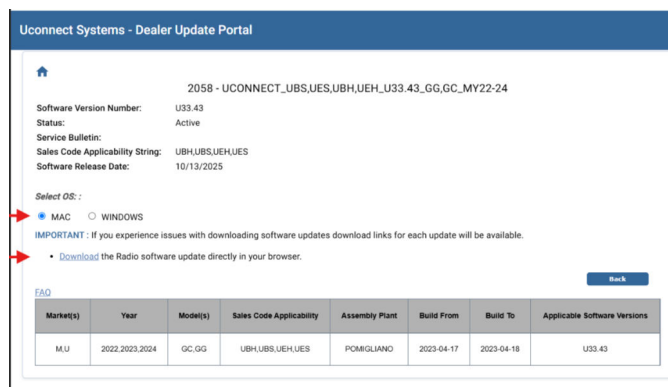
**Fig. 2**  
MAC Radial Button

7. Download the software update file to your local PC's desktop. Make sure to select the “MAC” radial button for all downloads [Fig.2](#).

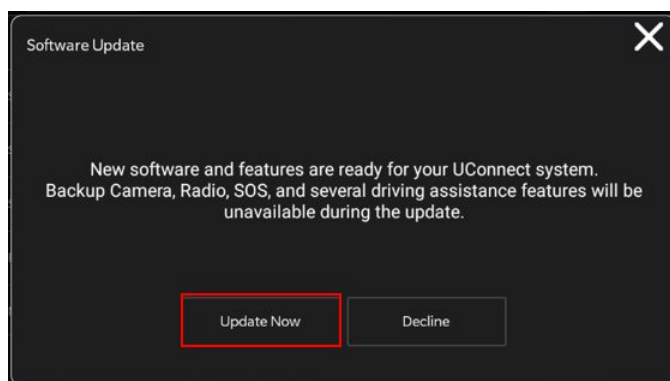
**Fig. 3**  
Software Update

13. Once the system has verified there is an available update, press the “**Update Now**” button. Make sure the vehicle is in park. **Do NOT turn the ignition off until the two minute timer has expired. The ignition doesn't have to be turned off to update the radio's software** [Fig.3](#).

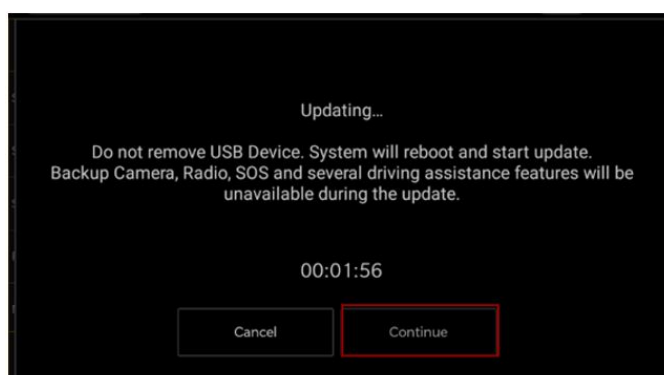
**Fig. 4**  
Software Updating

14. Press the “**Continue**” on the display screen [Fig.4](#).

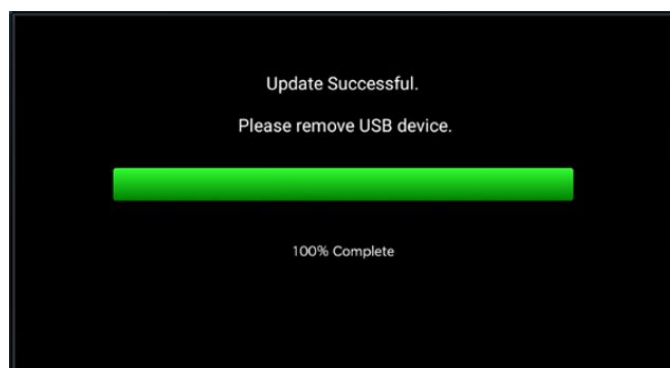
**Fig. 5**

15. The radio will reboot and the software update will begin. The software update should only take 30 minutes [Fig.5](#).

Update Successful

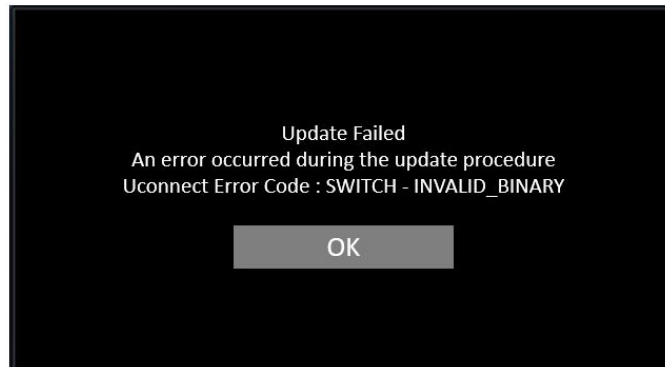
**Fig. 6**

16. **DO NOT** turn off the ignition at this point. The software update is still in process. Wait until the radio restarts and the home screen is displayed. This should take around five minutes.
17. If the radio displays an error pop up “ SWITCH-INVALID\_BINARY“ after successful radio update, ignore this error message and press “**OK**” to continue [Fig.6](#).

Update Failed

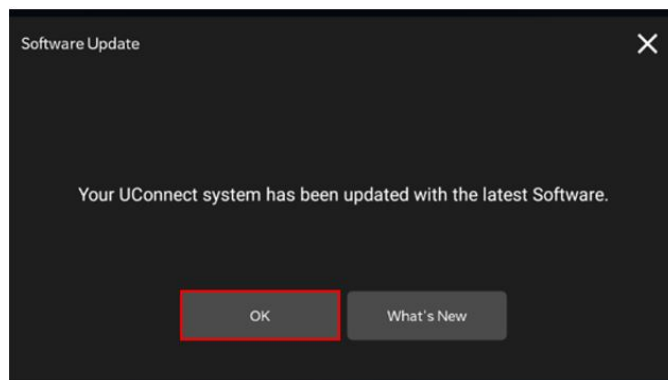
**Fig. 7**

18. Press “**OK**” to continue [Fig.7](#).

Completed Update
