**Technical Service Bulletin (TSB)**  
**Generic Key Fobs Shipped with Vehicle**

| REFERENCE: | TSB: 08-306-26<br>GROUP: 08 - Electrical | Date: | August 1, 2026 | REVISION: | 08-041-23 |
| VEHICLES AFFECTED: | 2023 (M1) Jeep Compass<br>This bulletin applies to vehicles built on or after September 29, 2022 (MDH 0929XX) and on or before November 19, 2022 (MDH 1119XX) equipped with a 2.0L I4 Turbo Diesel Engine (Sales Code EBT). | | | MARKET APPLICABILITY:<br><div><input type="checkbox"/> NA<input type="checkbox"/> CH</div> <div><input type="checkbox"/> EE<input type="checkbox"/> IAP</div> <div><input checked="" type="checkbox"/> SA<input type="checkbox"/> MEA</div><br><b>NOTE:</b> <b>**This bulletin applies to the South America markets.**</b> | |

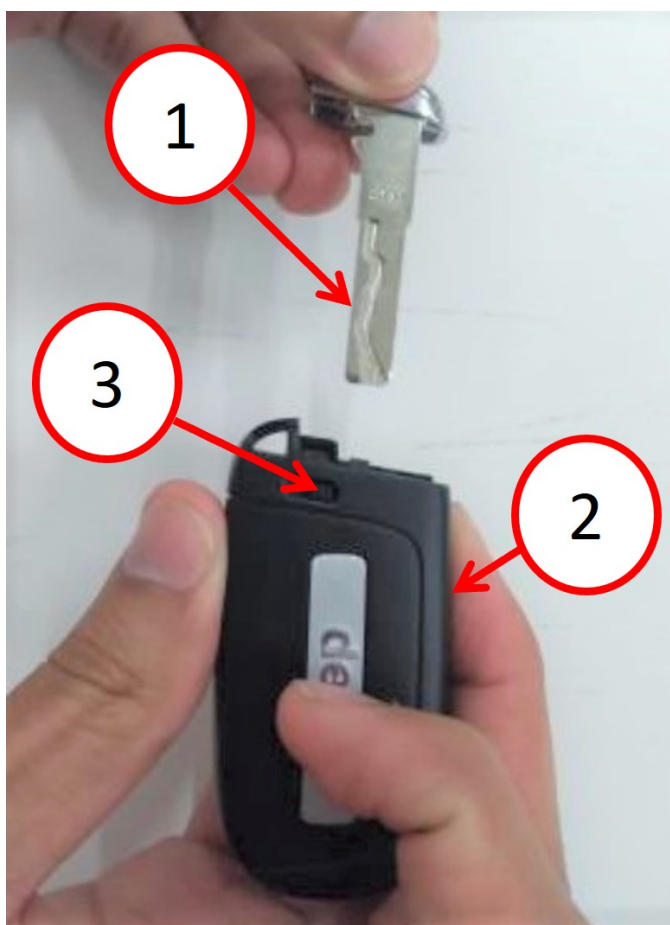
**Fig. 1**  
Key FOB Assembly

| CUSTOMER SYMPTOM: | Customers may comment on the following: <ul style="list-style-type: none"><li>Key FOBs are not specific to vehicle (during the delivery the customer was informed that they will need to return to dealer to change the key FOBs).</li></ul> | | | | |
| CAUSE: | Lack of assembly | | | | |

**NOTE: Do not discard the mechanical key. The mechanical key is to be reused with the new FOBs.**

2. Find the button for removal of the mechanical key on the back of the key FOB [Fig. 1](#).
3. Press the button and remove the mechanical key completely from the key FOB [Fig. 1](#). **Discard key FOB.**
4. Pick up a **NEW** key FOB and insert the mechanical key [Fig. 1](#).
5. Repeat for the other new key FOB.
6. Perform the programming procedure on the two new key FOBs. Refer to the detailed service procedures available in DealerCONNECT> Service Library under: Service Info> 08 Electrical / 8E Electronic Control Modules / Module, Radio Frequency (RF Hub) / Module Programming> Key Fob Programming.
