## TECH TIP

TT-26-006

### Driving Support Malfunction ABS Light On No Communication

2022MY to current L-Series trucks equipped with Lane Departure and Collision Mitigation.

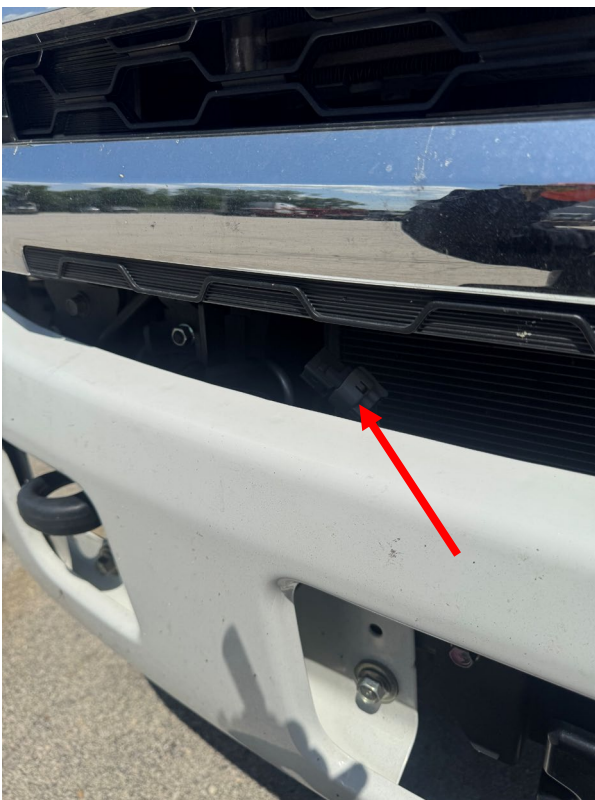
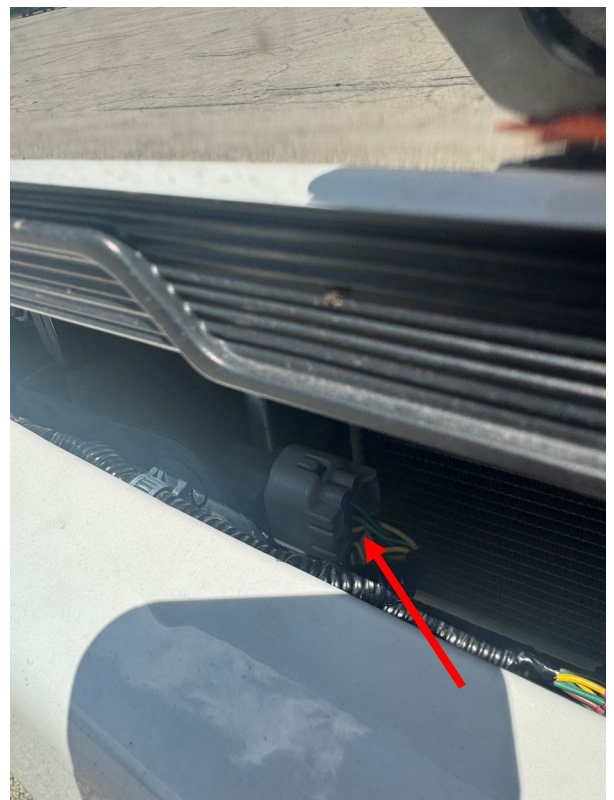
Driving Support Malfunction warning and/or ABS light on, communication concerns with the Wabco ABS module, possibly related DTC's too. We have found in some instances, a poor connection or backed out terminal found at the junction located behind the front bumper area. Follow the procedure to inspect the area of concern.

1. Locate the junction behind the front bumper as shown in the images below.

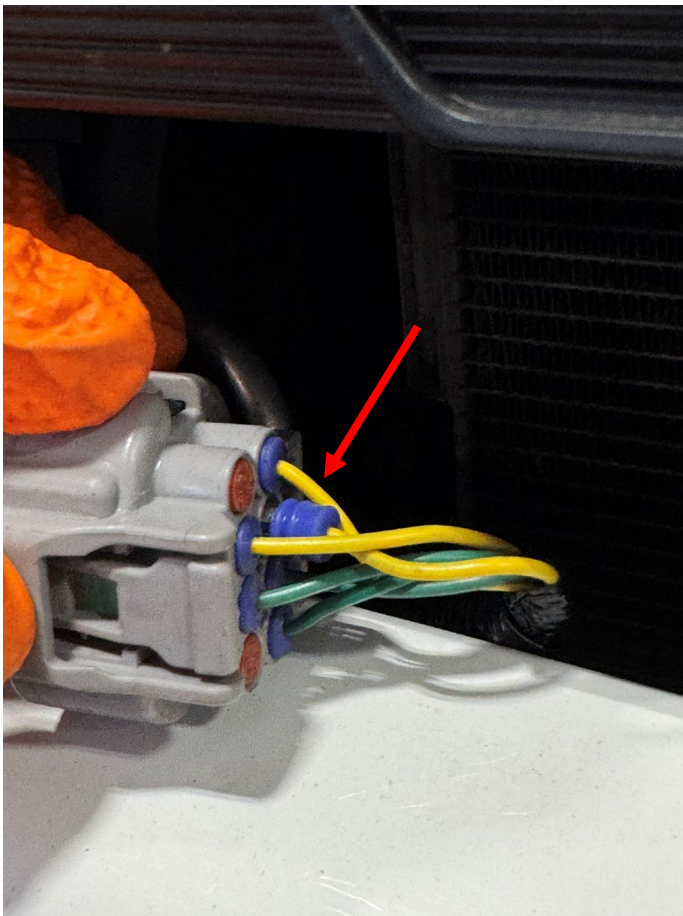
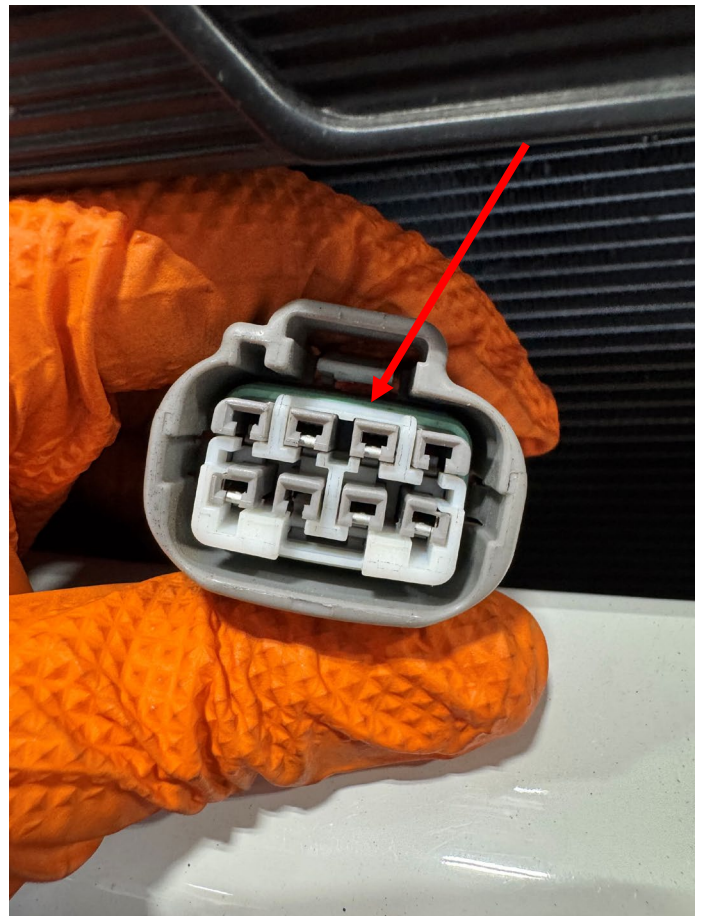
2. Inspect for backed out terminals, loose pins and/or corrosion and repair if found

3. Once repairs are complete, re-evaluate operation
