## RSB-56-25-002-2: Corrosion Below Door Handles

Rivian is launching a technical service bulletin for some model year 2022-2024 R1T and R1S vehicles that might have bubbles in the painted surfaces below the exterior door handles. On these vehicles, adhesive that secures an inner door reinforcement could allow contaminants to corrode the inner surface of the door over time, affecting the visual appearance of the door surface. Upon customer complaint, Rivian will repair and refinish the affected door(s).

| <b>Document Type</b> | Technical Service Bulletin |
| <b>Affected Model(s)</b> | R1T, R1S |

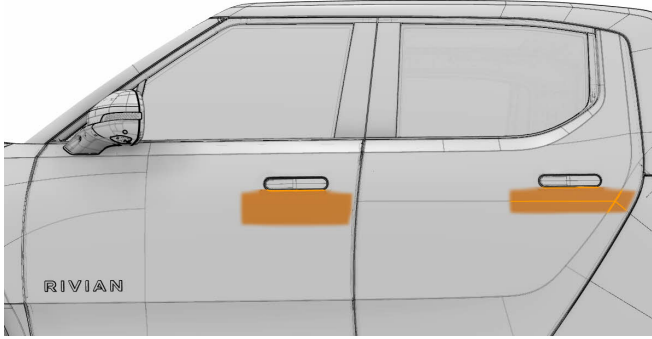
1. On both sides of the vehicle: Check the highlighted area(s) for damage.

2.
  - If there are 1 or more bubbles in the paint in any of the highlighted areas: The component must be repaired by a Rivian Certified Collision Center. The Rivian Certified Collision Center will follow the steps in the [Procedure](#) section.
  - If there is no corrosion, or there is corrosion in another area of the vehicle: This bulletin is not applicable. Discontinue this procedure.
