Mitsubishi Motors North America, Inc.

## TECHNICAL SERVICE BULLETIN

### FRONT FLAP OF CUP HOLDER DETACHED

No: TSB-26-52-002

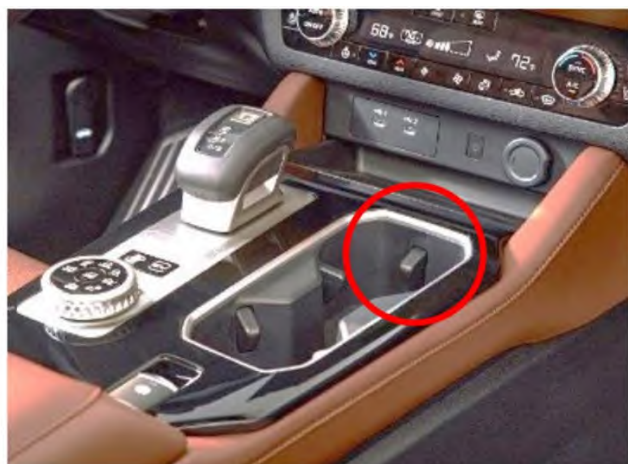
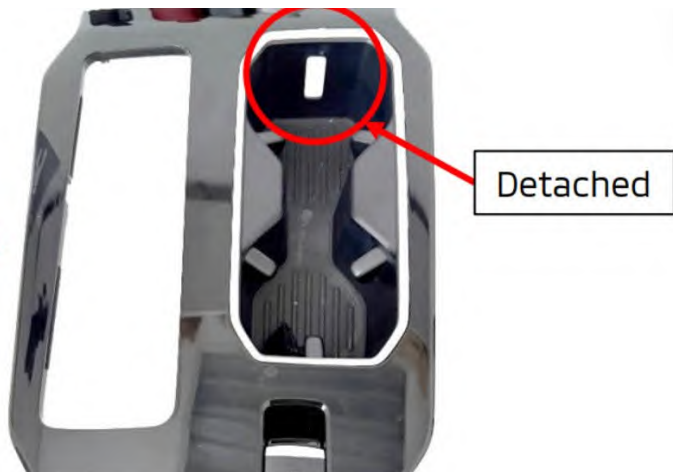
Front flap of the cup holder is missing or detached.

We have received reports regarding the front flap of the cup holder detaching in the Outlander and Outlander Plug-in Hybrid, and we are currently considering a countermeasure for this issue. This article outlines the repair procedures for this issue and the points to be explained to customers. Please utilize this information for customer handling until a countermeasure is available.

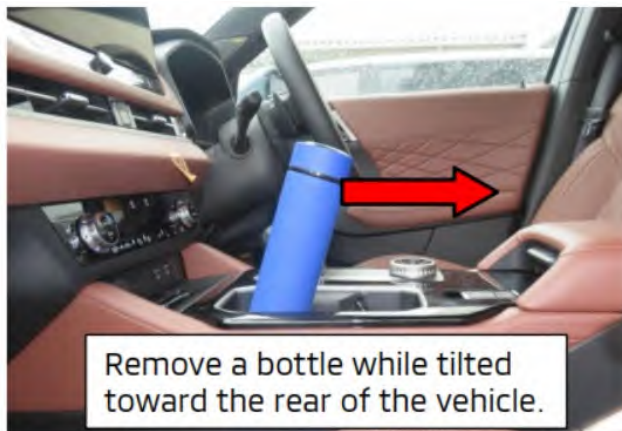
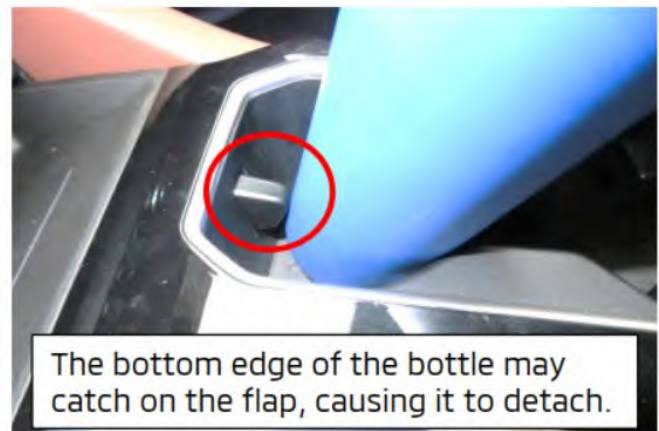
Reproduction testing has confirmed that if a bottle placed in the cup holder is removed while tilted toward the rear of the vehicle, the bottom edge of the bottle may catch on the front flap, causing it to detach. If a customer reports this issue, please inform them that a countermeasure is currently under consideration, and advise them to remove items from the cup holder as vertically as possible.
