Mitsubishi Motors North America, Inc.

TECHNICAL SERVICE BULLETIN

**HOOD FLUTTER  
MY 2022 OUTLANDER**

No: TSB-26-42A-002

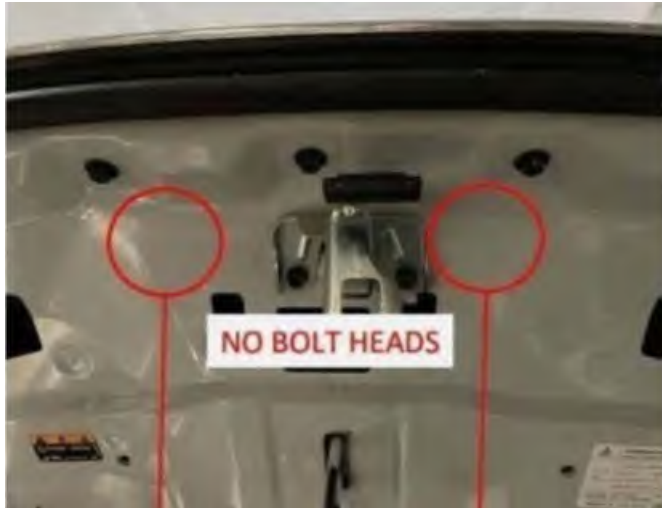
**NON-REINFORCED hood: No bolt heads visible → Hood replacement is required.**

All vehicles equipped with a NON REINFORCED hood will require the engine hood to be replaced with the updated reinforced hood design.

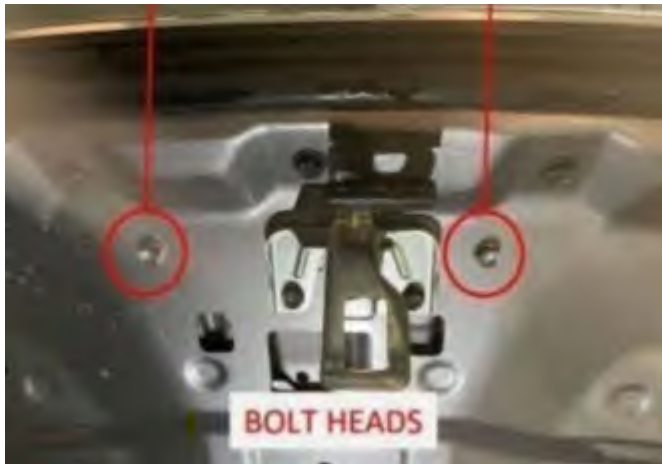
**REINFORCED hood: Bolt heads visible → Hood replacement is **not** required.**

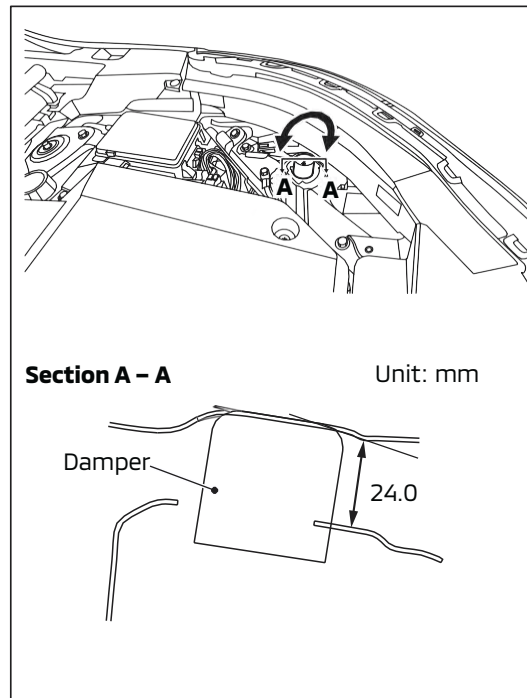
## ADJUSTMENT OF HOOD HEIGHT

If a rattling noise is heard due to the vibration of the hood when the vehicle is being driven, adjust the damper height until the damper is seated on the hood.

Turn the damper to the dimension shown in the figure to adjust the hood height. If the hood height is still not even, turn the damper again until the height is even. The damper height is altered by roughly 4 mm (0.2 inch) when the damper is rotated once.
