## Technical product information

| <b>Topic</b> | Window Drop Glass Operation Continental GT/GTC 19-24MY |
| <b>Transaction No.</b> | 2080375/4 |

Window Drop Glass Operation | Continental GT/GTC |19-24MY

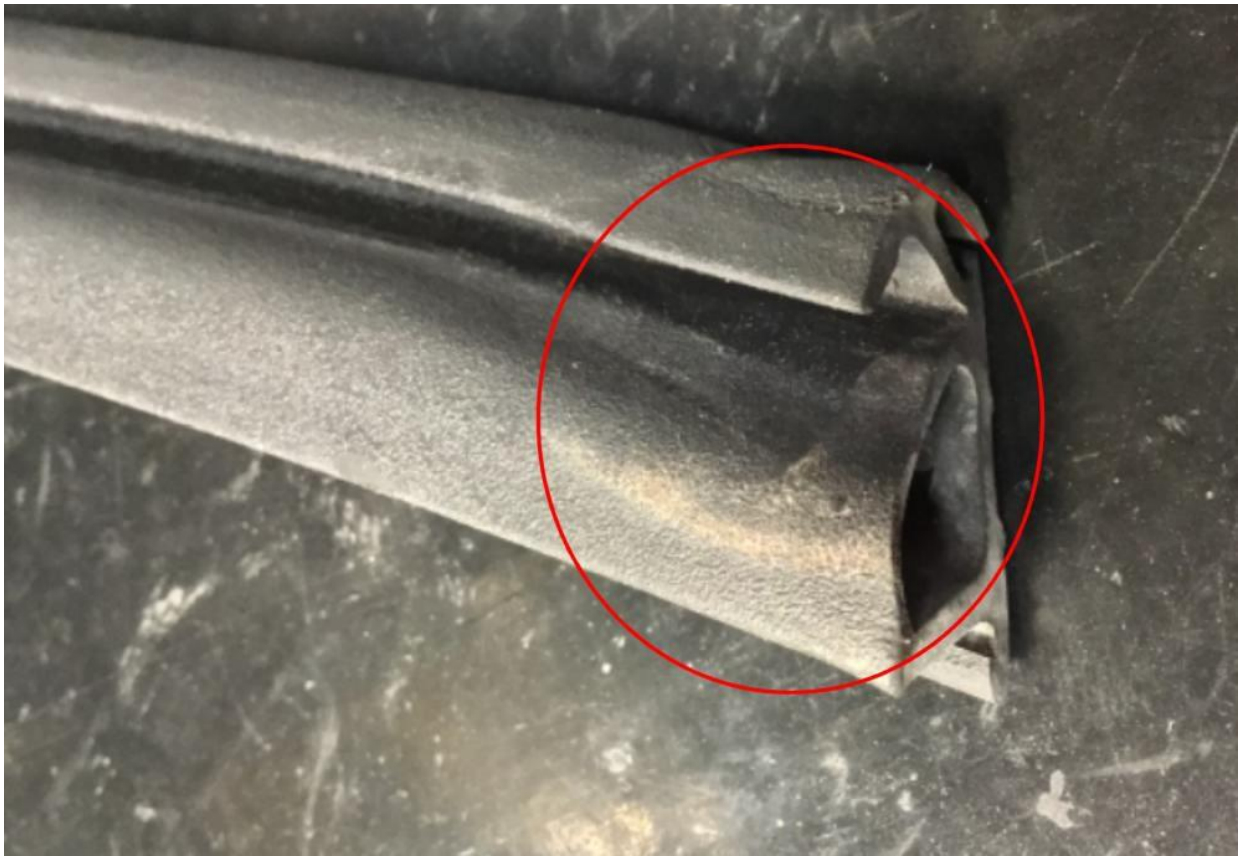
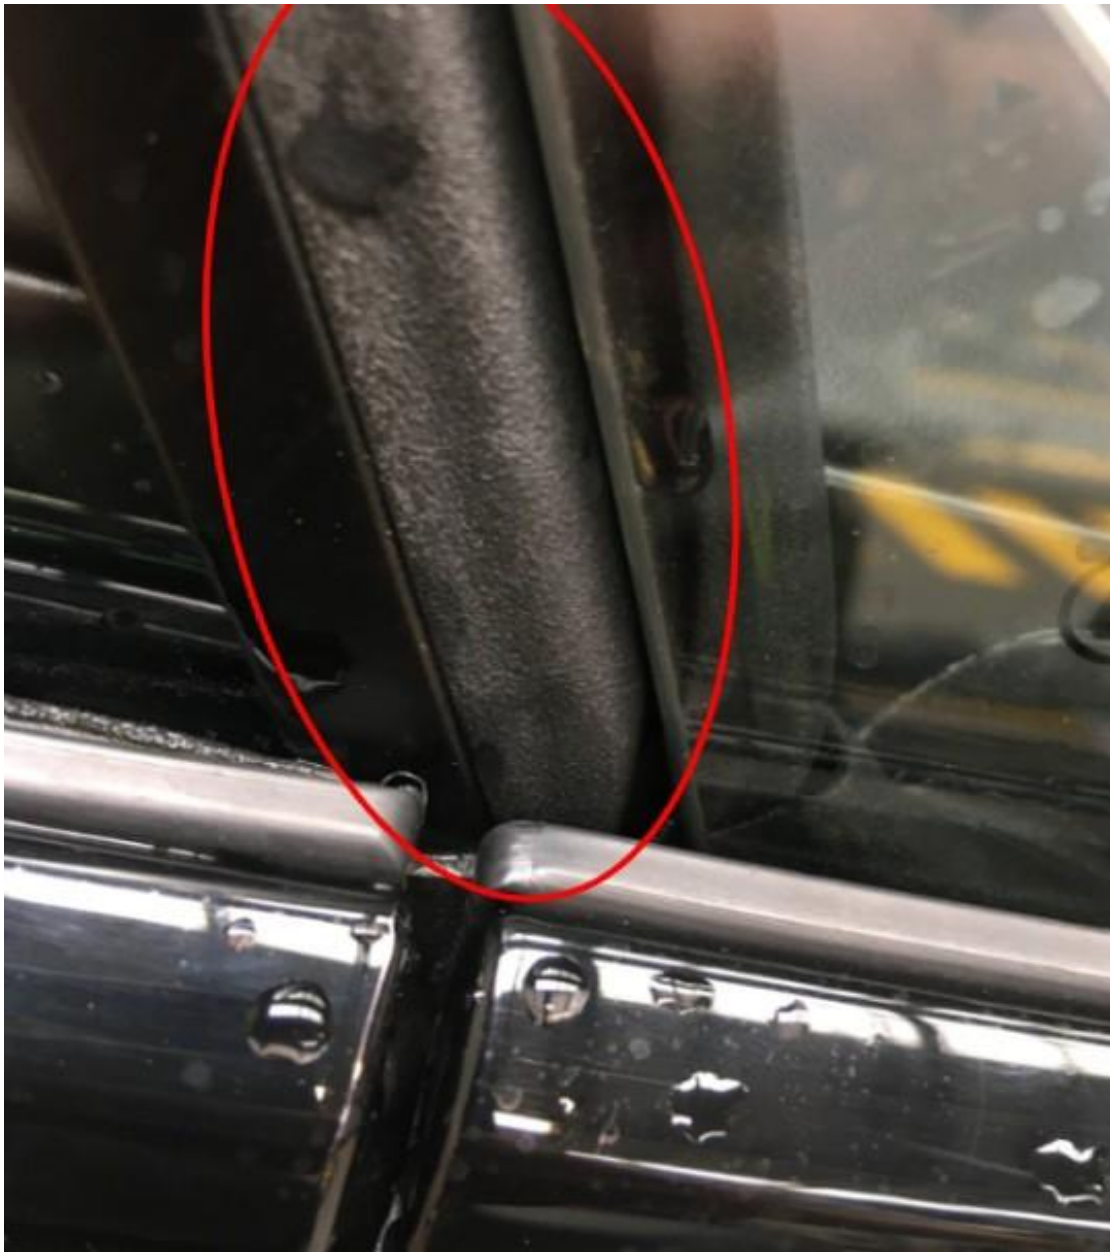
Figure 7

13. Conduct a thorough check of all Window / door seals for the following:

- Damage
- Splits
- Tears
- Misalignment
- Incorrectly fitted / located
- Drop glass seal deformation (see Figures 7 and 8 as examples)

**NOTE:** Any issues found with the window seals must be rectified before conducting the remaining steps

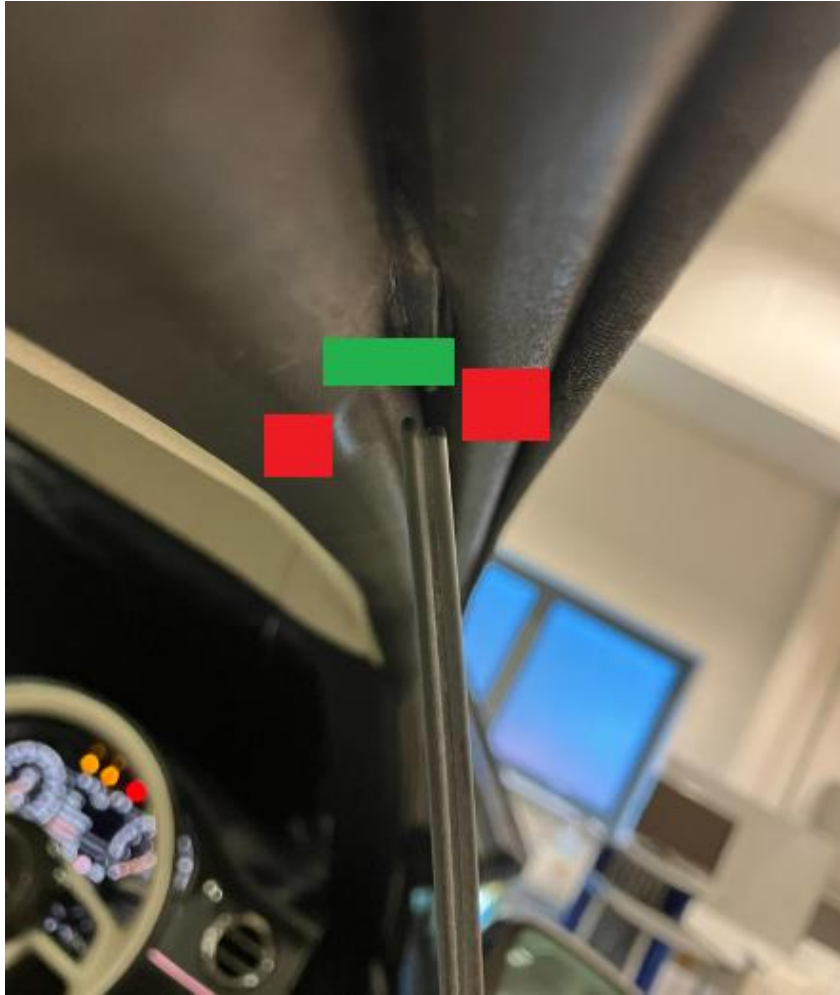
Front Window example showing correct operation

Windows should enter cant rail seal smoothly, making contact with green area.

For the front door, poor door profile point is a major contributing factor here and should be checked/adjusted if window found to be entering seal incorrectly.

If this is not correct, it will cause the window to bounce back causing a loss of basic settings.

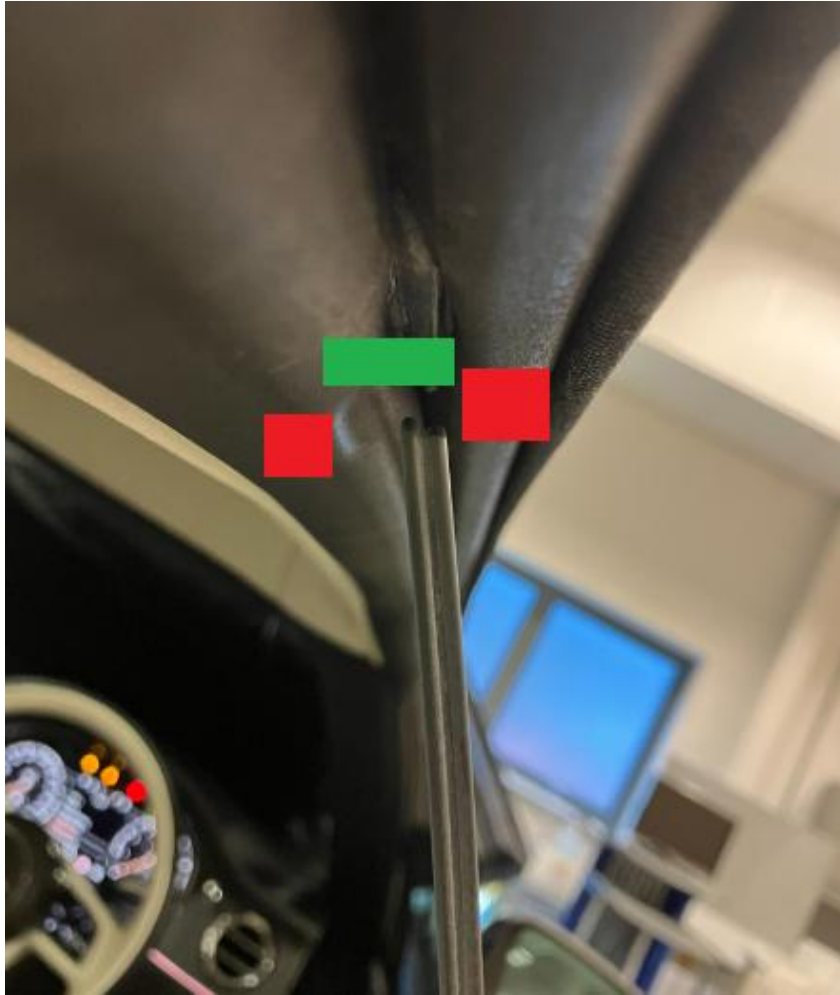
Front Window example showing correct operation

Windows should enter cant rail seal smoothly, making contact with green area.

For the front door, poor door profile point is a major contributing factor here and should be checked/adjusted if window found to be entering seal incorrectly.

If this is not correct, it will cause the window to bounce back causing a loss of basic settings.

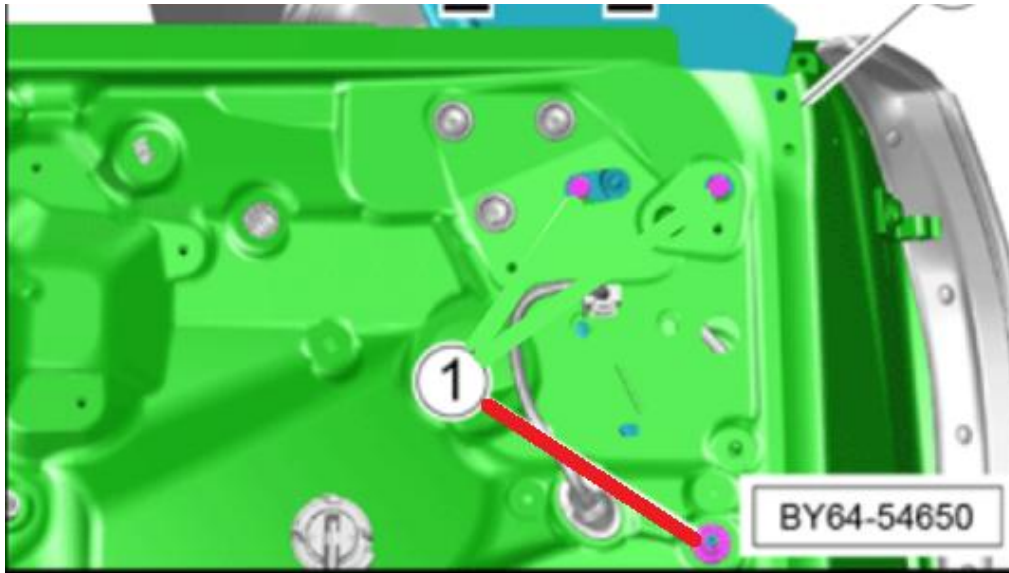
*Figure 1. Image for reference, glass does not require removal from vehicle*

In instances of multiple window drop concerns it has been found that to achieve the glass set specification, some adjusters are being adjusted out of specification.

In some cases, since not all adjusters are visible, there is a possibility that the adjusters can be set to their maximum inboard/outboard and induce excess tension in the regulators and affect the angle the windows enter the seals. There is free play built into the front and rear regulators, therefore as the windows are being held in place by the cant rail/convertible roof seals when closed, this may not be apparent when measuring. However, these extreme adjustments can cause issues with how the windows enter the cant rail/convertible roof seals or how the front and rear glasses interlock with each other, in some cases this can cause the seals to pinch and cause an anti-trap condition leading to window reversal.

The measurement between the bottom of the mounting washer and division bar frame, is 12.5mm.

1. loosen the lock nut.
2. Screw the adjuster fully clockwise until it bottoms out on the frame.
3. Unscrew the adjuster counterclockwise by four complete turns.
4. Resecure the lock nut.

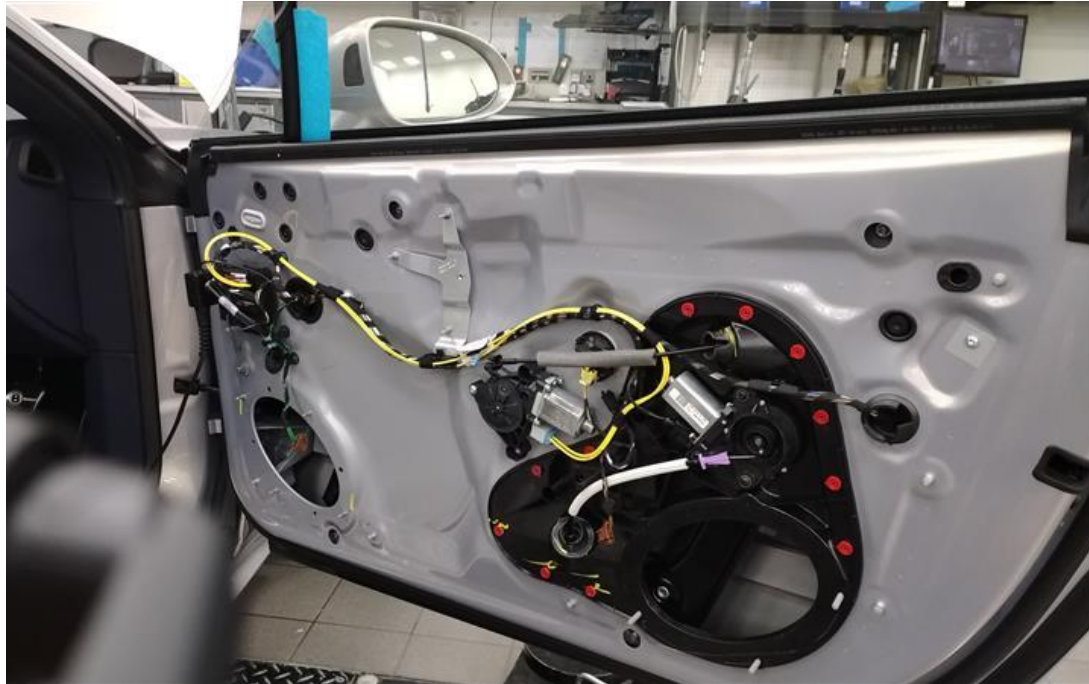
*Figure 8*

After completing the regulator reset procedure, measure the diameter of the motor-to-door ECU feed wires at the motor connector.

If the wires are 1.5mm diameter, carry out the replacement of the original motor-to-door ECU feed wires (yellow in the photograph) with the 2.5mm diameter new wires (part number: 000 979 242 E).

Refer to the information in ElsaPro Repair Group 97 Wiring harness repairs
