| <b>Job Code:</b> | M920035 – 26-008 | <b>Product:</b> | Lineage LVT1 |

### Purpose

This bulletin describes the procedure to install the Compressor Power Relay Upgrade on affected Lineage units. The upgrade routes the A/C compressor positive power feed through a dedicated 120-amp relay, removing the compressor load from the control board. The upgrade is supplied as SDG kit 5000041 (GDRV PN 710676).

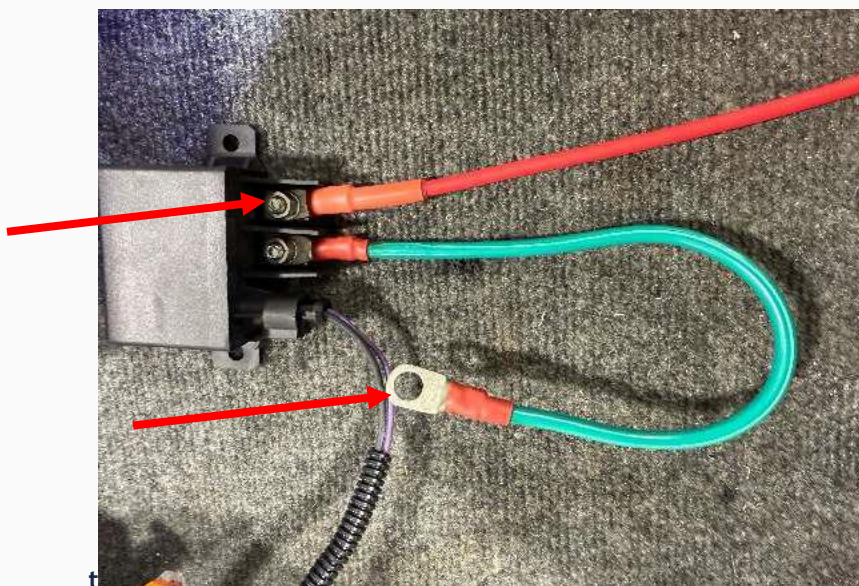
**Fig. 1** — New 120-amp relay — compressor positive power wire and 12" power wire connections.

**Step 1** — Access the chassis power strip or breaker where the compressor positive power wire is connected. Disconnect the wire and reconnect it to the new relay as shown.

**Step 2** — Connect the 12" power wire (PN 0100149) from the relay to the original stud or breaker that the compressor power wire was removed from. Tighten all connections.

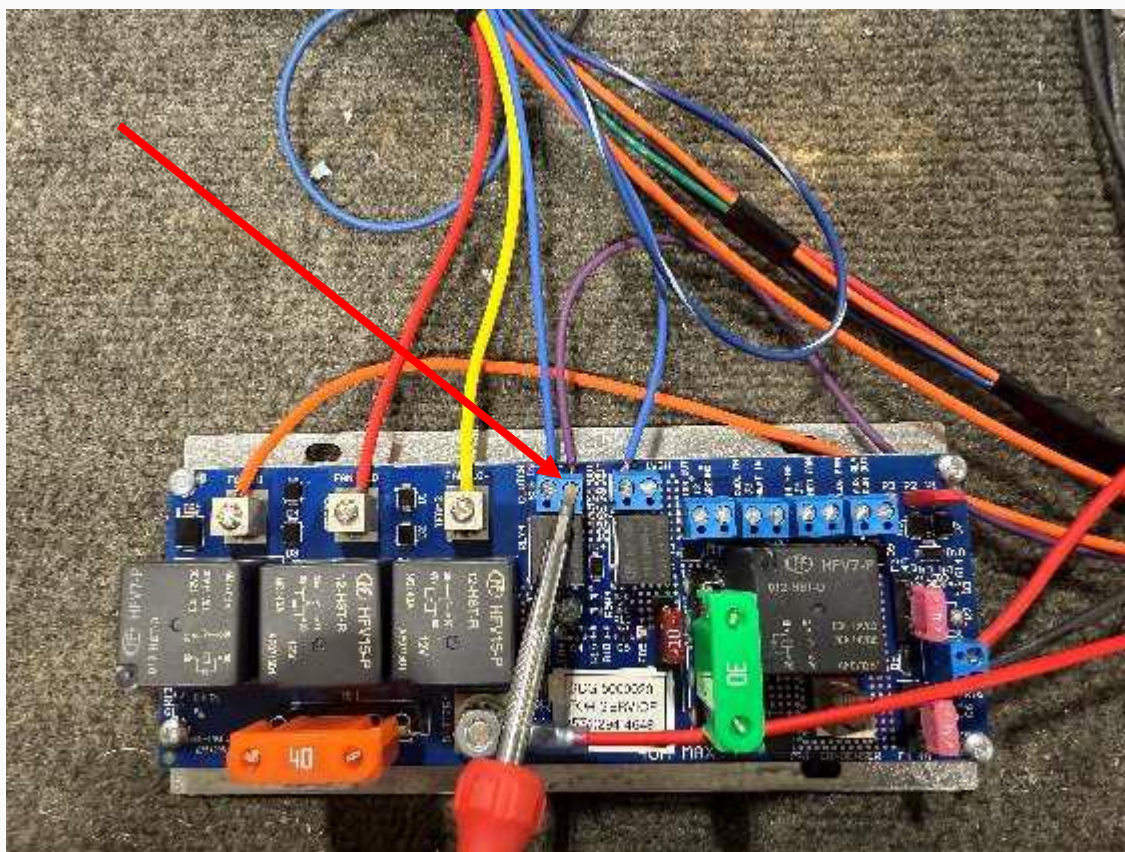
**Fig. 2** — Control board — purple wire terminal location.

**Step 3** — Remove the purple wire from the control board using a 1/8" screwdriver tip as shown.

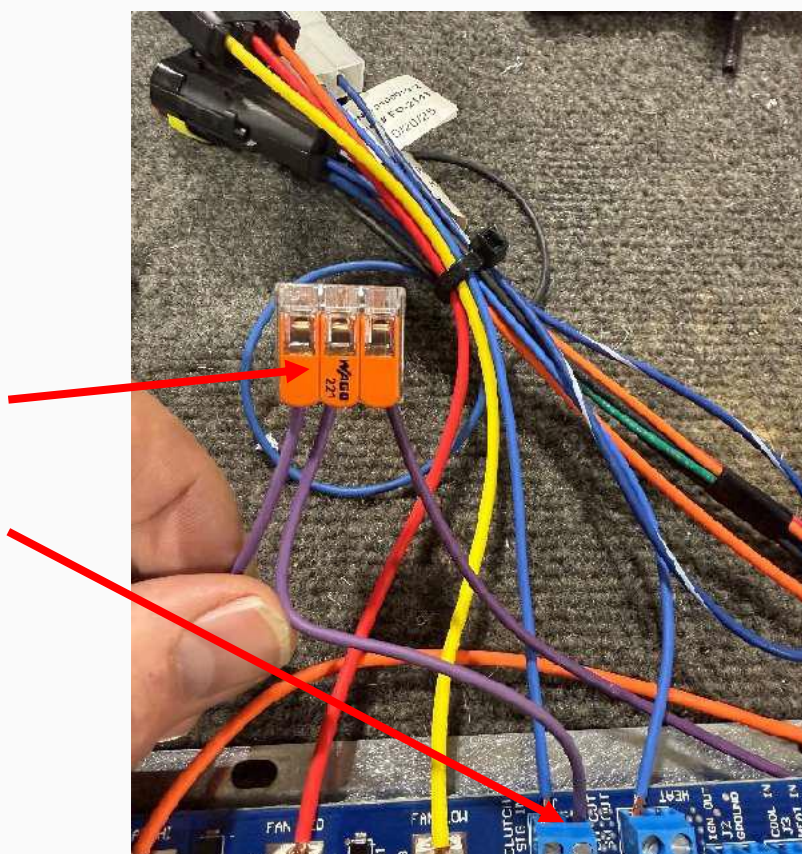
**Fig. 3** — WAGO connector splice — removed purple wire and short purple wire to control board.

**Step 4** — Connect the removed purple wire to the supplied WAGO connector as shown.

**Step 5** — Connect the short purple wire on the WAGO connector back onto the control board in the same position the original purple wire was removed from.
