### AC and DC Charging inoperative with no failure codes in the relevant control units.

| Topic number | LI54.10-P-080881 |
| Function group | 54.10 - Battery, power supply, voltage converter |
| Validity | BEVs (Battery Electric Vehicles) & PHEVs (Plug-in Hybrid Electric Vehicles) with code 83B. |

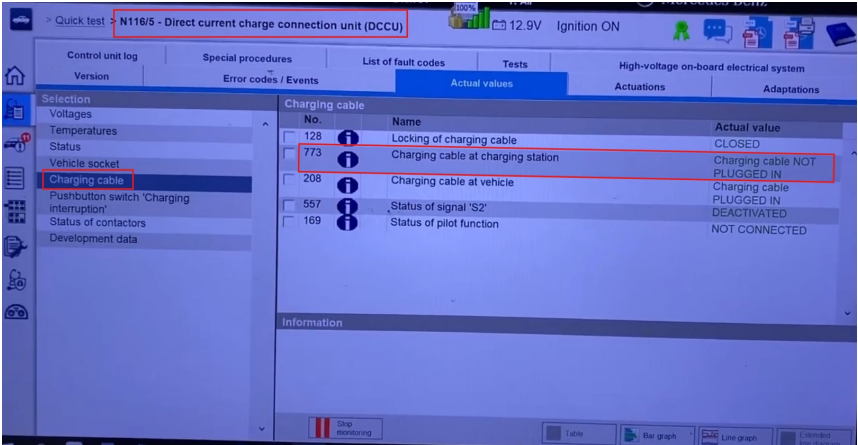
Control pilot (CP) circuit in DCB (N116/5: Direct current charge connection unit) might be not functional due to electrical overstress from EVSE (Electric Vehicle Supply Equipment | Charging Station).

The actual value “Charging cable at charging station” and “status of pilot function” shows “Charging cable NOT PLUGGED IN” & “CP not connected” respectively, even though the charging cable is connected on both sides. This confirms a possible breakdown of Control Pilot (CP) circuit inside the DCB.

Refer to the charging cable actual values in DCB (N116/5).
