| Voluntary Service Campaign | 2027MY Telluride (LQ2) |
| SC377 | August 2026 |

BRAKE BOOSTER PUSHROD ADJUSTMENT (SC377)

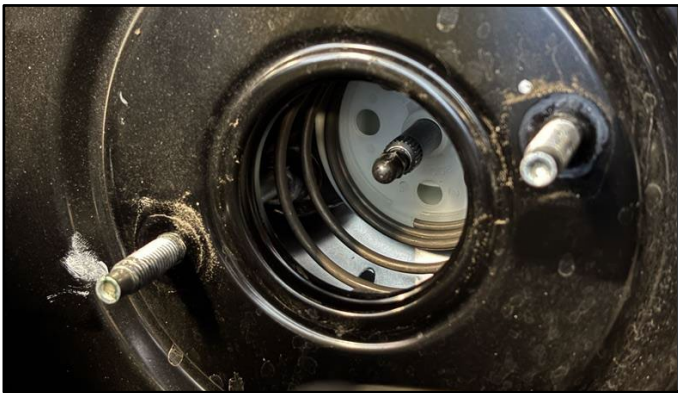
This bulletin provides information for adjusting the brake booster pushrod on certain 2027MY Telluride (LQ2) vehicles produced from January 2, 2026, through April 22, 2026. The brake booster pushrod may be improperly adjusted. As a result, following certain low-speed automatic braking events, a small amount of residual brake pressure may temporarily remain after systems such as Reverse Parking Collision-Avoidance Assist (PCA-R) or Rear Cross-Traffic Collision-Avoidance Assist (RCCA) automatically apply the brakes to help prevent a collision. After the automatic braking is canceled, the driver may experience the brakes lightly dragging for a short time. This condition does not affect braking performance or stopping distance. Follow the procedure outlined in this bulletin to adjust the brake booster pushrod and ensure brake pressure is released normally after a low-speed automatic braking event is canceled. Before performing the procedure, confirm that the vehicle is included in the list of affected VINs.

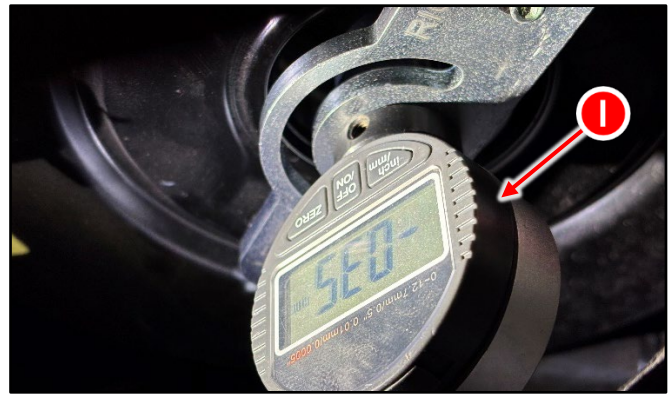
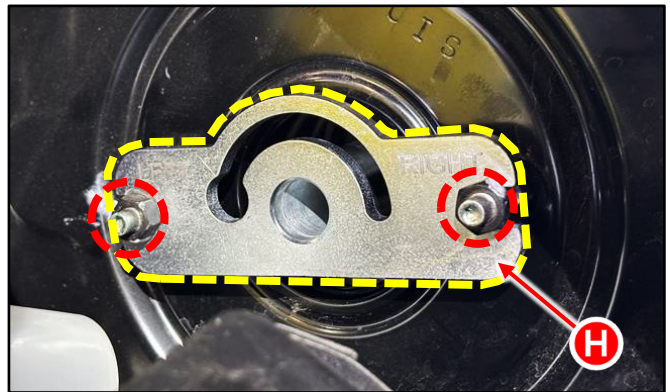
The new output rod measurement should read (negative) -0.30mm or greater. If the new measurement reads -0.29mm or less, repeat steps 14 to 19 to increase above -0.30mm.

18. Insert the digital gauge (I) through the bracket and ensure that it is making internal contact against the brake booster output rod.
19. Press the digital gauge (I) inward and hold firm to measure the new output rod reading on the screen.

20. Loosen the two (2) output rod bracket (H) retaining nuts and remove it.
