**Grinding Noise When Using the Indicator Lever**

| REF NO:<br><b>TJ 37868.1.0</b> | ISSUING DEPARTMENT:<br><b>Technical Service</b> | CAR MARKET:<br><b>United States and Canada</b> | |

TJ Instruction VCC-537279-2

| <b>Title</b> | Steering wheel module (SWM) | <b>Page</b> | 1 ( 5 ) |

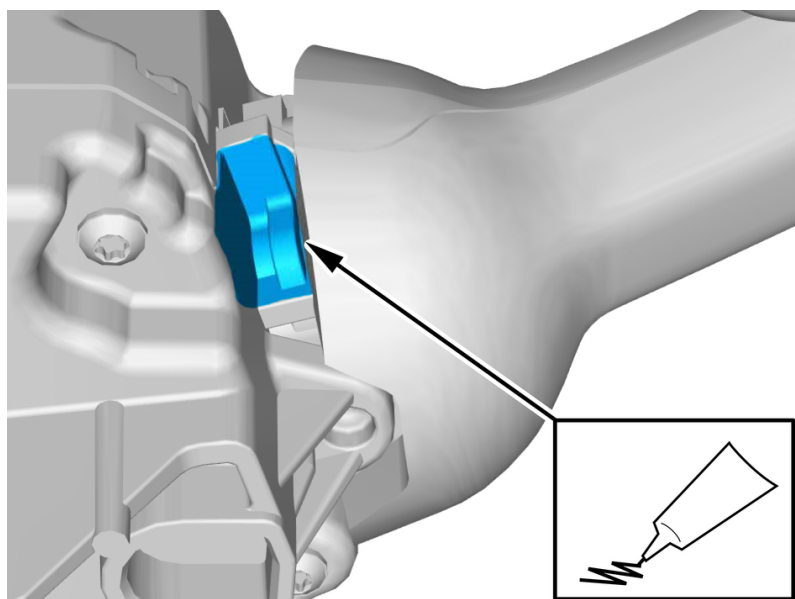
If a customer complains on a grinding noise from SWM area when using the indicator lever, follow advice under Service.

Apply grease on the area indicated.

**Use:** Silicone grease , 1161687
