## Volvo Car USA LLC

## Technical Journal

| Technical Journal Title<br>Aftermarket OBD2 Devices Causing VIDA Connection Issues or SW Download Failures | | Ref. No.<br>TJ 37231.1.1 | |

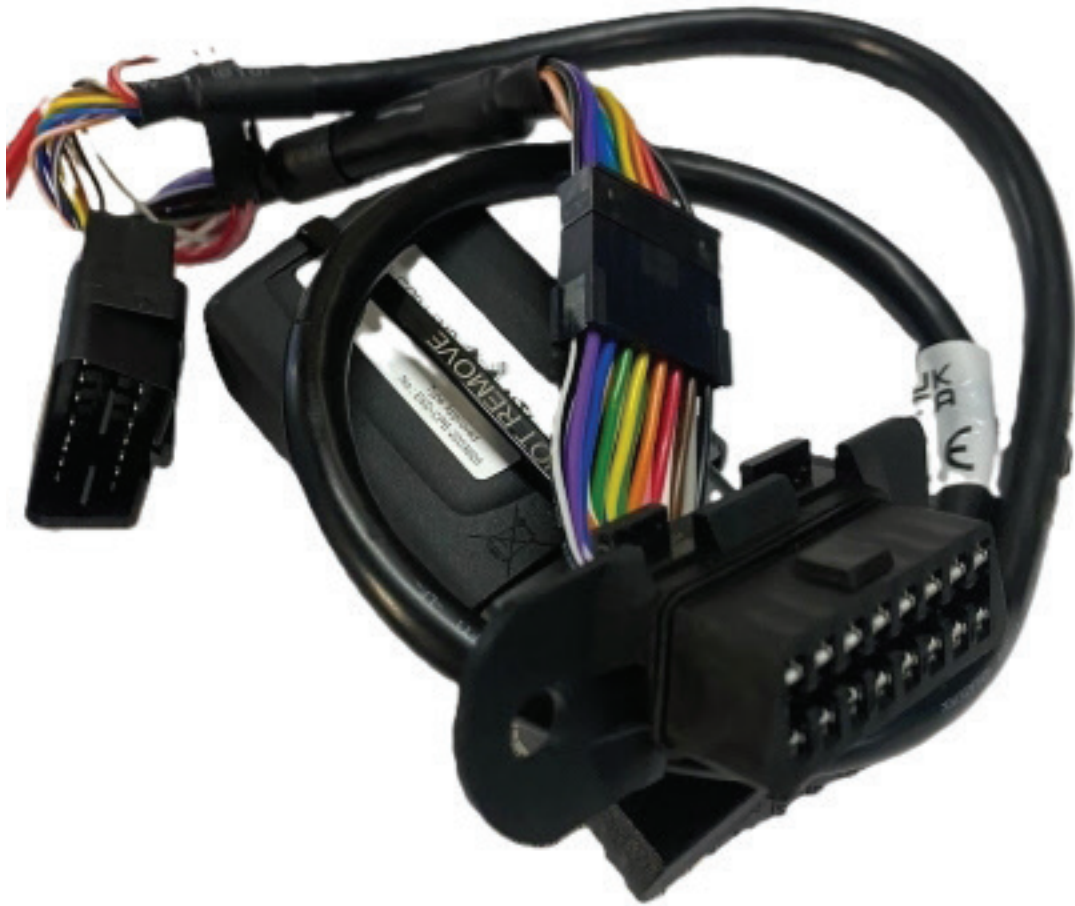
| File Name | File Size |
|---|---|
| Aftermarket OBD2.jpg | 0.0767 MB |

**TIP: Volvo DLC ports are dark grey, if the port is in the factory location but is black, this is a sign that aftermarket equipment is installed.** See attachment Aftermarket OBD2.jpg for an example.

Before starting fault-tracing ensure all third-party (aftermarket) devices are disconnected from the car.
