Subject: UPDATE: N242471460-01 – Customer Satisfaction Program  
Electrical Drive Unit Leak  
Updated Parts Information, Service Procedure

Models: 2024 Chevrolet Blazer EV  
2024 Chevrolet Equinox EV

## N242471460 Electrical Drive Unit Leak

| <b>Condition</b> | Certain vehicles listed above, may have been built with an Electric Drive Unit mounting bolt that is too long, causing damage to the Drive Unit case. |

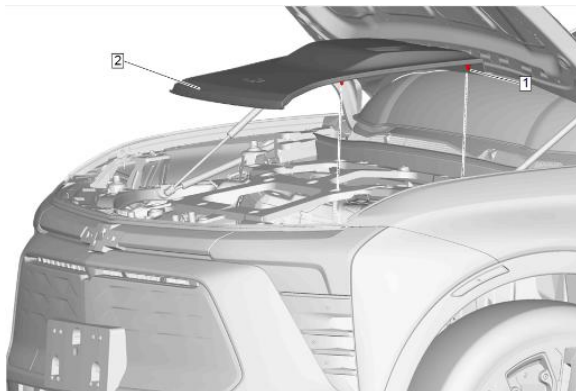
6275385

- Remove the Front Compartment Center Sight Shield and Compartment Support (if equipped) . Refer to *Front Compartment Center Sight Shield Replacement* and *Front Trim Finish Compartment Support Replacement* in SI.

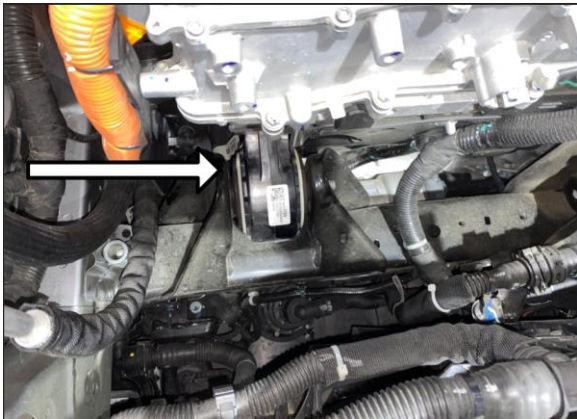
2. Locate the Right Side Drive Motor Mount.

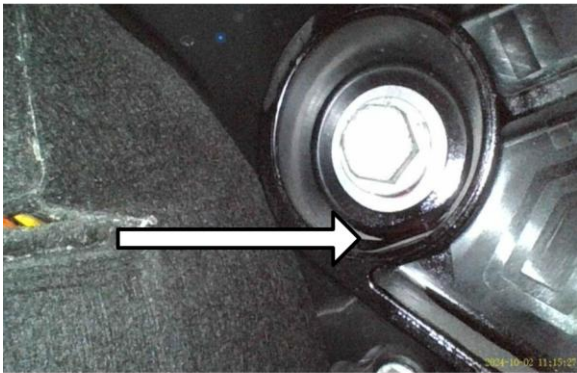
3. Inspect for the presence of fluid on and around the Right Side Drive Motor Mount.
- If fluid is present on or around the Right Side Drive Motor Mount, proceed to step 5.
  - If fluid is NOT present on or around the Right Side Drive Motor Mount AND THE VEHICLE IS IN DEALER INVENTORY, proceed to step 4.
  - If fluid is NOT present on or around the Right Side Drive Motor Mount AND THE VEHICLE IS CUSTOMER DRIVEN, Front Electric Drive Transmission Module is OK. Reinstall the Front Compartment Center Sight Shield and Compartment Support (if equipped) . Refer to *Front Compartment Center Sight Shield Replacement* and *Front Trim Finish Compartment Support Replacement* in SI. No further action is required.

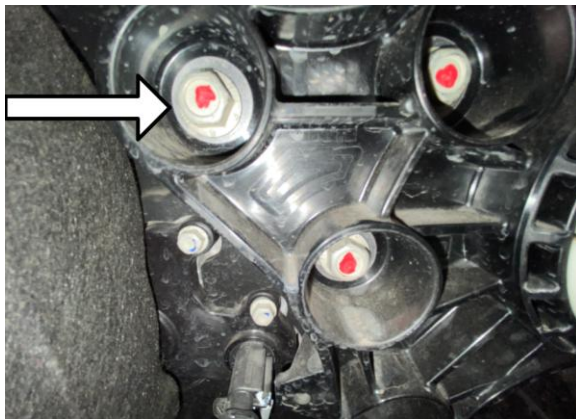
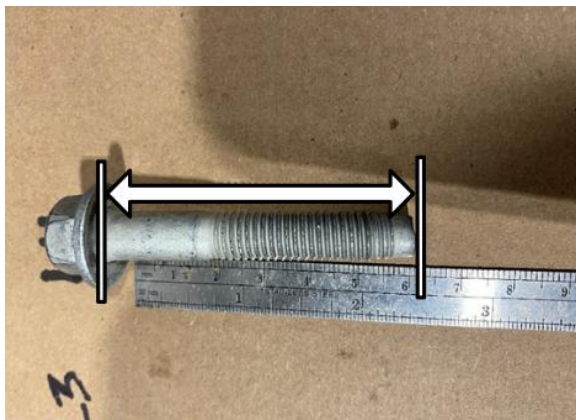
**Important:** ONLY REMOVE THE DRIVE MOTOR MOUNT FASTENER AS DEPICTED IN THE ABOVE GRAPHICS. DO NOT REMOVE ANY ADDITIONAL FASTENERS AS PART OF THIS INSPECTION STEP.

**Note:** Ensure the measurement is taken from the bottom of the bolt flange to the bolt tip, as depicted in the above graphic.

- If the RH Front Drive Motor Mount Fastener measures 55 mm, the Front Electric Drive Transmission Module is OK. Replace the fastener with a NEW fastener. Torque to 58 N•m (43 lb ft) and then an additional 75 degrees rotation. Reinstall the Front Compartment Center Sight Shield and Compartment Support (if equipped) . Refer to *Front Compartment Center Sight Shield Replacement* and *Front Trim Finish Compartment Support Replacement* in SI. No further action is required.
- If the RH Front Drive Motor Mount Fastener measures 60 mm or more, the Front Electric Drive Transmission Module is NOT OK. Proceed to step 5.

4. Remove the RH Front Drive Motor Mount Fastener and measure the fastener.

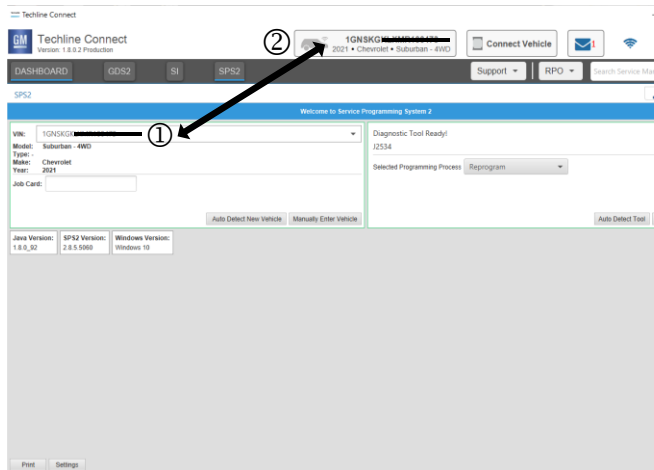
5743643

**Caution:** Be sure the VIN selected in the drop down menu (1) is the same as the vehicle connected (2) before beginning programming.

**Important:** Techline Connect screen shown above.

- Reprogram the Drive Motor Control Module. Refer to *K107 Drive Motor Control Module: Programming and Setup* in SI.

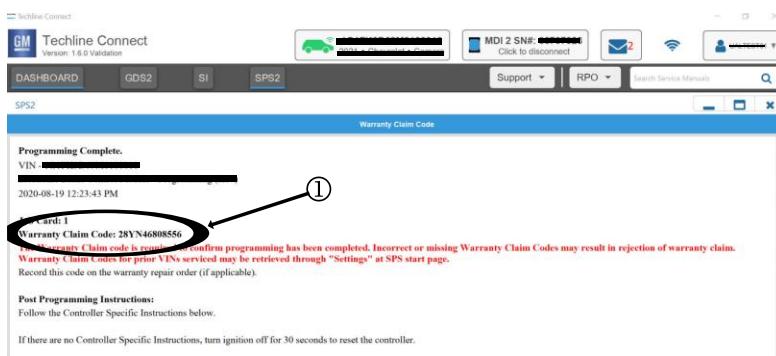
5644478

**Important:** To avoid warranty transaction rejections, you **MUST** record the warranty claim code provided on the Warranty Claim Code (WCC) screen shown above on the job card. Refer to callout 1 above for the location of the WCC on the screen.

- Record SPS Warranty Claim Code on job card for warranty transaction submission.

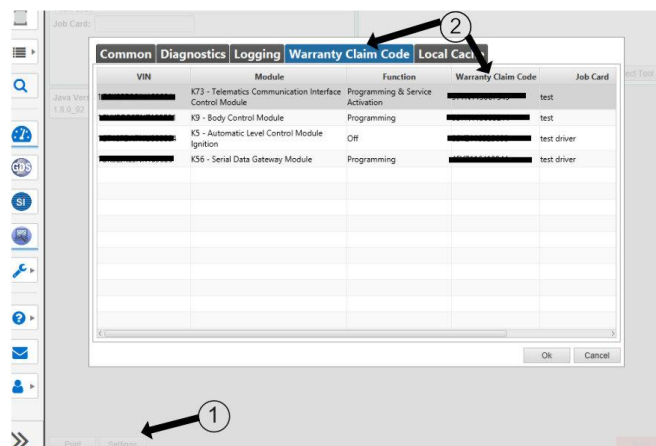
6125774

1. Open TLC on the computer used to program the vehicle.
2. Select and start SPS2.
3. Select Settings (1).
4. Select the Warranty Claim Code tab (2).
