**Technical Service Bulletin (TSB)**  
**Umbrella Valve Seal Missing From Cylinder Head Cover**

| REFERENCE: | TSB: 09-017-26 REV. A<br>GROUP: 09 - Engine | Date: | August 19, 2026 | REVISION: | 09-017-26 |
| VEHICLES AFFECTED: | 2026 - 2027 (WL) Jeep Grand Cherokee / Grand Cherokee L<br>This bulletin applies to vehicles built on or before August 15, 2026 (MDH 0815XX) equipped with a 2.0L Hurricane 4 Turbo W/ESS (Sales Code EC7). | | | MARKET APPLICABILITY:<br><div><input checked="" type="checkbox"/> NA<input type="checkbox"/> MEA<br/><input type="checkbox"/> EE<input type="checkbox"/> IAP<br/><input type="checkbox"/> SA<input type="checkbox"/> CH</div><br>NOTE: This bulletin applies to North America markets. | |
| CAUSE: | Cover Cylinder Head Umbrella valve seal missing | | | | |

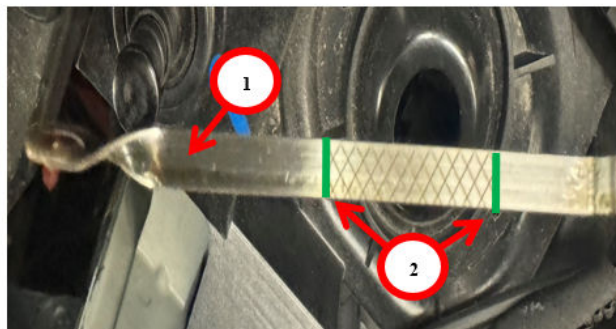
**Fig. 1**  
Oil Level Inspection

1 - Oil Level - Low  
2 - Oil Level - Acceptable Range

2. Is the oil level low [Fig. 1](#)?
  - YES>>> Proceed to [Step 3](#).
  - NO>>> This bulletin has been completed. Use Inspection LOP 09-35-20-98) to close the active RSU.  
**Refer to service library for further misfire diagnosis.**

3. If the engine oil level is found to be low, remove the Positive Crankcase Ventilation (PCV) valve. Refer to the detailed service procedures available in DealerCONNECT/Service Library under: Service Info> 25 - Emissions Control / Crankcase Ventilation / Valve, Positive Crankcase Ventilation (PCV) / Removal and Installation.

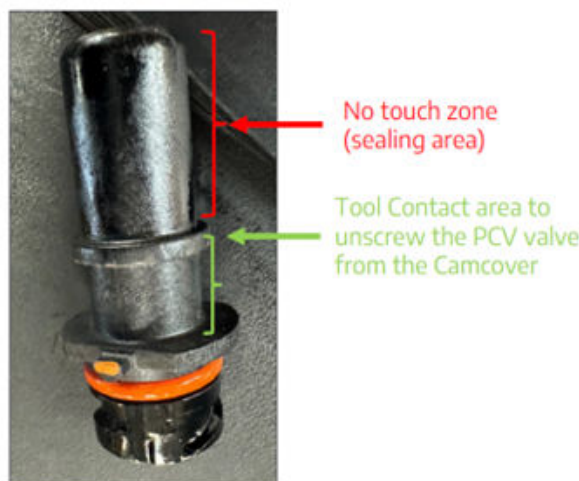
**Fig. 2**  
PCV Valve During Removal

**NOTE: Be sure to follow warnings regarding location on the PCV valve where tool contact should be avoided [Fig. 2](#).**

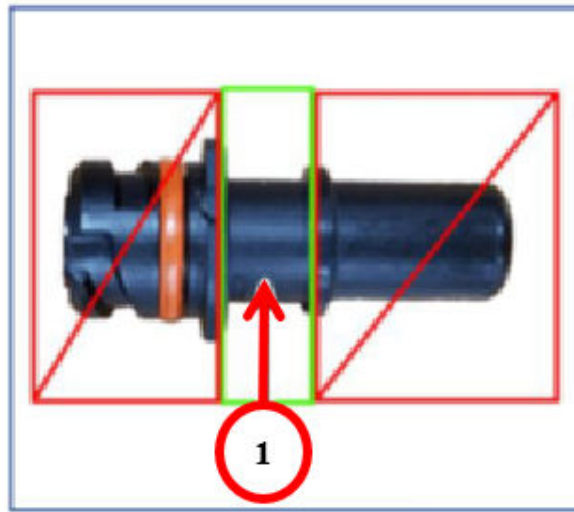
**Fig. 3**  
Approved Zone - PCV Valve Removal

**NOTE:** Use a pair of thin nosed pliers inserted into the approved zone on the PCV valve for removal [Fig. 3](#).

1 - Approved Zone In Green

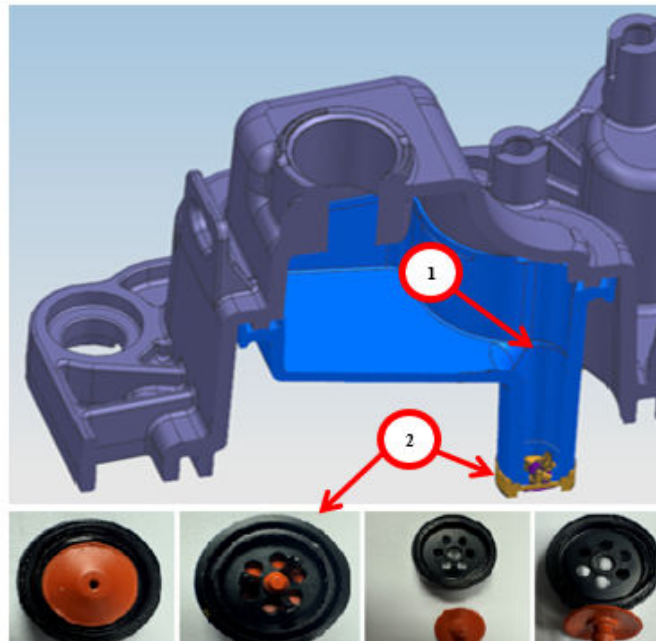
**Fig. 4**  
Borescope to PCV Valve Opening

4. With the PCV valve removed, insert a borescope into the PCV valve opening [Fig. 4](#) to inspect if the umbrella valve is missing or present [Fig. 5](#) [Fig. 6](#).

1 - PCV Valve Chamber - PCV Valve Removed  
2 - Umbrella Valve Seal

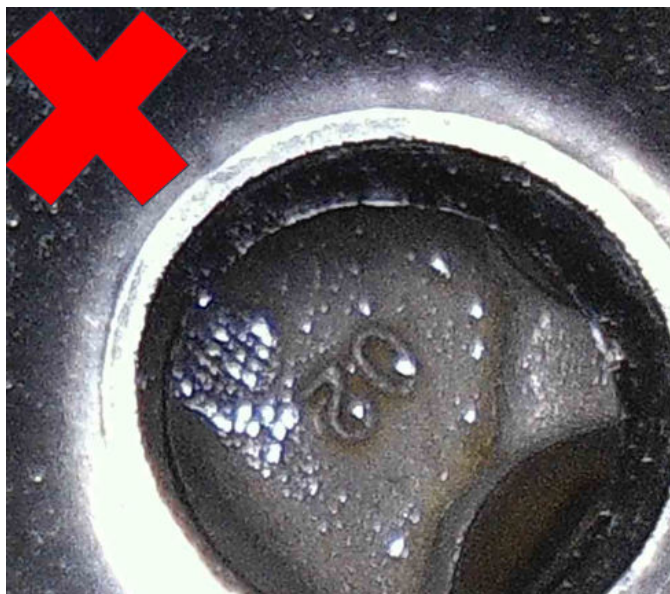
**Fig. 5**  
Umbrella Valve Seal - Missing

5. Is the umbrella valve seal missing [Fig. 5](#)?
  - YES>>> Replace the cylinder head cover assembly. Refer to the detailed service procedures available in DealerCONNECT/Service Library under: Service Info> 09 - Engine, 2.0L / Cylinder Head / Cover(s), Cylinder Head / Removal and Installation and then proceed to [Step 6](#).
  - NO>>> This bulletin has been completed. Use Inspection LOP (09-35-20-98) to close the active RSU.  
**Perform further oil consumption diagnosis as required.**
6. Ensure that the engine oil level is to proper specification.
7. \*\*Using wiTECH, perform the PCM Reset ECU routine. Navigate to **Guided Diagnostics > Reset ECU**, select **PCM**, and follow the on-screen instructions to complete the procedure.\*\*
8. Clear DTCs.

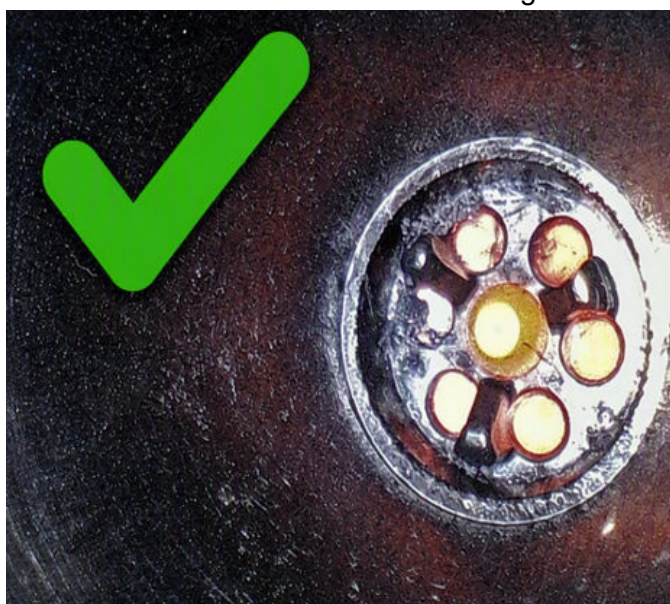
**Fig. 6**  
Umbrella Valve Seal - Present
