**Technical Service Bulletin (TSB)**  
**Umbrella Valve Seal Missing From Cylinder  
Head Cover - UNSOLD POPULATION ONLY**

| REFERENCE: | TSB: 09-020-26<br>GROUP: 09 - Engine | Date: | August 20, 2026 | REVISION: | — |
| CAUSE: | Cover Cylinder Head Umbrella valve seal missing | | | | |

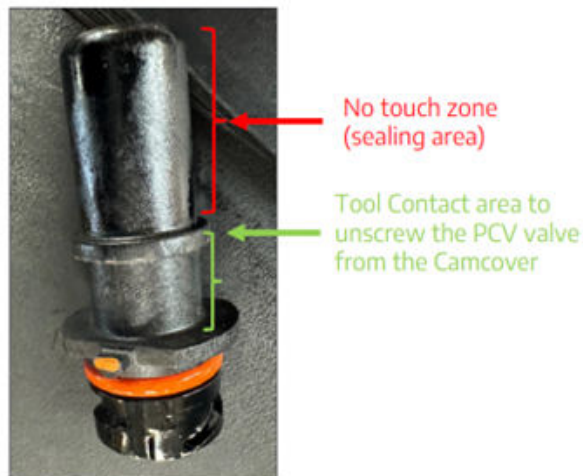
**Fig. 1**  
PCV Valve During Removal

**NOTE:** Be sure to follow warnings regarding location on the PCV valve where tool contact should be avoided [Fig. 1](#).

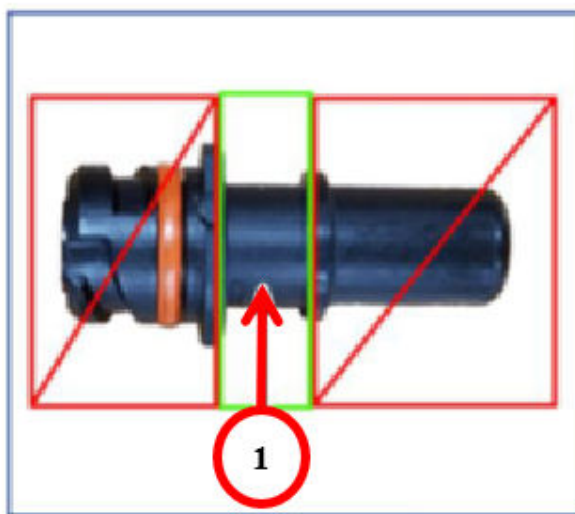
**Fig. 2**  
Approved Zone - PCV Valve Removal

**NOTE:** Use a pair of thin nosed pliers inserted into the approved zone on the PCV valve for removal [Fig. 2](#).

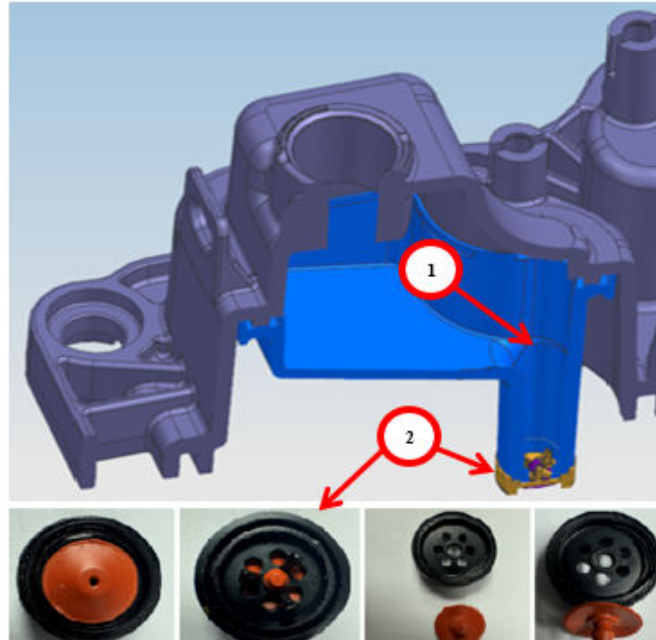
**Fig. 3**  
Borescope to PCV Valve Opening

2. With the PCV valve removed, insert a borescope into the PCV valve opening [Fig. 3](#) to inspect if the umbrella valve is missing or present [Fig. 4](#) [Fig. 5](#).

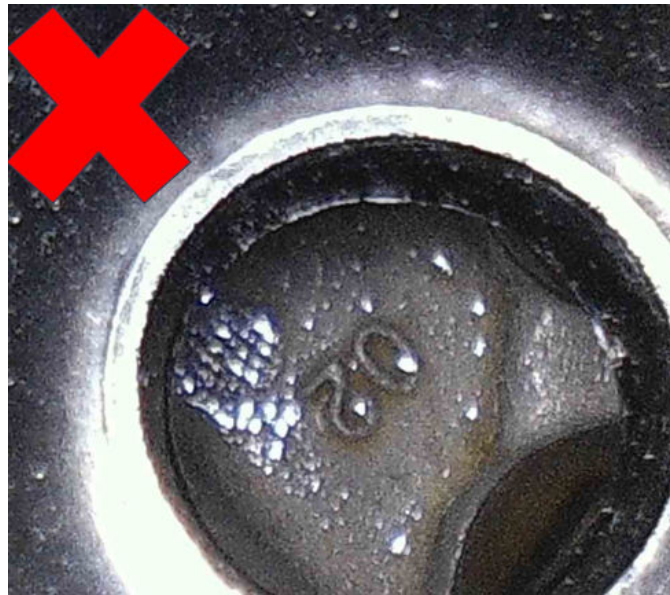
**Fig. 4**  
Umbrella Valve Seal - Missing

1 - PCV Valve Chamber - PCV Valve Removed  
2 - Umbrella Valve Seal

3. Is the umbrella valve seal missing [Fig. 4](#)?
  - YES>>> Replace the cylinder head cover assembly. Refer to the detailed service procedures available in DealerCONNECT/Service Library under: Service Info> 09 - Engine, 2.0L / Cylinder Head / Cover(s), Cylinder Head / Removal and Installation and then proceed to [Step 4](#).
  - NO>>> This bulletin has been completed. Use Inspection LOP (09-35-20-98) to close the active RSU.
4. Ensure that the engine oil level is to proper specification.
5. Using wiTECH, perform the PCM Reset ECU routine. Navigate to **Guided Diagnostics > Reset ECU**, select **PCM**, and follow the on-screen instructions to complete the procedure.
6. Clear DTCs.
